STRUCTURAL EVALUATION OF  
WASHINGTON ELEMENTARY SCHOOL  
WEST CONTRA COSTA UNIFIED SCHOOL DISTRICT  
(WCCUSD)

DASSE Design, Inc.  
33 New Montgomery Street #850  
San Francisco, CA 94105  
(415) 243-8400

April 30, 2002

DASSE Design Project No. 01B300

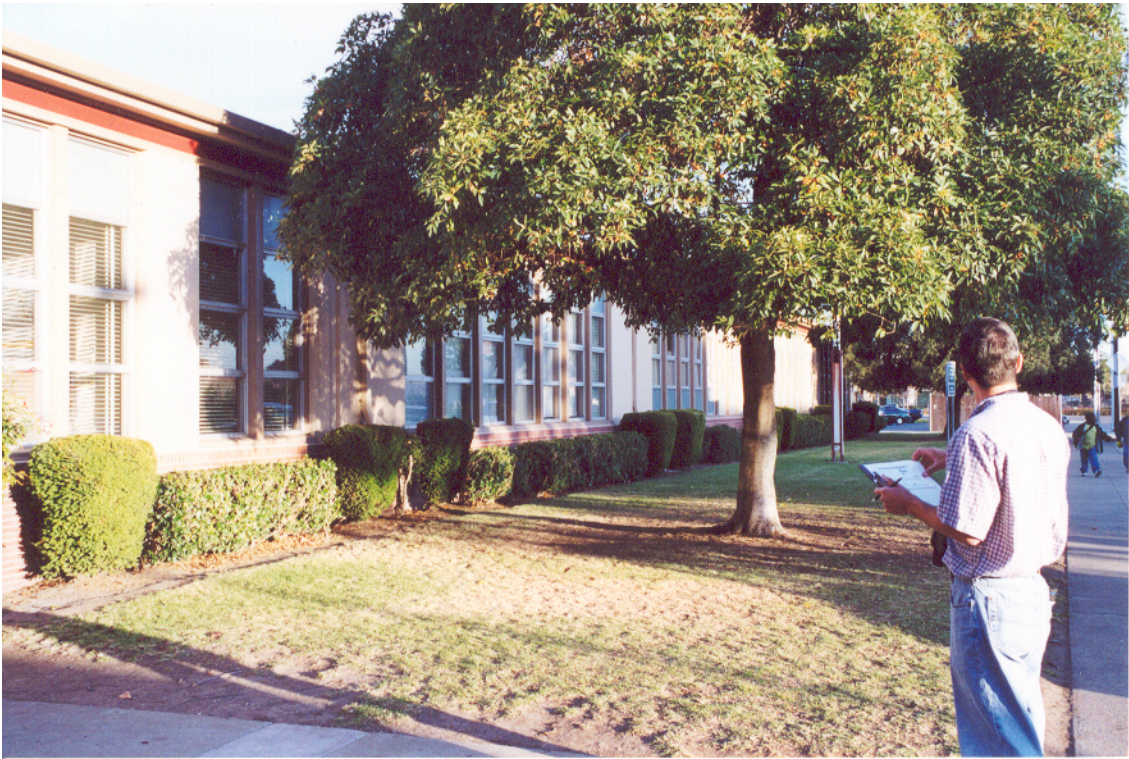
Figure 2: Main building (front)

diaphragm across the ridgeline.
13.	At the classroom wing of the main building, the exterior longitudinal walls are overstressed.
14.	The north wall of the multi-purpose wing of the main building has excessive window openings. The shear wall panels are overstressed.
15.	The south and east exterior walls of the kindergarten area of the main building have excessive window openings. The shear wall panels are overstressed.
16.	At the main building, the north and west shear walls of the kindergarten area also carry loads from the classroom and multi-purpose wings, respectively. These shear walls are overstressed.

13.	Add new plywood sheathing to the unsheathed corridor wall. Provide new collectors and holdowns as required.	1.6	2
14.	Infill windows with new framing and plywood sheathing. Strengthen collectors and provide new holdowns as required.	1.3	5

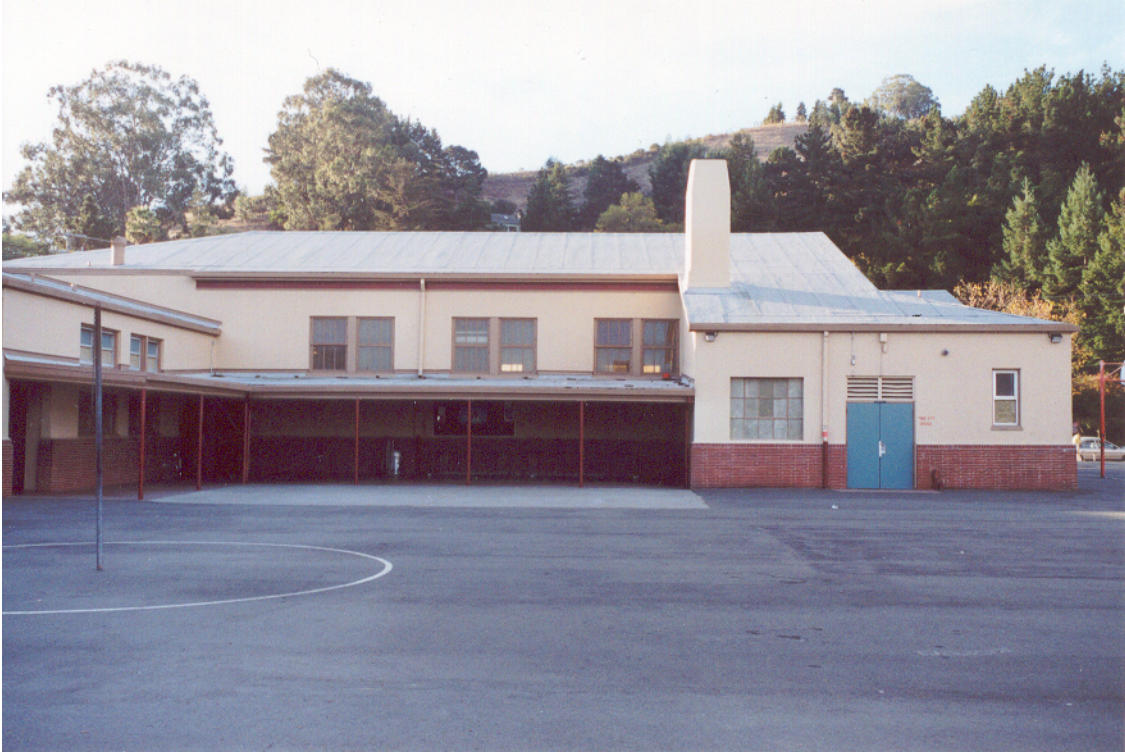
Figure 5: Main building and auditorium

9.	The main building lacks collectors at re-entrant corners, at the boiler room concrete walls, and at the back of the stage where the auditorium area meets the main building area, which may result in damage to the roof diaphragm at these locations and may cause partial collapse.

7.	Remove the existing chimney or provide new bracing of chimney to the roof	1.3	5, 8
8.	Provide new flexible conduit connections at seismic joints	1.9	13

9.	Add new blocking and straps at roof where roof is at same level. Add new posts or diagonal braces where roof levels differ. Some existing connections may need to be strengthened.	1.6	5

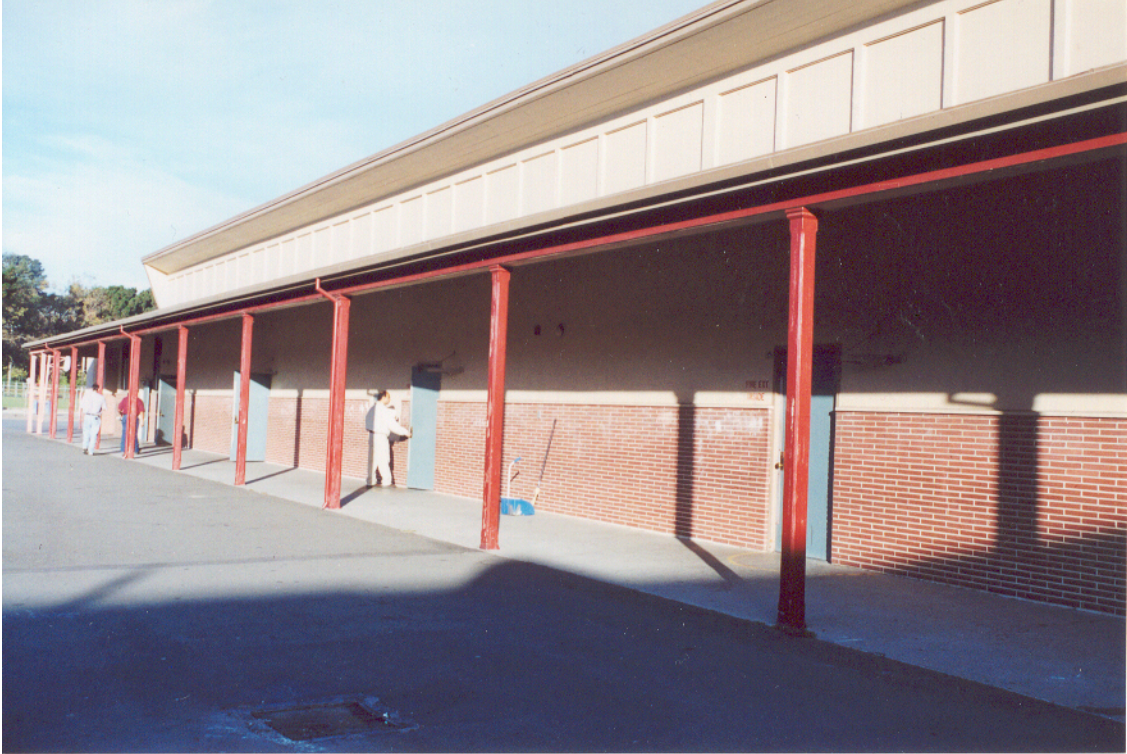
Figure 6: Classroom building, rooms 10-13 (south face)

Item	Building Structural Deficiencies
1.	The classroom buildings have plywood infill in the clerestory windows. The connection of this plywood to the collector above and to the shear wall below may be inadequate.

Item	Recommended Remediation	Priority	Figure Number
1.	Add plywood shear wall at clerestory windows. Strengthen collectors and provide new holdowns as required.	1.4	6

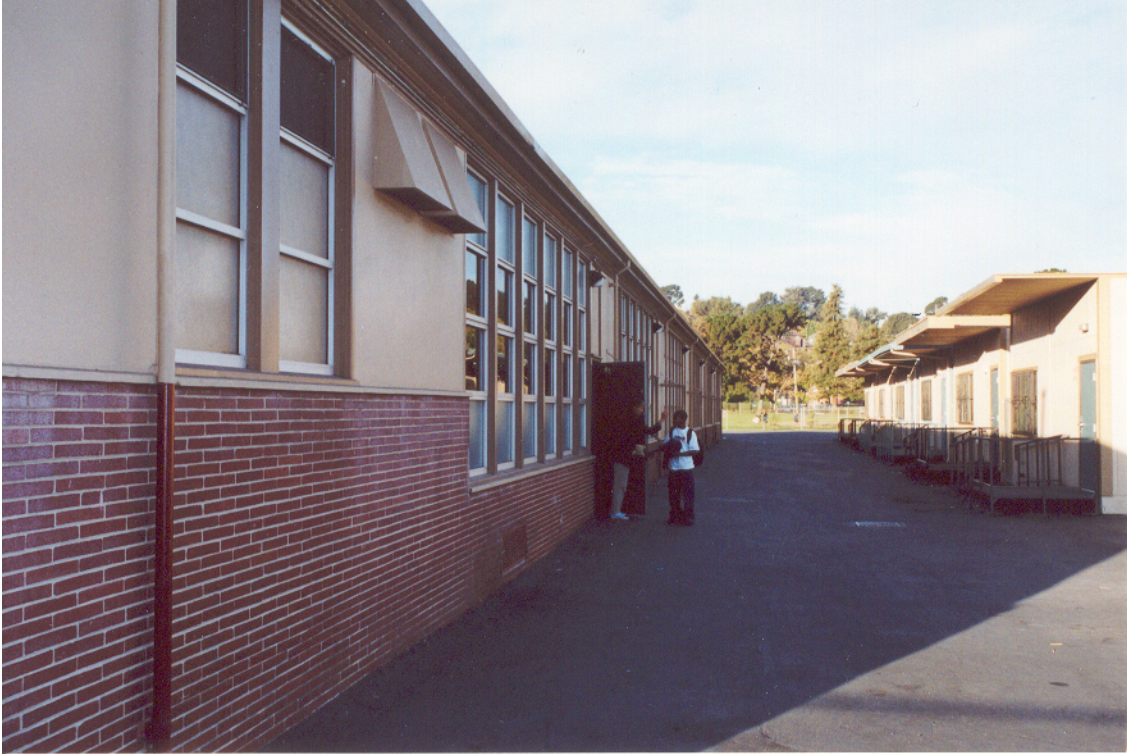
Figure 7: Classroom building, rooms 14-19 (north face)

2.	At the north exterior walls of the classroom buildings, the plywood shear walls are overstressed.
3.	There are electrical conduits attached to the walkway that may snap and fall when the corridor is damaged.

2.	Infill windows with new framing and plywood sheathing. Strengthen collectors and provide new holdowns as required.	1.2	7
3.	Provide new flexible conduit connections at seismic joints	1.9	10

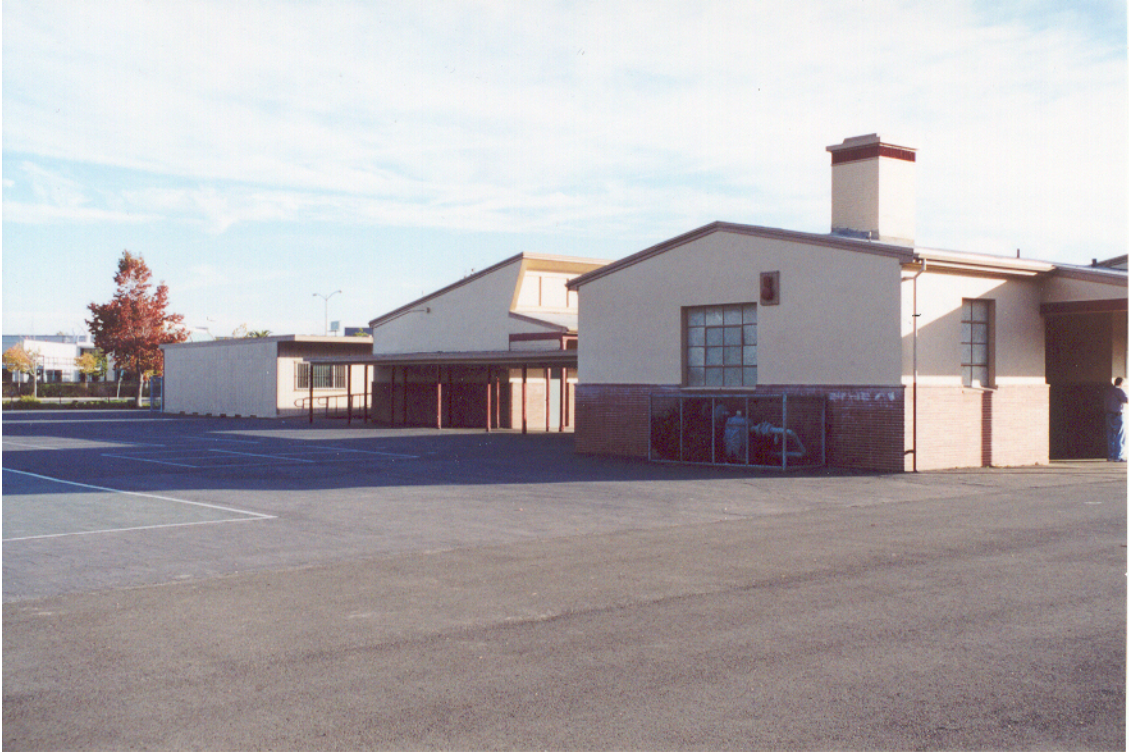
Figure 8: Classroom buildings (west side)

There are covered walkways connecting all the buildings. The walkways are supported by wood posts and beams, and frame into the building walls along the length of the classroom buildings. The walkways are generally only attached to one of the buildings, but there is one location, at the east end of the classroom buildings, where the covered walkway frames into both buildings (see figure 9). The walkway at the west end of the classroom buildings appears to be deteriorated (see figure 10). There are electrical conduits between the buildings that are supported by the covered walkway. There is a large brick chimney at the west end of the south classroom building (see figure 8).

7.	The brick chimney at the south classroom building that may collapse during an earthquake.
8.	The electrical conduit running between the portable classrooms near the roof level has no flexible connection. It may be damaged as the buildings move independently.

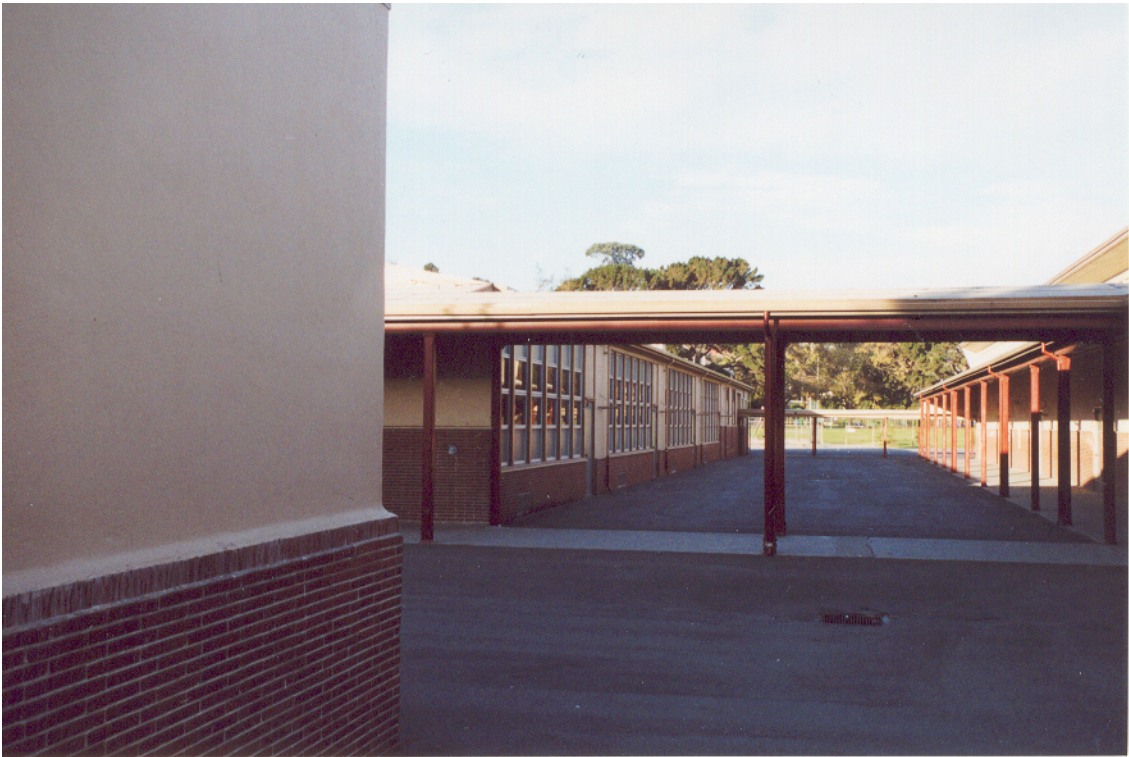
Figure 9: Covered walkway between classroom buildings

6.	The covered walkway from near room number 10 to room number 15 is connected to both classroom buildings and may be damaged and collapse as the buildings move independently.

4.	Demolish existing covered walkway and build a new one.	2.5	10
5.	Provide new steel posts and piers at ends of beams	2.5	12
6.	Provide a new seismic joint and add new columns and footings under the existing beams for gravity and lateral support	1.6	9

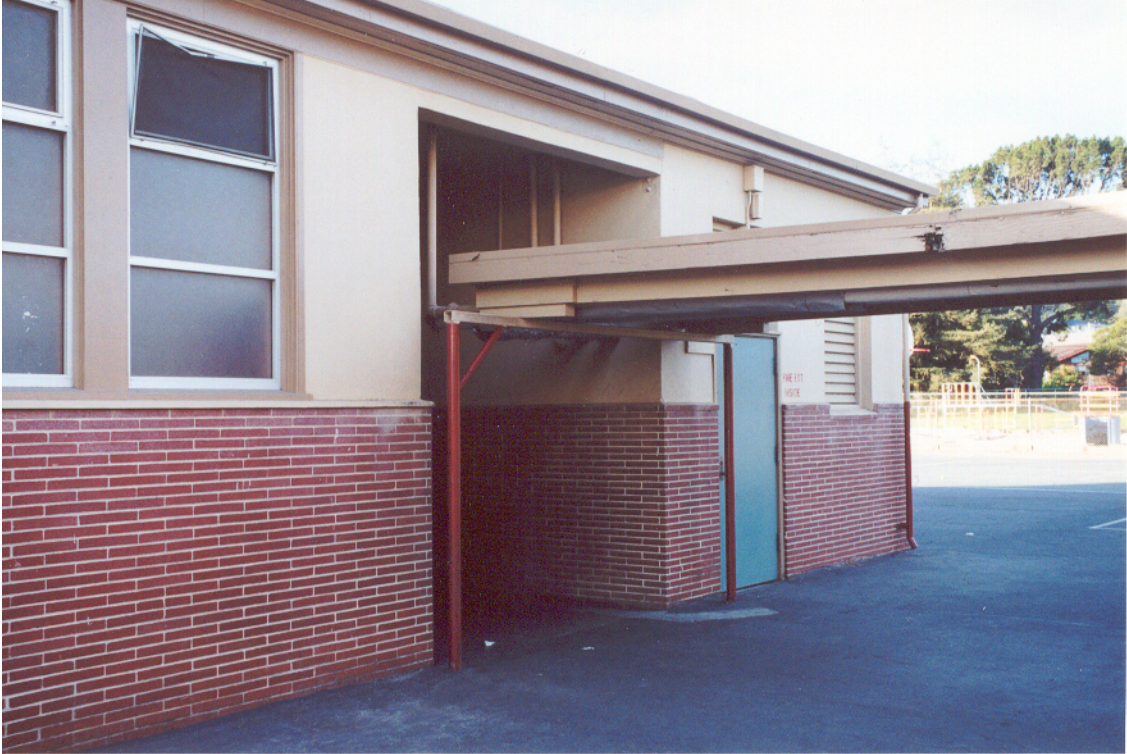
Figure 10: Covered walkway at classroom building (near room 13)

4.	The covered walkway near room number 19 has deteriorated.
5.	Where the covered walkway connects to the main building, the walkway is hung from the building roof by 3/4” dia. rods. There is inadequate seismic bracing of the walkway at this location.

10.	The collector connections from the concrete boiler room portions of the main building and the south classroom building to the rest of the structures may be overstressed.

10.	Strengthen existing collectors and add new collectors where required	1.5	10
11.	Add new holdowns at the ends of shear walls.	1.0	N/A
12.	Provide new blocking and continuous straps above the existing roof sheathing, aligned with the shear walls below.	2.8	N/A

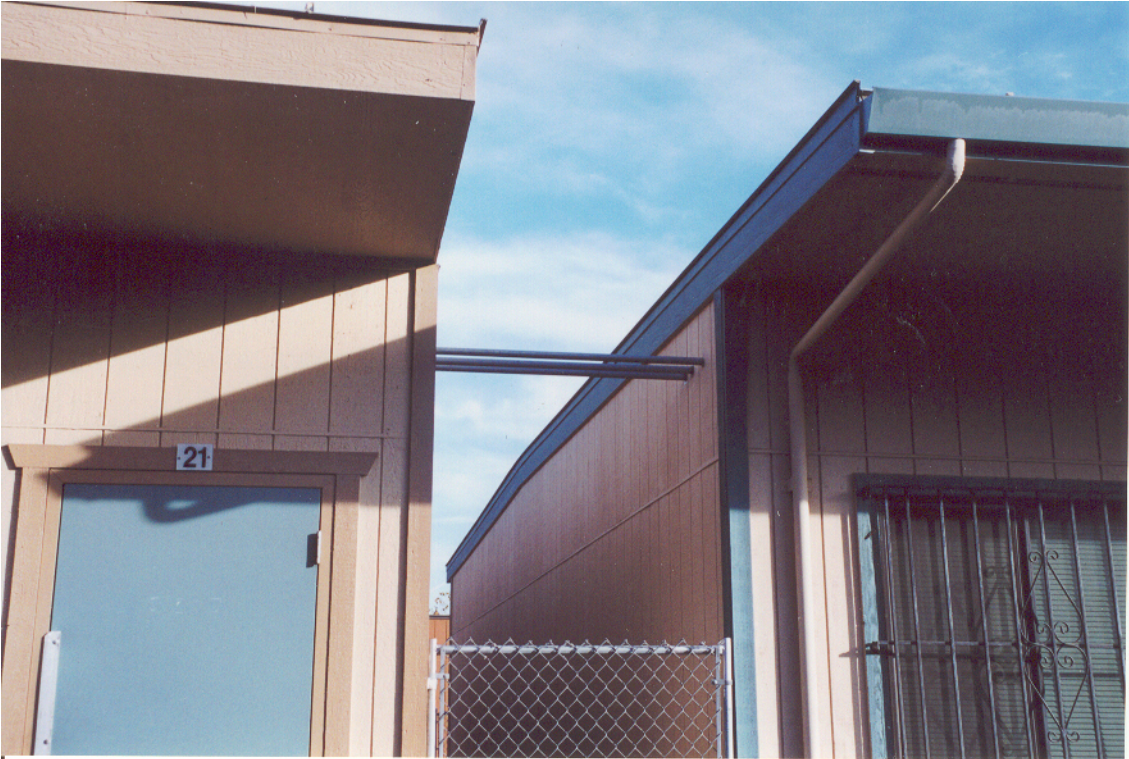
Figure 13: Electrical conduit at portables

There are electrical conduits running between the portables near the roof level (see figure 13)
