CAMERON SPECIAL EDUCATION CENTER

FACILITY ASSESSMENT REPORT

HAMILTON + AITKEN ARCHITECTS
525 Brannan Street Suite 400
San Francisco, CA 94107

12/27/2014

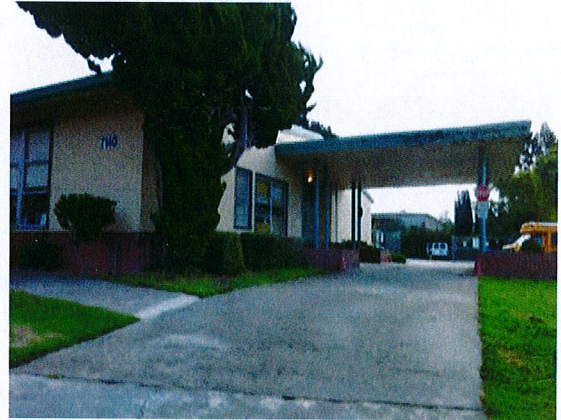
Construction is slab-on-grade foundation with steel columns and wood framed enclosing walls. The roof is low pitch and framed with steel bar joists. The exterior finishes include a brick veneer wainscot and cement plaster (stucco) walls above. Many of the original interior finishes are still intact, with very minor alterations. The heating system is a radiant floor system, which appears to be in working condition.

The adjacent site also contains- a fenced and roofed toddlers play yard, and parking for 25 autos in the vicinity of the school. The site has about a 15-foot elevation change from east to west. To the east a driveway leads from Lawrence Street to a 2200 square foot four-door garage in current use as District-wide storage for low-incidence equipment for disabled students. The Lawrence Street driveway has parking for 8 vehicles. (33 total for the site.) A 5-foot high shed for earthquake supplies is built along the eastern retaining wall and contains plastic containers with earthquake supplies

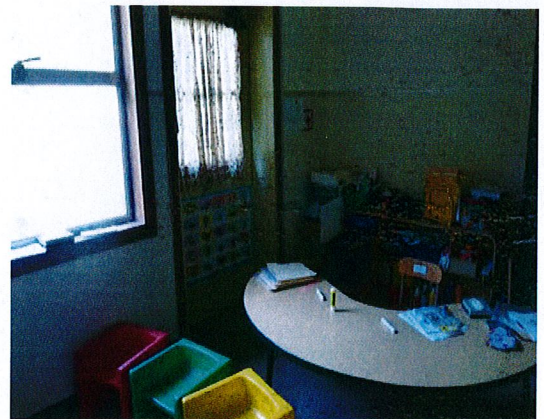
The current restroom space for public/visitors is inadequate. Restrooms for children is being used as storage rooms and is not immediately accessible from class/therapy rooms. The administration staff have private restrooms that are used as file rooms. None of the existing restrooms are accessible.

The current circulation is about 14% of the total existing square footage which is ideal in design standards. However, there is lack of circulation control between public/visitors and the core program users. There is a primary need for point of control to provide security and boundary between different user groups.

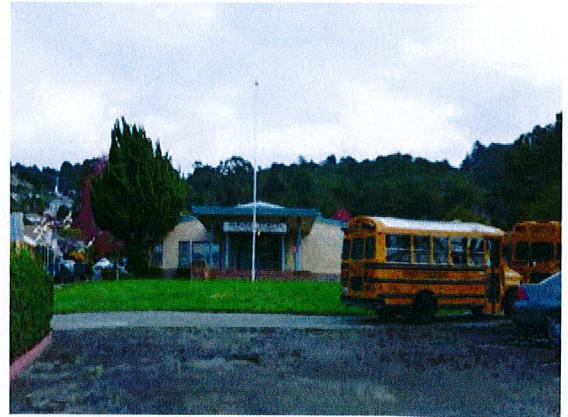
Bus Zones

One of the most dangerous conditions of the current site is the intersection of different circulation paths: the buses cross in front of pedestrian access and the only auto entry or exit. Autos loop around the outdoor toddler play space. A complete study of the site and the possibilities of better separation of pedestrian and child play areas from parking and bus routes will benefit the safety of the program participants.

Finally, the number of buses waiting for students far exceeds the capacity of the site and the driveway to accommodate them. The neighboring streets take a load and occasionally the driveway is blocked as well.
