STRUCTURAL EVALUATION OF
CHARLES ADAMS MIDDLE SCHOOL
WEST CONTRA COSTA UNIFIED SCHOOL DISTRICT
(WCCUSD)

October 17, 2002

DASSE Design Project No. 01B300X2

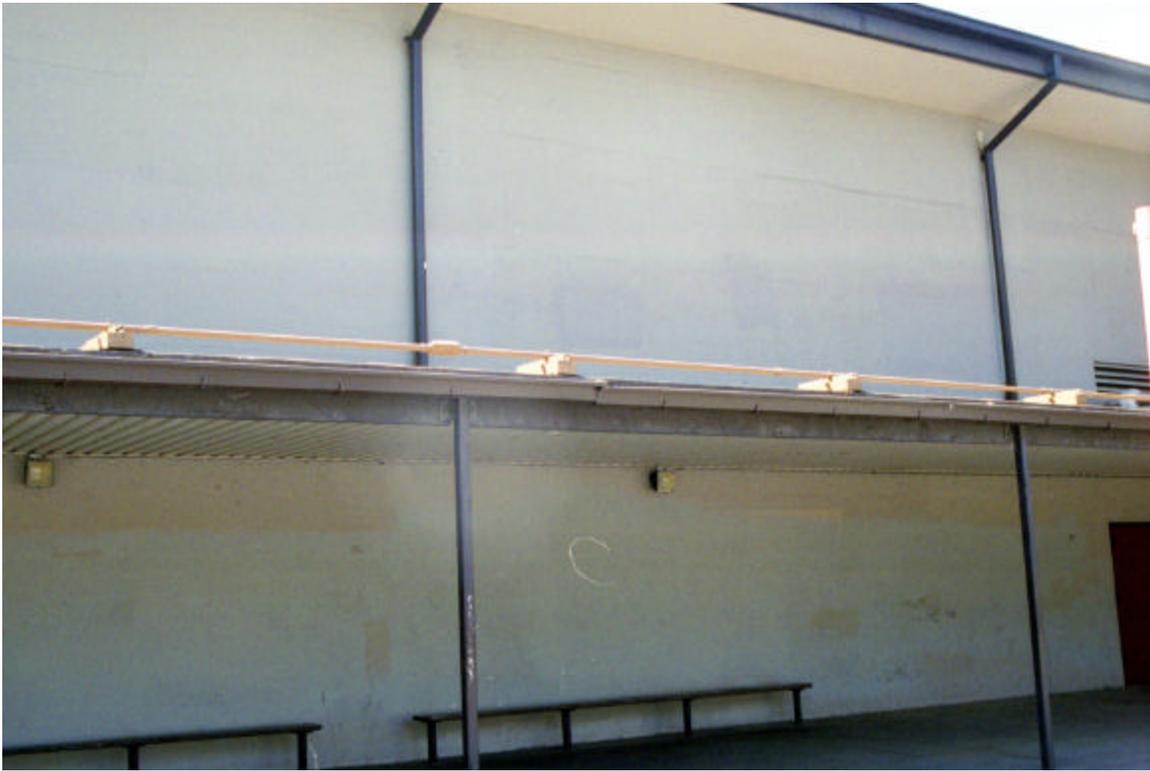
FIGURE 8: GYMNASIUM BUILDING, NORTH ELEVATION

The one story Gymnasium building is constructed on a level lot. It has steel girders spanning 86' supported on concrete pilasters and supporting steel joists (Figure 9). The exterior cast-in-place concrete walls on four sides appear to be in good condition (Figure 8). A small wall separation was observed between the interior stage stud wall and the exterior concrete wall where some roof leak damage was also observed. The steel joists were design-built type, therefore, not all details appeared in the drawings, such as the bridging.
