STRUCTURAL EVALUATION OF  
EL CERRITO HIGH SCHOOL  
WESTERN CONTRA COSTA UNIFIED SCHOOL DISTRICT  
(WCCUSD)

**October 17, 2002**

**DASSE Design Project No. 01B300 X2**

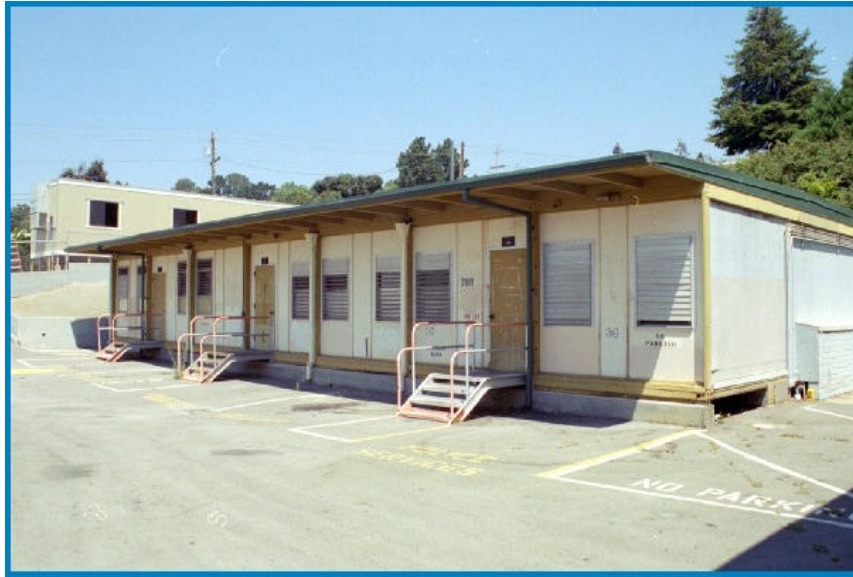
Figure 21: Site Portable Buildings

DASSE's review of portable buildings has been limited to identifying clearly visible seismic deficiencies observed during our site visit and these have been documented in the report. Portable buildings pose several issues with regard to assessing their life safety hazards. First, drawings are often not available and when they are, it is not easy to associate specific drawings with specific portable buildings. Second, portable buildings are small one story wood or metal frame buildings and have demonstrated fairly safe performance in past earthquakes. Third, there is a likelihood that portable buildings (especially those constructed prior to 1982) are not in compliance with state regulations, either because they were not permitted or because the permit was for temporary occupancy and has expired.
