STRUCTURAL EVALUATION OF
HARBOUR WAY DAY ACADEMY
WEST CONTRA COSTA UNIFIED SCHOOL DISTRICT
(WCCUSD)

DASSE Design, Inc.
33 New Montgomery Street #850
San Francisco, CA 94105
(415) 243-8400

October 17, 2002

DASSE Design Project No. 01B300x2

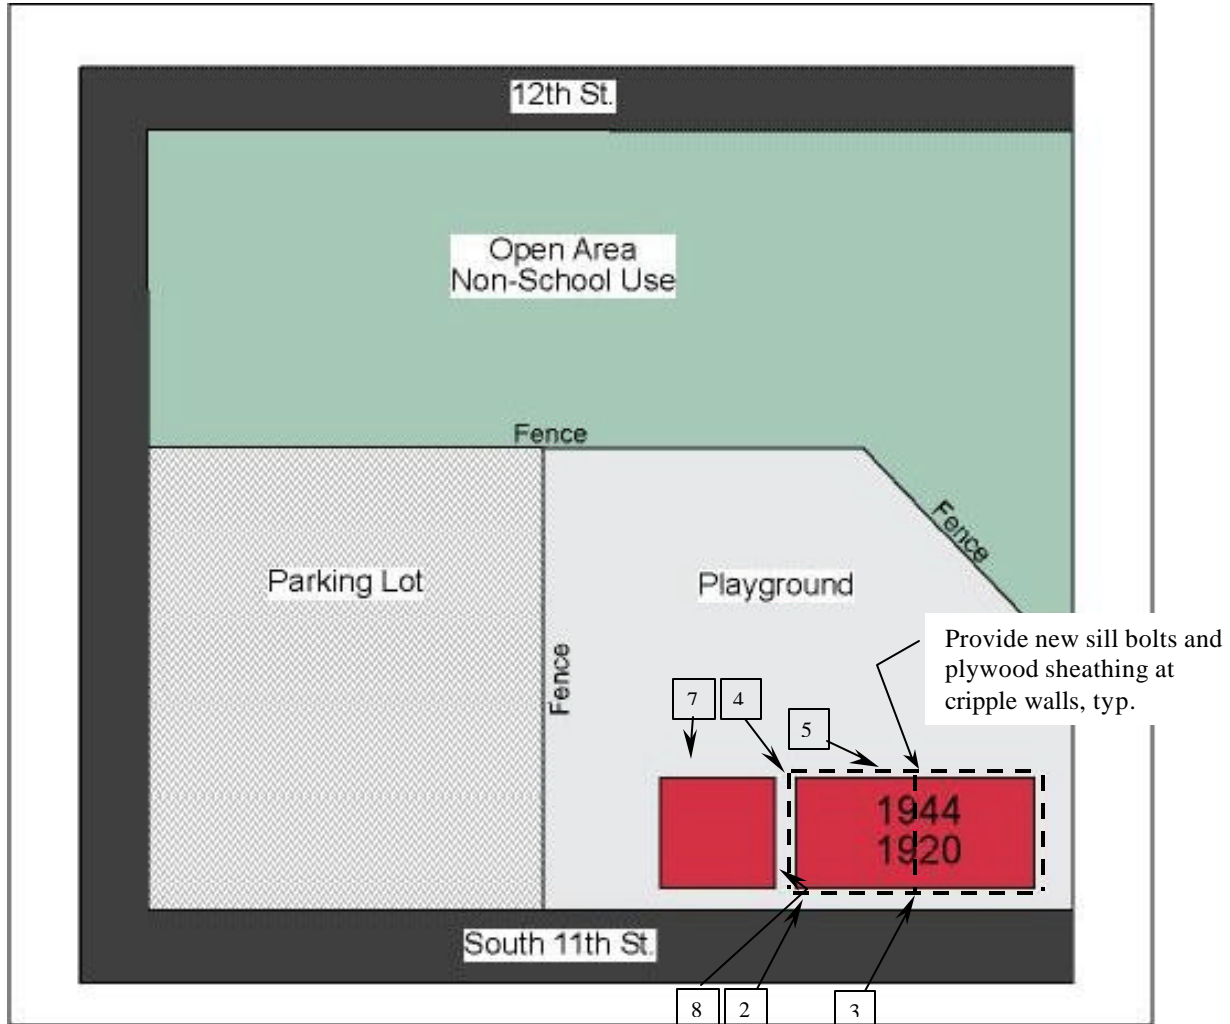
Harbour Way Community Day Academy
214 South 11th St.
Richmond, CA 94801
West Contra Costa Unified School District
Site Acreage: Not Available

Portable Classroom 1998 ← Yr Built
960 ← SqFt
