STRUCTURAL EVALUATION OF
JOHN F. KENNEDY HIGH SCHOOL
WEST CONTRA COSTA UNIFIED SCHOOL DISTRICT
(WCCUSD)

DASSE Design, Inc.
33 New Montgomery Street #850
San Francisco, CA 94105
(415) 243-8400

October 17, 2002

DASSE Design Project No. 01B300x2

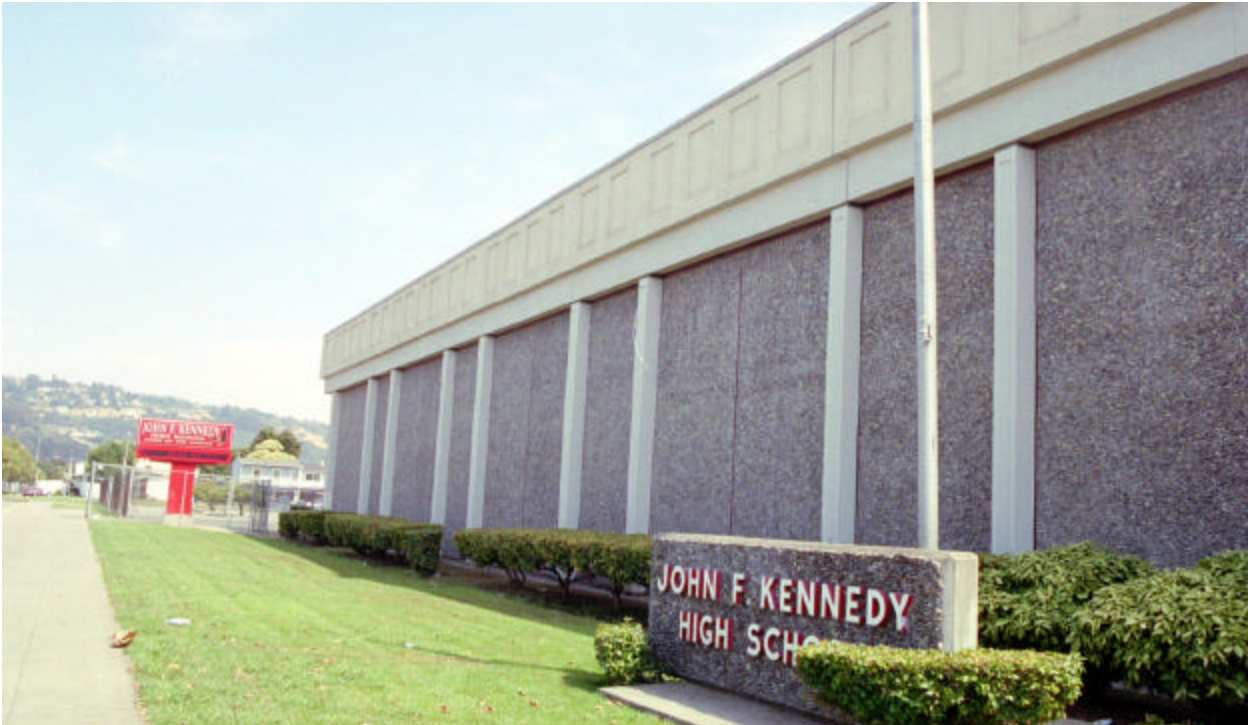
Figure 2: Building 11 North Side

This entire campus was re-roofed approximately in year 2000 per the district maintenance staff. Buildings I and II (facing Cutting Boulevard) are two story buildings see (figures 2&3) with exterior concrete tilt-up walls and with interior plywood shear walls in the transverse direction. The roof and the second floor have plywood sheathing. Both of these buildings were seismically retrofitted in 1988. There is seismic joint between these buildings and the connecting corridor. The building exterior typically has a stone aggregate finish. Covered walkways have plaster finishes at ceilings and are connected at either end to the main buildings. There are no door or window openings on the north wall of these buildings except for the full height door opening (see figure 3 & 4), which leads to entrance lobby and connects with buildings I and II. The entrance lobby has a pre-cast stair that leads to the second floor of buildings I & II (see figure 5). The second floor corridor has continuous window openings on the south longitudinal wall (see figure 6). There is a staircase at the west side of building I.

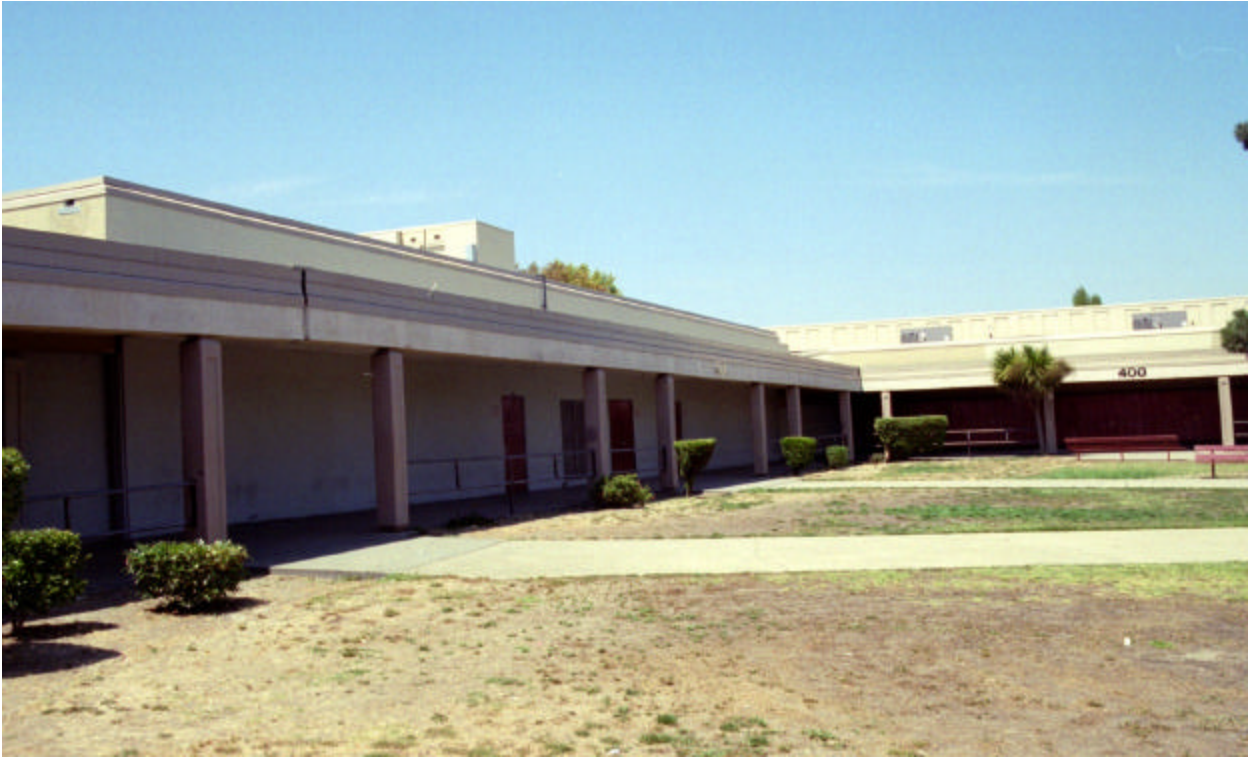
Figure 7: West Elevation of Building IV

Building IV is called Arts, Crafts and Home-Making Building (see figure 7). This building was originally constructed in 1956 and some minor modifications were done such as adding partition walls in 1965. New covered walkways were added to the west and north side of the building in 1965. Minor modifications were performed in year 1998 to this building. The building has perimeter concrete walls with steel framing and metal deck at the roof. There are numerous openings on the south longitudinal wall of this building (see figure 8). The building has a metal deck roof with steel trusses supported on steel columns on one side and corridor shear walls on the other side (see figure 9).

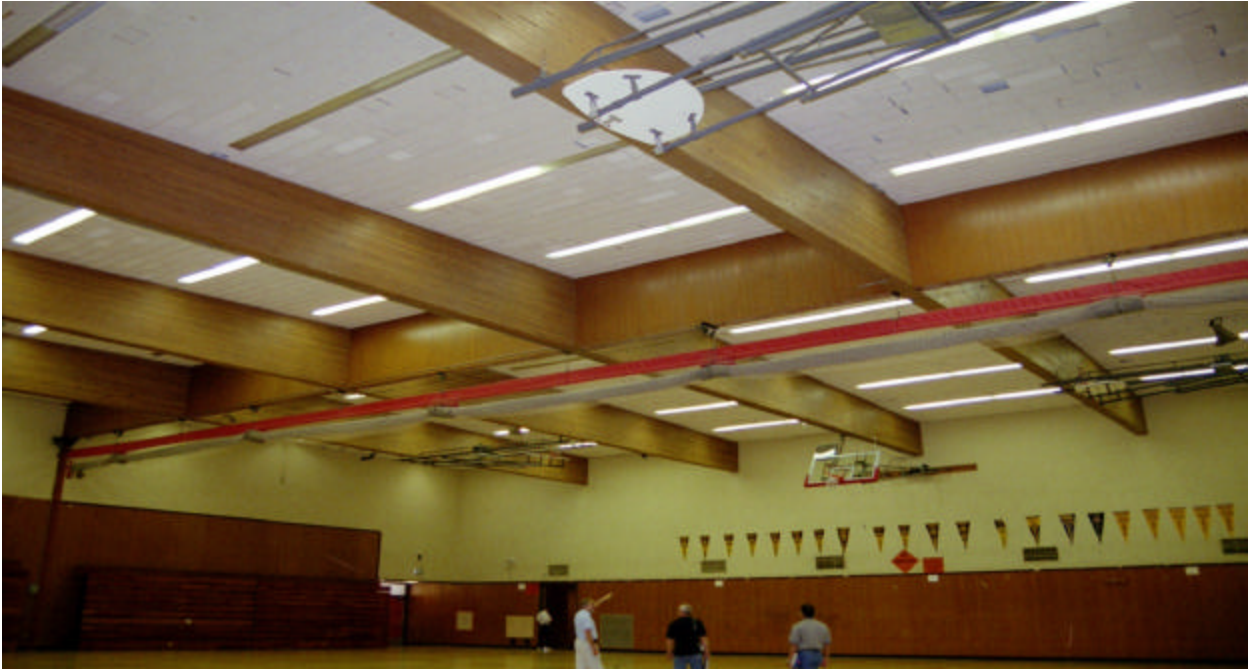
Figure 10: Gymnasium Building Roof Framing

Building V is a Gymnasium Building. This building has perimeter concrete walls and a plywood roof at the low roof covering Girls and Boys locker rooms. The roof of the gymnasium building has glu-lam beams spanning 105 feet with metal deck acting as the diaphragm (see figure 10). The north, west and east walls are plywood shear walls, and the south wall is a concrete wall. Glu-lam beams are supported on steel wide flange columns.

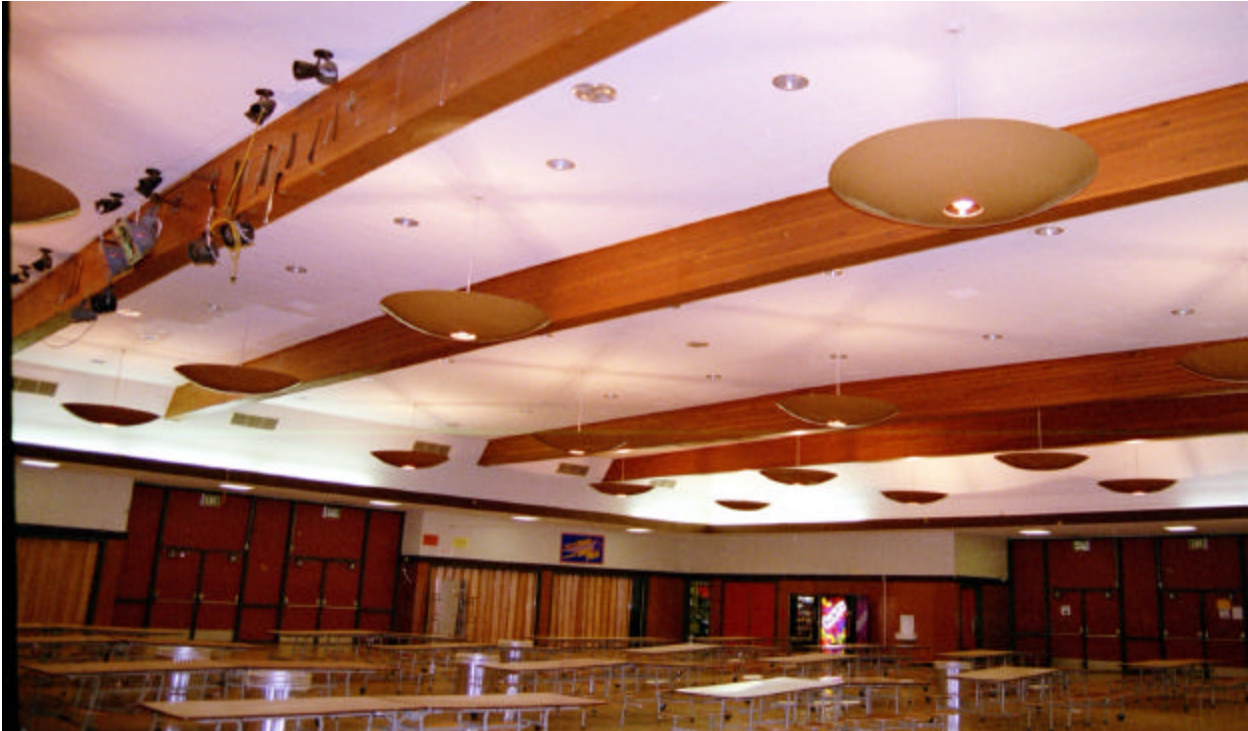
Figure 11: Roof Framing of Multi-Purpose Room

Building VII is called Multi-Use Building consisting of a cafeteria with an adjacent kitchen wing, an instrumental music building with an adjacent theater (choral and dramatic arts room – see figure 13). It is essentially a single story building with perimeter pre-cast concrete walls. Some of the transverse walls in the cafeteria and kitchen wing and the instrumental music buildings have plywood shear walls. The south and the east walls of the cafeteria/kitchen buildings have numerous openings. The roof of the multi-use building consists of wood framing with glulam beams and plywood roof sheathing (see figure 12).

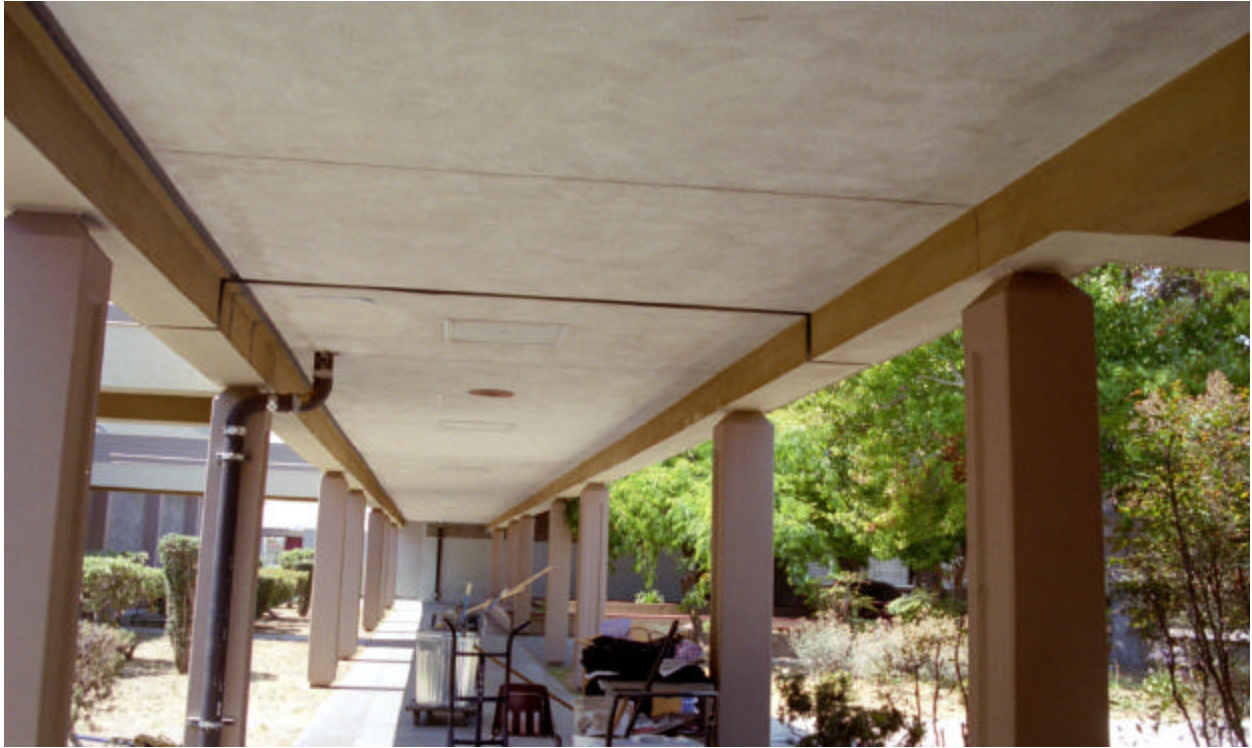
Figure 14: Typical Covered Walkway with Seismic Joint

There are numerous covered walkways, which envelop the perimeter of the buildings (see figures 14, & 15). These walkways have plastered ceilings and are supported on pre-cast concrete columns that taper top and bottom. The walkways have seismic joints at various locations.
