STRUCTURAL EVALUATION OF
PINOLE VALLEY HIGH SCHOOL
WEST CONTRA COSTA UNIFIED SCHOOL DISTRICT
(WCCUSD)

DASSE Design, Inc.
33 New Montgomery Street #850
San Francisco, CA 94105
(415) 243-8400

October 17, 2002

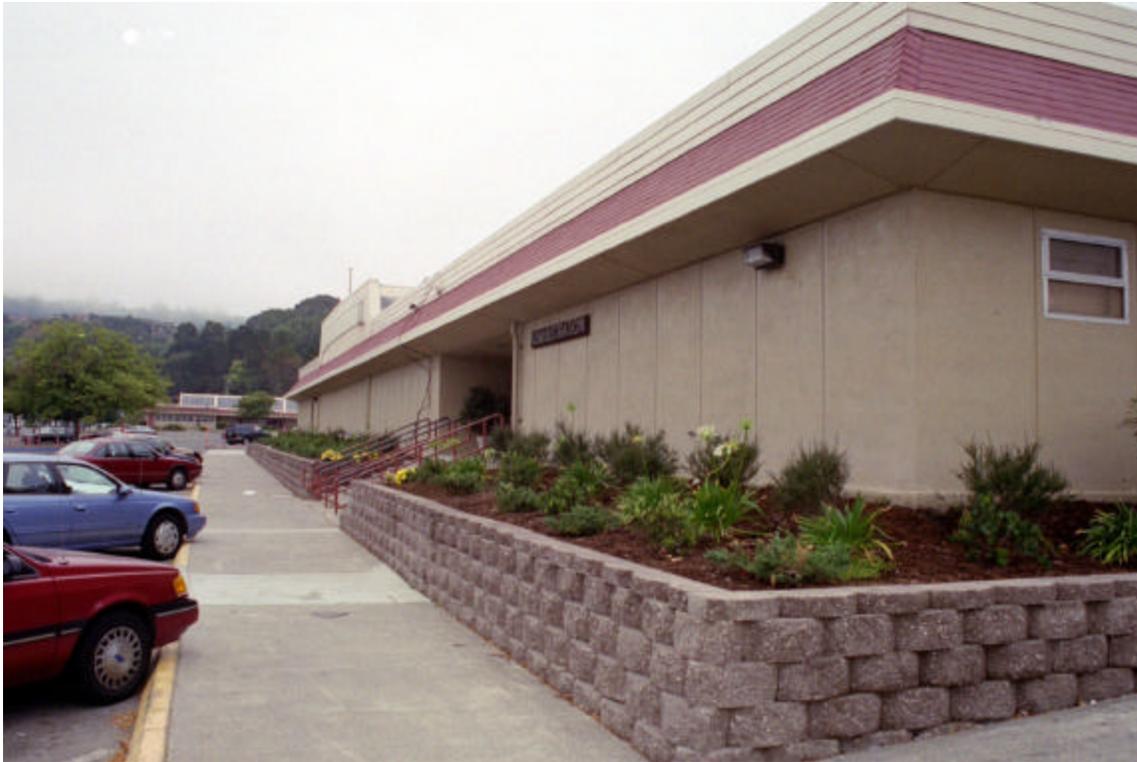
The library and administration building (Building A/B, see figures 4 through 6) has a blocked roof diaphragm of 3/8" plywood supported by 2x14 joists spaced at 16" centers. In the low roof areas, these joists span a maximum of 27 ft. between bearing walls. At the high roof, the 2x14 joists span 19 ft between the five pre-cast concrete frames, each of which has a single span of 52 ft in the building's longitudinal direction (see figure 5). There are no interior shear wall lines. Collector elements from the concrete frames extend 20 ft in plan into the adjacent low roof areas. There is a concrete vault inside of the administration area, but these walls do not continue up to the roof and therefore do not act as shear or bearing walls for the building. Because of the long spans between the shear wall lines and frames, the diaphragm chords at the north end of the building could be overloaded during a major earthquake and the roof diaphragm could experience significant damage.

Figure 4: Northeast corner of the administration and library building

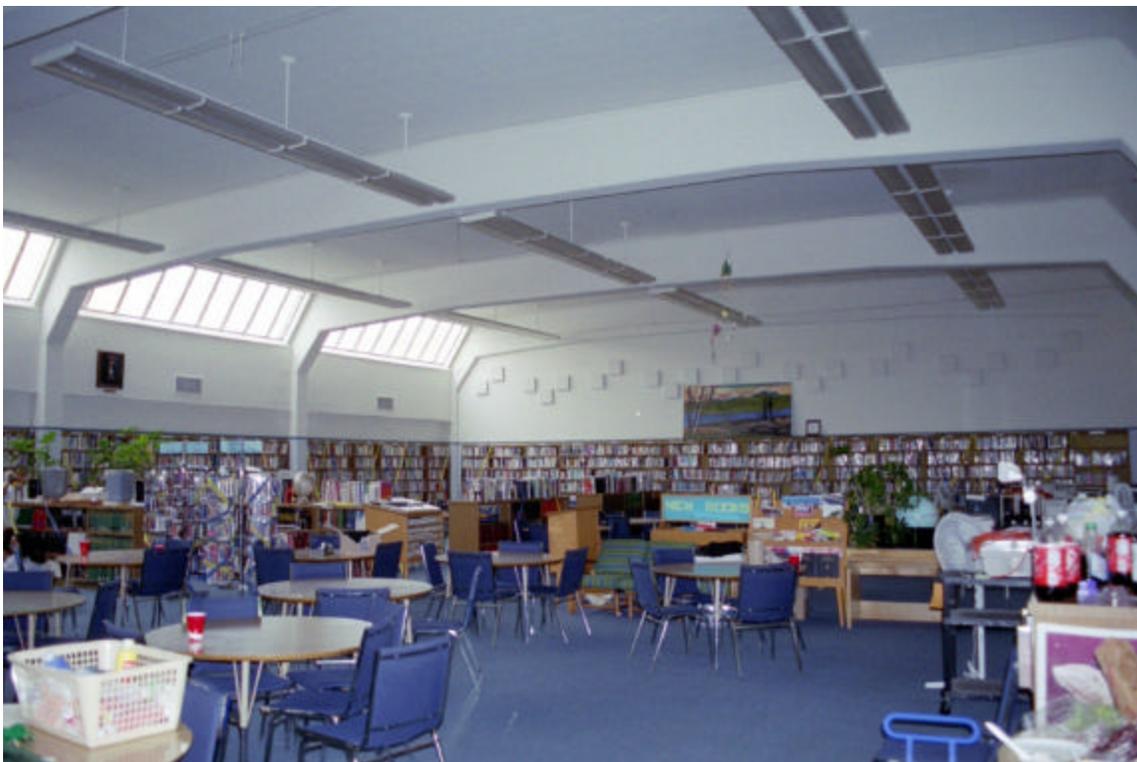
Figure 5: Clerestory windows at the library

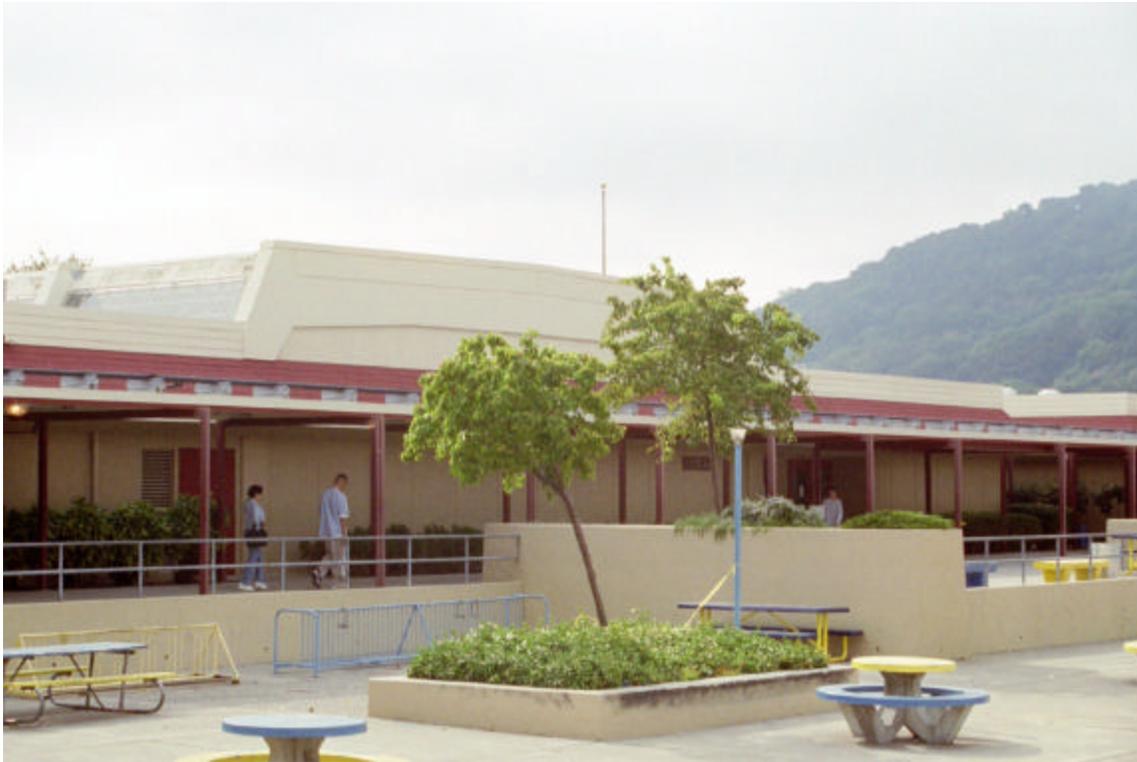
Figure 6: West side of the administration and library building

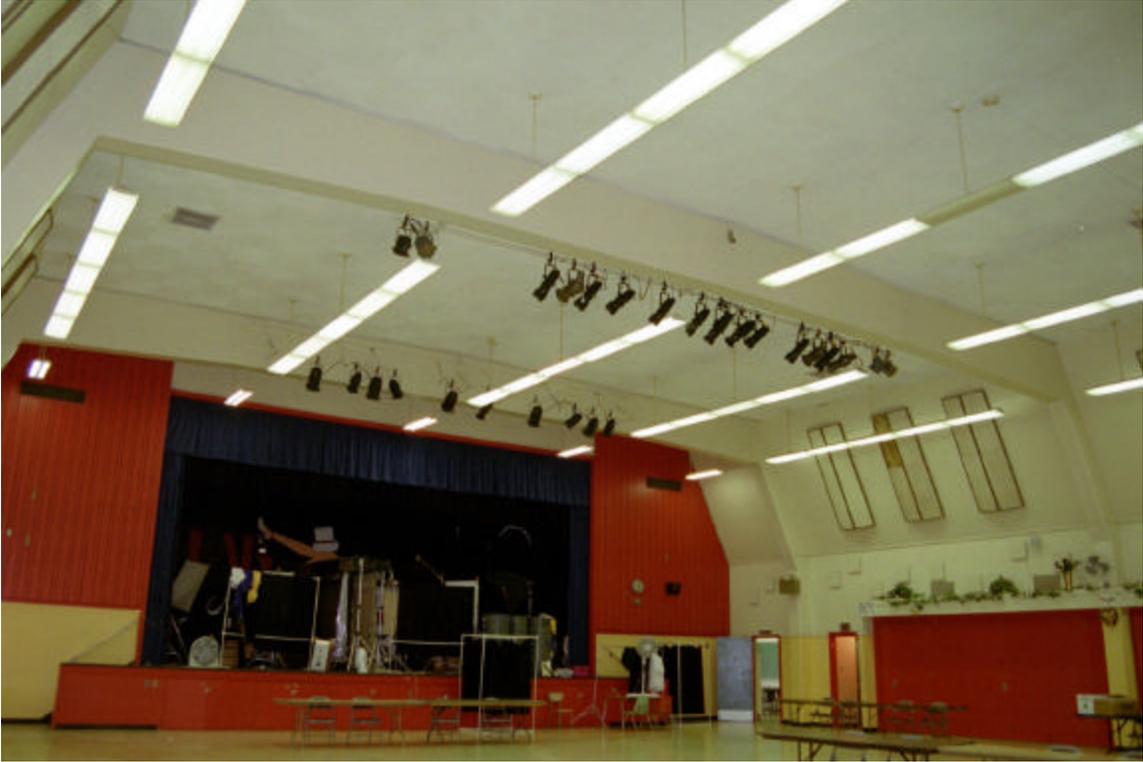
The Cafetorium (Building F) has a blocked roof diaphragm of 3/8" plywood sheathing supported by 2x14 joists (2x12 at south wing) spaced at 16" centers. At the high roof area, joists span 26 ft between five pre-cast concrete frames that span 63 ft (see figure 12). At the west low roof area, the joists span 26 ft between glue-laminated beams that align with the pre-cast frames and between wood stud bearing walls. At the north and south low roof areas, wood stud bearing walls support the joists. At the north and south sides of the high roof area, the low roof frames into wood stud walls. The portion of these walls above the low roof level is sheathed with plywood and the portion below is unsheathed, causing the forces to be transferred upward from the low roof to the concrete moment frame.

Figure 12: Interior of the cafetorium

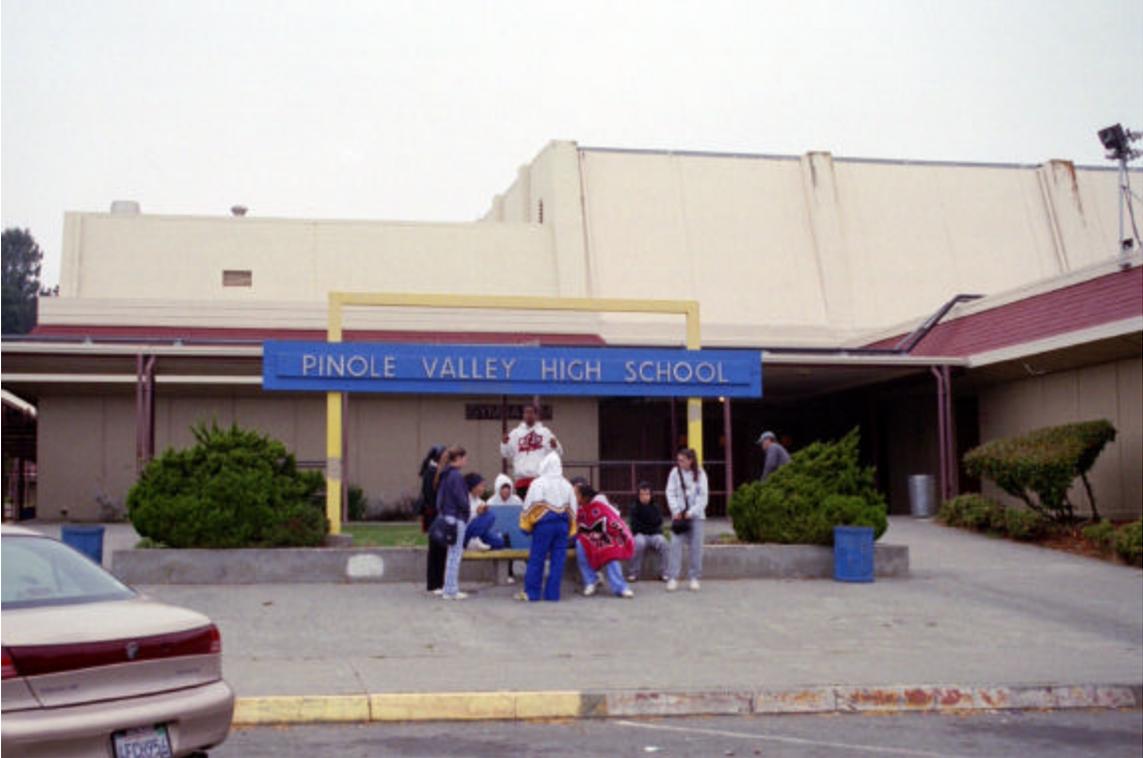
The northern low roof area of the Gymnasium (see figure 13) has a blocked roof diaphragm of ½” plywood sheathing over 2x12 joists spaced at 16” centers that span 18 ft. between the concrete wall and a 2x6 stud wall. The roof joists are anchored to the concrete wall with steel angles spaced every 4 ft. At the other low roof areas, the roof framing is made up of open-web trusses joists that span up to 49 ft. The trusses are connected to concrete walls using steel angles spaced at 4 ft centers that are bolted to a piece of 2x12 which is nailed to the top chord of the truss. The bearing walls have plywood at the perimeter of the building are sheathed with 3/8” plywood and rest on typical grade beams.

Figure 13: East side of the gymnasium

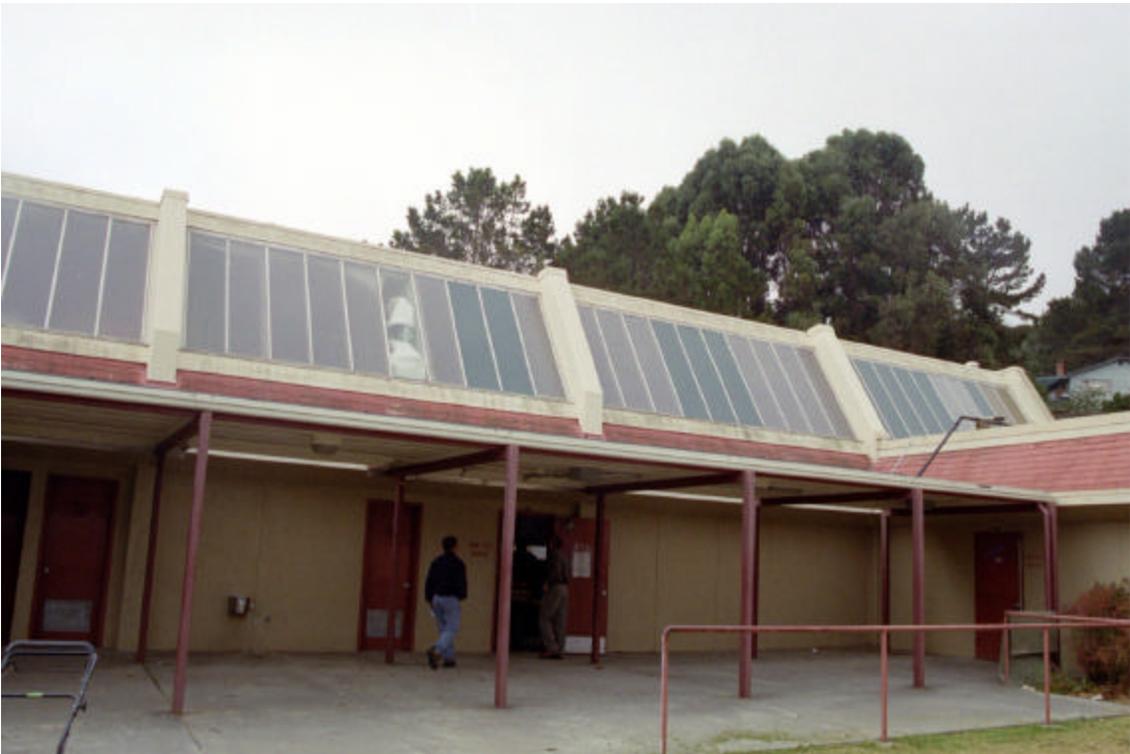
Figure 17: Front of the industrial arts building

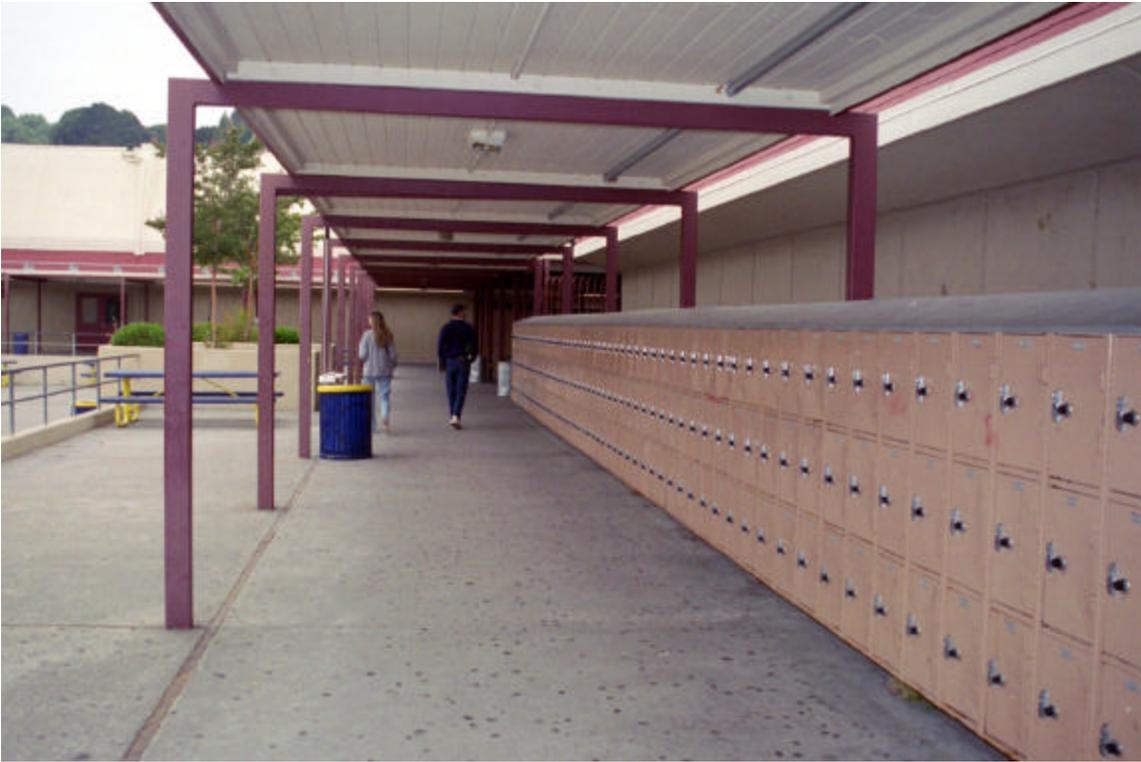
The covered walkways have 3x6 tongue and groove decking that typically spans 10 to 12 ft. between tube steel moment frames. The frames have 5x3x1/4 beams and 5x3x3/16 columns. These columns are embedded in 18" diameter, 9 foot. long drilled piers. The frames are typically 11'-5" wide and extend out past the outside edge of the roof sheathing. In the direction perpendicular to the frames, the columns act as cantilevers (see figure 21). Because of the cantilever action of the columns and their orientation with the narrow dimension in this direction, the covered walkways could experience large lateral deflections during an earthquake. Although this is not desirable, the flexural capacity of the columns is adequate to resist the anticipated seismic forces. The large deflections discussed above should be reduced by the covered walkway segments running in perpendicular directions that are connected to each other.

Figure 21: Typical covered walkway

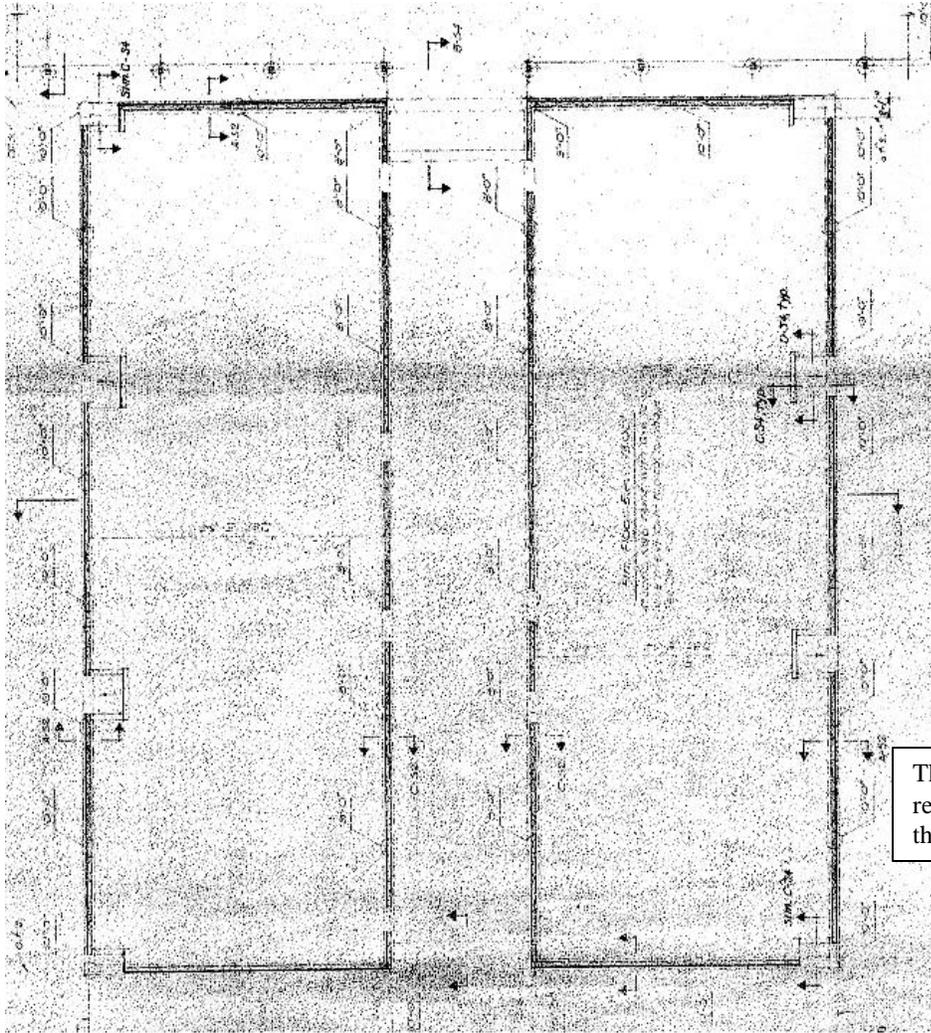
Drawing 7: Classroom building DR floor plan

There is no seismic retrofit work recommended for this building at the foundation level.

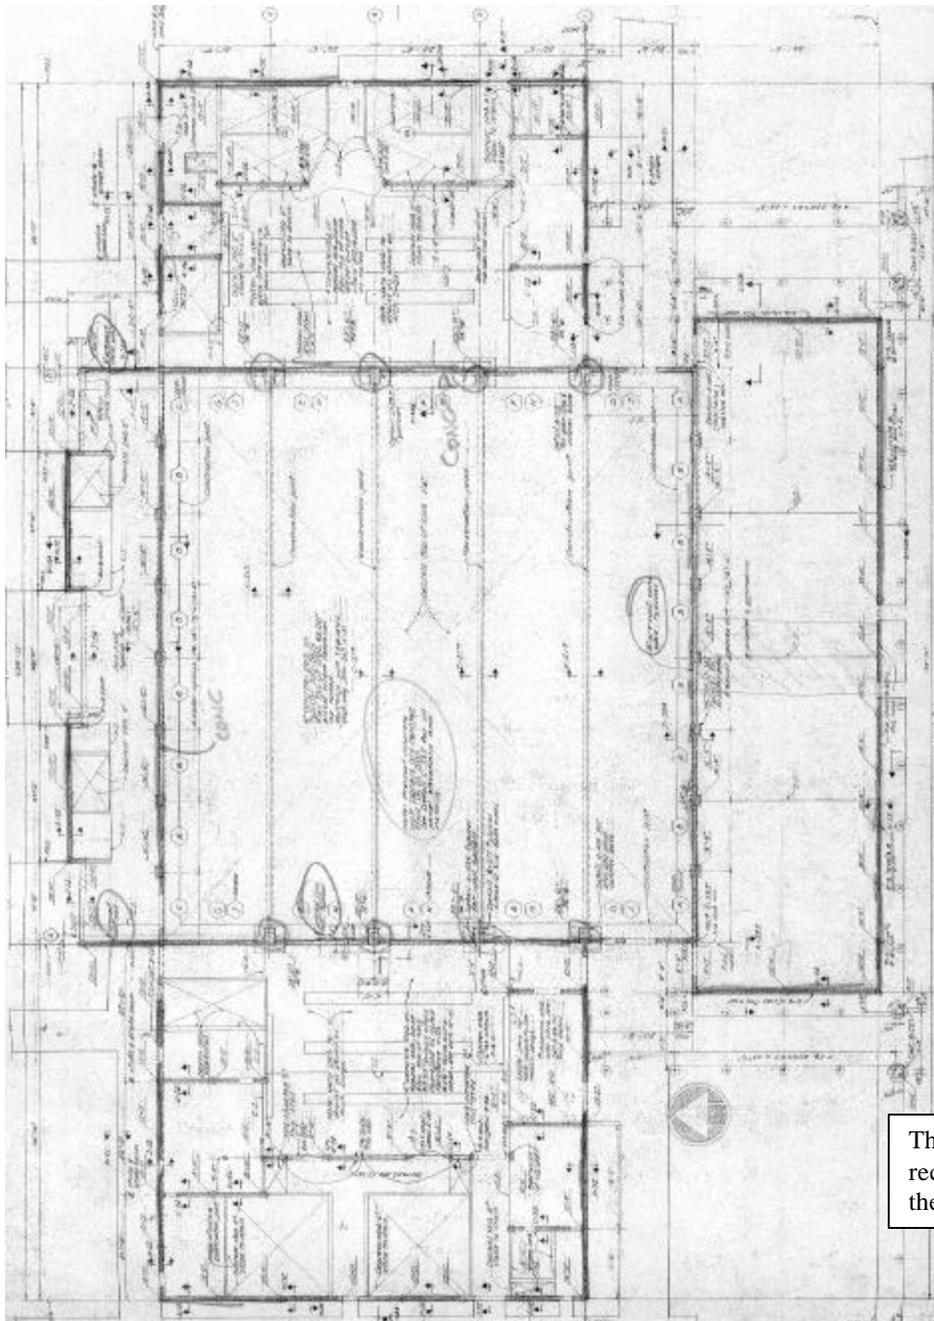
Drawing 13: Gymnasium (G) floor plan

There is no seismic retrofit work recommended for this building at the foundation level.
