STRUCTURAL EVALUATION OF  
COLLINS ELEMENTARY SCHOOL  
WEST CONTRA COSTA UNIFIED SCHOOL DISTRICT  
(WCCUSD)

DASSE Design, Inc.  
33 New Montgomery Street #850  
San Francisco, CA 94105  
(415) 243-8400

April 30, 2002

DASSE Design Project No. 01B300

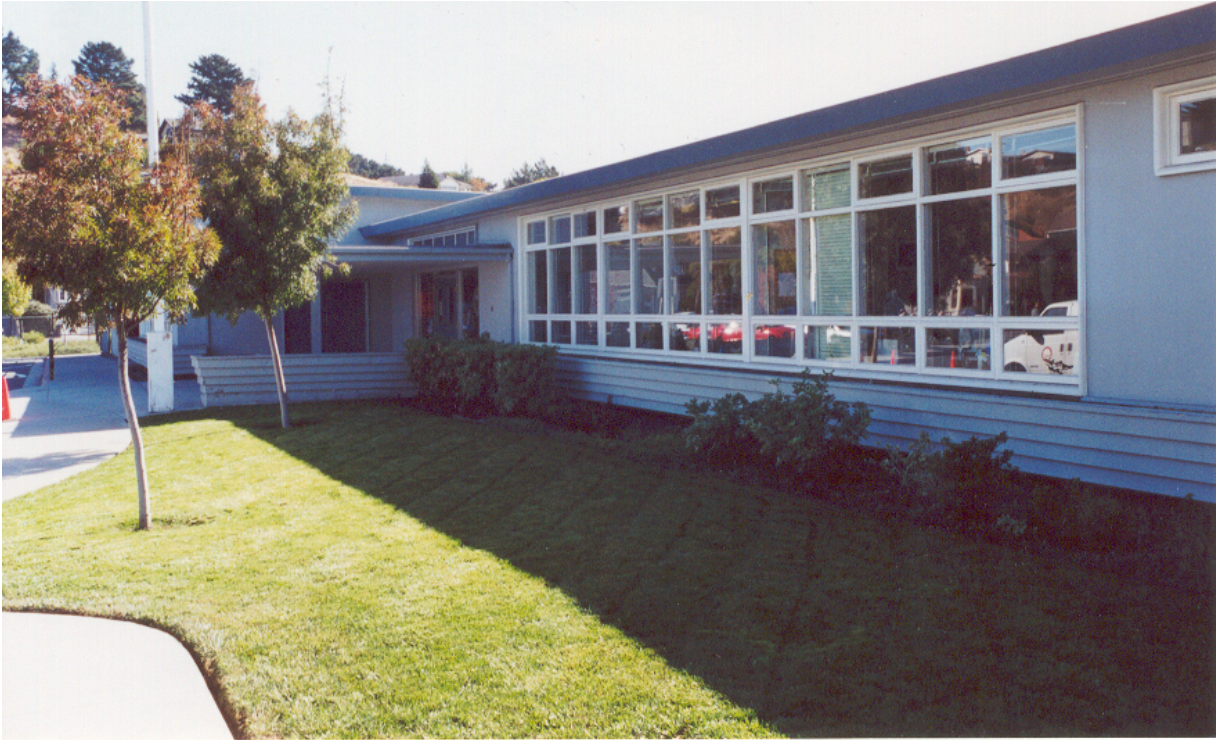
Figure 2: Main Entrance

School is located in the city of Pinole and was built in 1949 and consisted of Administration wing and classrooms 1 to 6 and K1. Subsequently, additions were made in the years 1954, 1960, and 1965. This is a one-story wood framed structure and has stucco finish on the exterior (see figure 2). There are six main buildings (permanent structures) and seven portable classroom buildings (see figure 1). There are two 1988 portables, three 1989 portables, one 1996 portable, and one 1997 portable. In addition there are three portable buildings of indeterminate age used for day care. The total square footage of the permanent structures is about 43,327 square feet.
