STRUCTURAL EVALUATION OF  
CORONADO ELEMENTARY SCHOOL  
WEST CONTRA COSTA UNIFIED SCHOOL DISTRICT  
(WCCUSD)

WLC Architects  
Kaiser Building  
1300 Potrero Avenue  
Richmond, CA 94804

DASSE Design, Inc.  
33 New Montgomery Street #850  
San Francisco, CA 94105  
(415) 243-8400

April 30, 2002

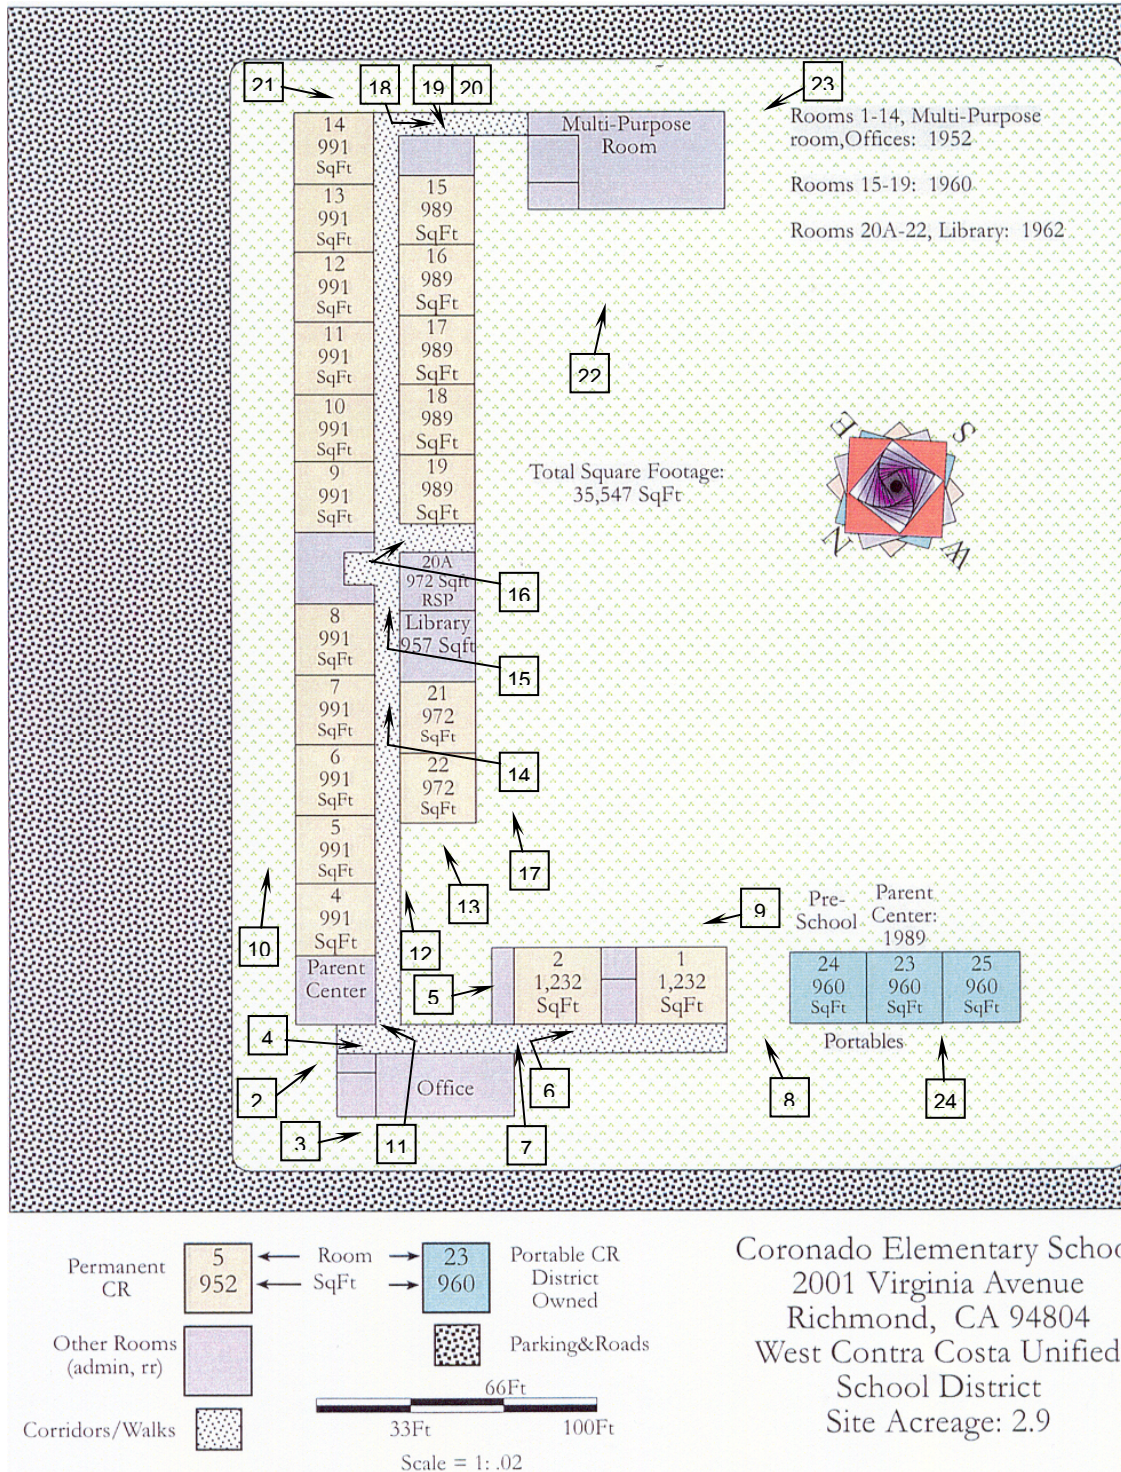
Figure 1: School Layout Plan

The school was built in 1952. The original buildings include one one-story wood structure (office building) and three one-story wood- and steel-framed structures (multi-purpose, kindergarten, and 1952 classroom buildings). There are two additional one-story wood classroom buildings built in 1960 and 1962. There are three 1989 portables (see figure 1). The total square footage of the permanent structures is about 35547 square feet.

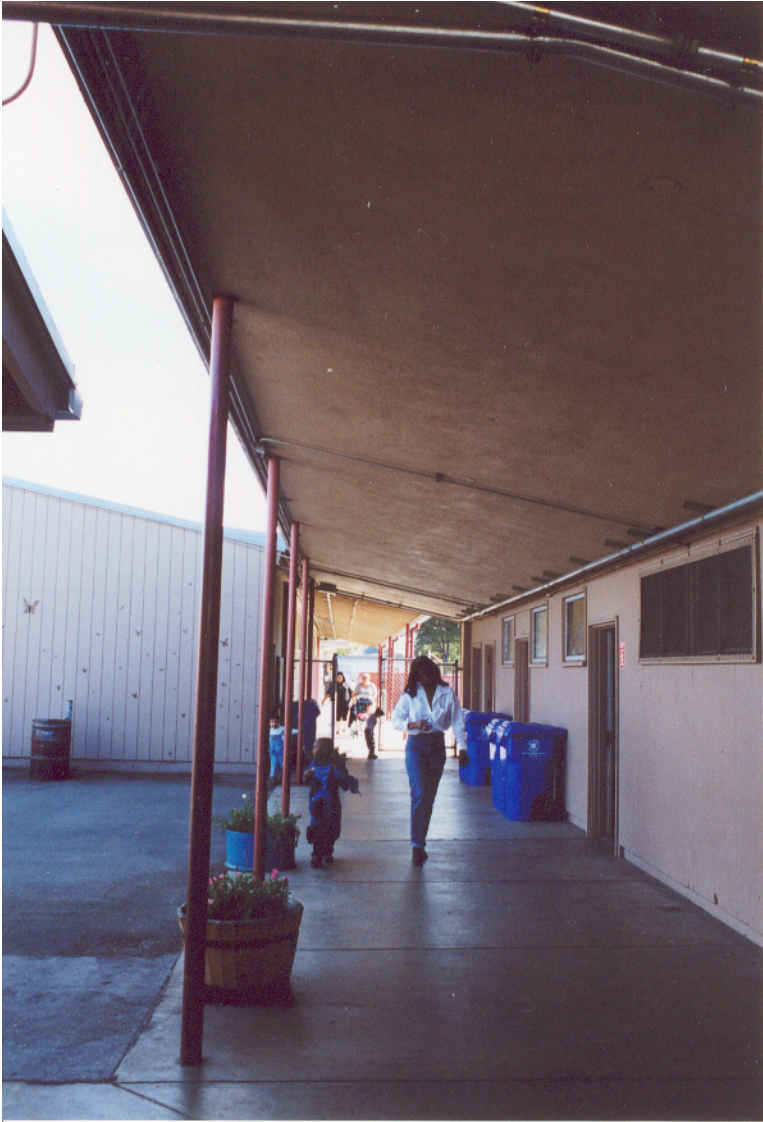
Figure 4: Southeast Face of Office Building

The office building has wood siding at the transverse end walls (see figure 2). The exterior longitudinal walls have stucco finish and openings along a large portion of their length (see figures 3 and 4). The roof overhang at the office building has a plaster soffit instead of exposed sheathing (see figure 4) and connects to the building at an angle, creating a valley along the length of the building where it intersects the main roof.
