STRUCTURAL EVALUATION OF
HARDING ELEMENTARY SCHOOL
WEST CONTRA COSTA UNIFIED SCHOOL DISTRICT
(WCCUSD)

DASSE Design, Inc.
33 New Montgomery Street #850
San Francisco, CA 94105
(415) 243-8400

April 30, 2002

DASSE Design Project No. 01B300

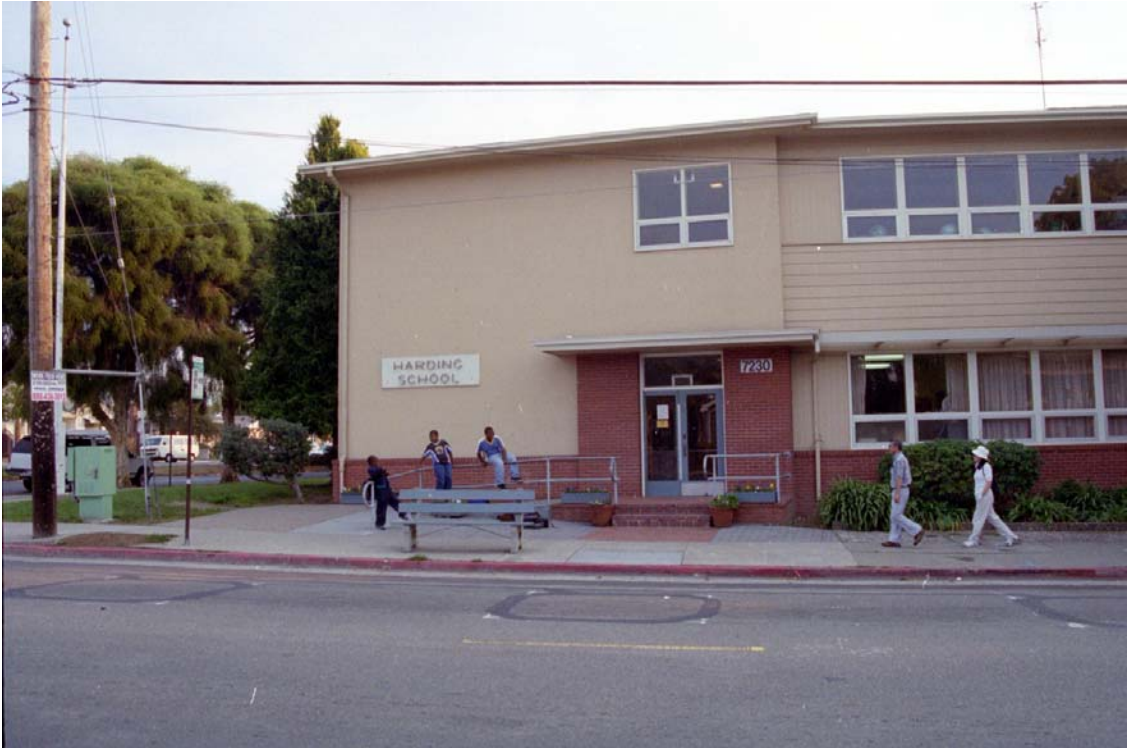
Figure 2: Main Entrance

The two-story main classroom building and single story auditorium building are wood-framed structures of similar construction (see figures 2, 3, 4, 6, and 7). Building exteriors are constructed of a combination of brick wainscot veneer, stucco, and wood siding. The auditorium building has a high ceiling with exposed wood trusses, while the classroom building has acoustical tile ceilings that are raised at some locations. The west side of the classroom building facing Ashbury Avenue is almost entirely a window wall (see figure 4). The cafeteria building is another single story wood-framed structure that, unlike the others, uses glue-lam beam construction (figure 5). Two additional single story classroom buildings also are constructed with wood framing and wood siding exteriors (see figures 8, 10, and 11). These buildings typically have extensive window walls at each classroom. It was observed that two of the portable buildings share a common foundation, but appear to be independent structures. Because these buildings have virtually no separation to allow for opposing lateral displacements, they have the potential to “pound” each other during an earthquake. This pounding potential should be investigated further. The additional classroom buildings and portable buildings are linked to each other and the rest of the campus through a system of covered walkways (figure 9), which are of two different construction types: wood post and beam or steel pipe column with wood beams. Electrical conduit was found to be running along the covered walkways between multiple buildings and between portable buildings. Due to the inability of this conduit to withstand these differential movements, this is also identified as a life safety hazard.
