STRUCTURAL EVALUATION OF
HIGHLAND ELEMENTARY SCHOOL
WEST CONTRA COSTA UNIFIED SCHOOL DISTRICT
(WCCUSD)

WLC Architects
Kaiser Building
1300 Potrero Avenue
Richmond, CA 94804

DASSE Design, Inc.
33 New Montgomery Street #850
San Francisco, CA 94105
(415) 243-8400

April 30, 2002

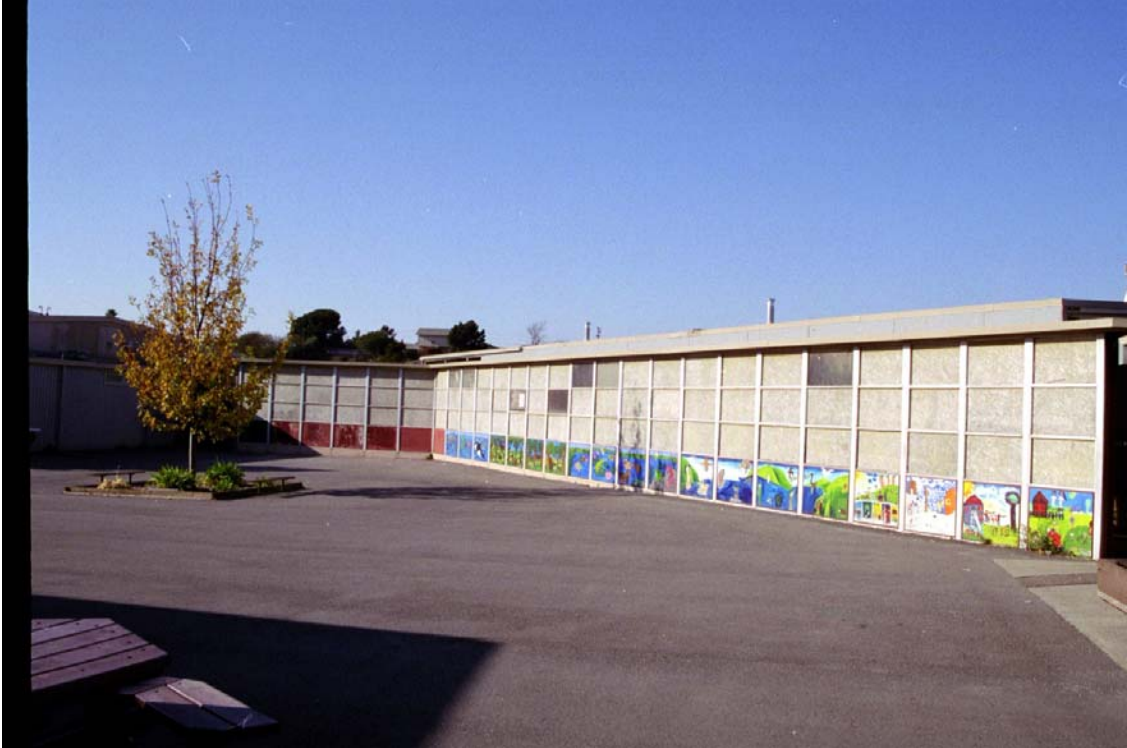
Figure 9: Covered Walkway, outside

apart when subject to displacements induced by a seismic event. Due to the magnitude of load carried by these beams, the questionable integrity of these connections constitutes a life safety hazard. Covered walkways throughout the campus are constructed with very substantial steel frames that will resist lateral loading (see figures 9 and 10). However, these walkway structures are supported by multiple buildings giving them the potential to pull apart if the buildings experience opposing displacements during a seismic event. Additionally, electrical conduit mounted to some of the covered walkways passes into adjacent buildings, without compensation for the potential differential displacements. These two conditions also represent life safety hazards. At the portable buildings, hard conduits were observed to be passing from structure to structure, posing a life safety hazard similar to that observed at the covered walkway.
