STRUCTURAL EVALUATION OF

LINCOLN ELEMENTARY SCHOOL

WEST CONTRA COSTA UNIFIED SCHOOL DISTRICT
(WCCUSD)

April 30, 2002

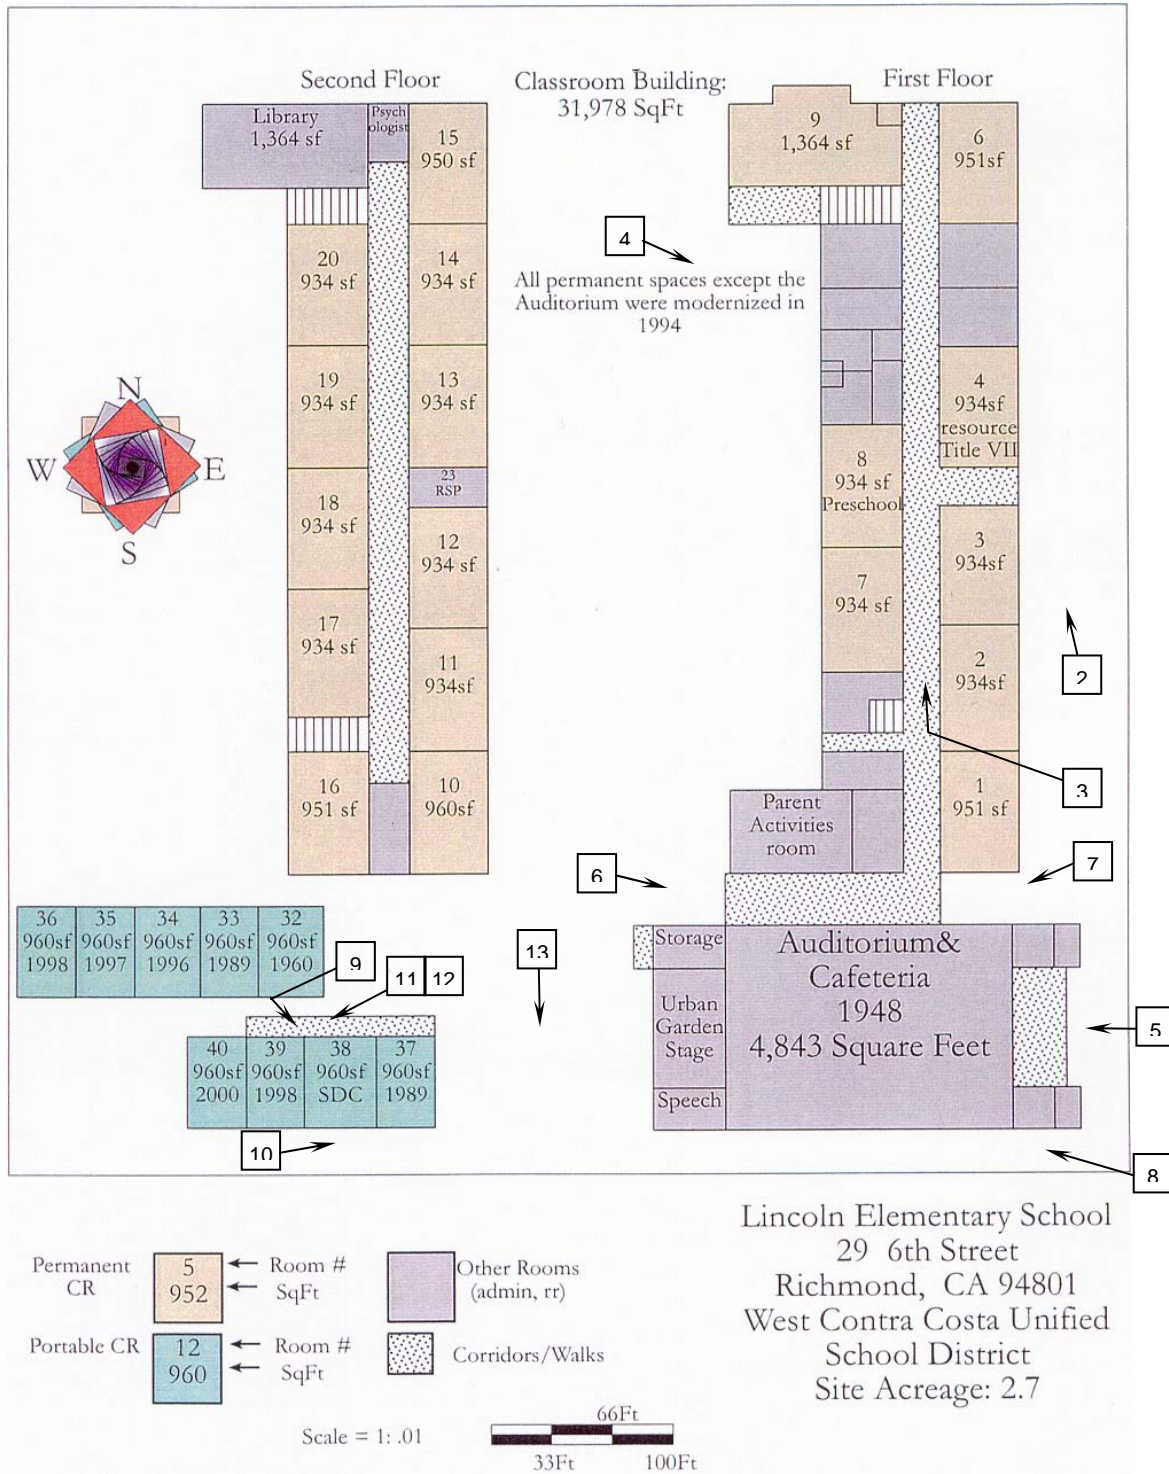
Figure 1: School Layout Plan

There were no drawings of the classroom building available for review. Although the site map (figure 1) shows the construction date of the building as 1989, it appears to be older. Furthermore, the site map shows classrooms number 37 and number 38 as portable units instead of as a permanent structure.
