STRUCTURAL EVALUATION OF
MADERA ELEMENTARY SCHOOL
WEST CONTRA COSTA UNIFIED SCHOOL DISTRICT
(WCCUSD)

WLC Architects
Kaiser Building
1300 Potrero Avenue
Richmond, CA 94804

DASSE Design, Inc.
33 New Montgomery Street #850
San Francisco, CA 94105
(415) 243-8400

April 30, 2002

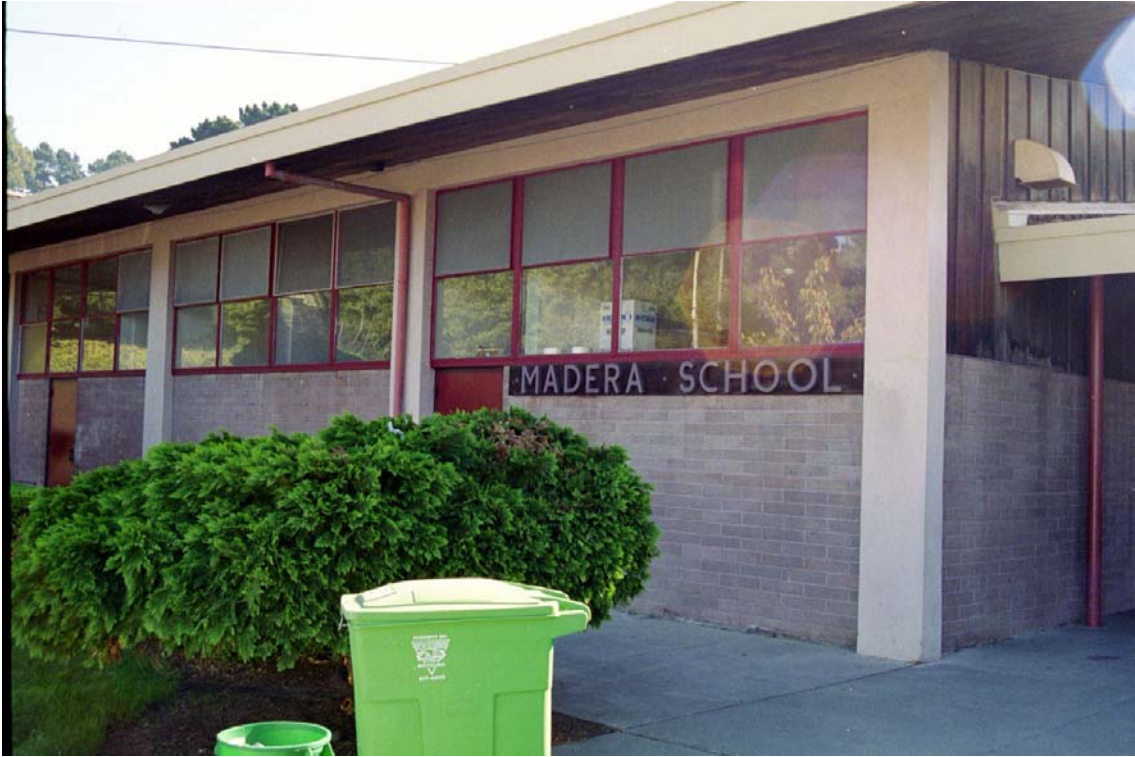
Figure 2: Front Entrance to School

The school was built in 1955. The original building is a one-story wood and steel-framed structure with CMU wall infill on the exterior (see figure 2). There is one main building and four portable buildings all constructed in 1955 (see figure 1). The total square footage of the permanent structures is about 31,049 square feet. There is also a day care facility run by the City of El Cerrito on the campus that is outside the scope of this report.

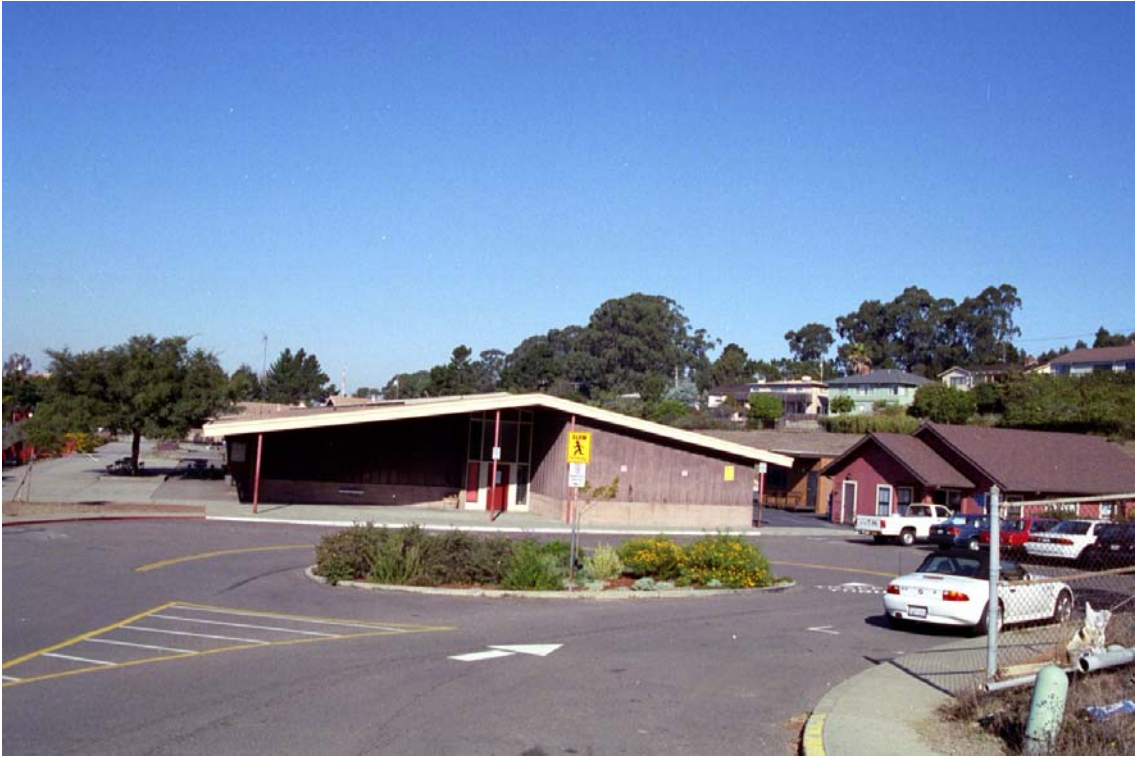
Figure 3: East End of Classroom Wing

The main building is L-shaped, consisting of a long classroom wing (see figures 2-4) and a multi-purpose wing (see figures 8-12). The north and south faces of the classroom wing have multiple large window openings above CMU block infill. There are steel braced frames spaced along the length of the interior corridor, the tie rods of which are visible through the high windows along the corridor (see figure 5). There is a large opening in the roof diaphragm for skylights above the corridor and classrooms (see figures 4 and 6). Diagonal tie rods have been used to transfer diaphragm forces across this opening (see figure 7). The multi-purpose wing also has large high window openings along the east, west, and south faces. There is brick veneer and wood paneling on the north wall (see figure 8). The roof of the multi-purpose room is higher
