STRUCTURAL EVALUATION OF

OLINDA ELEMENTARY SCHOOL

WEST CONTRA COSTA UNIFIED SCHOOL DISTRICT
(WCCUSD)

April 30, 2002

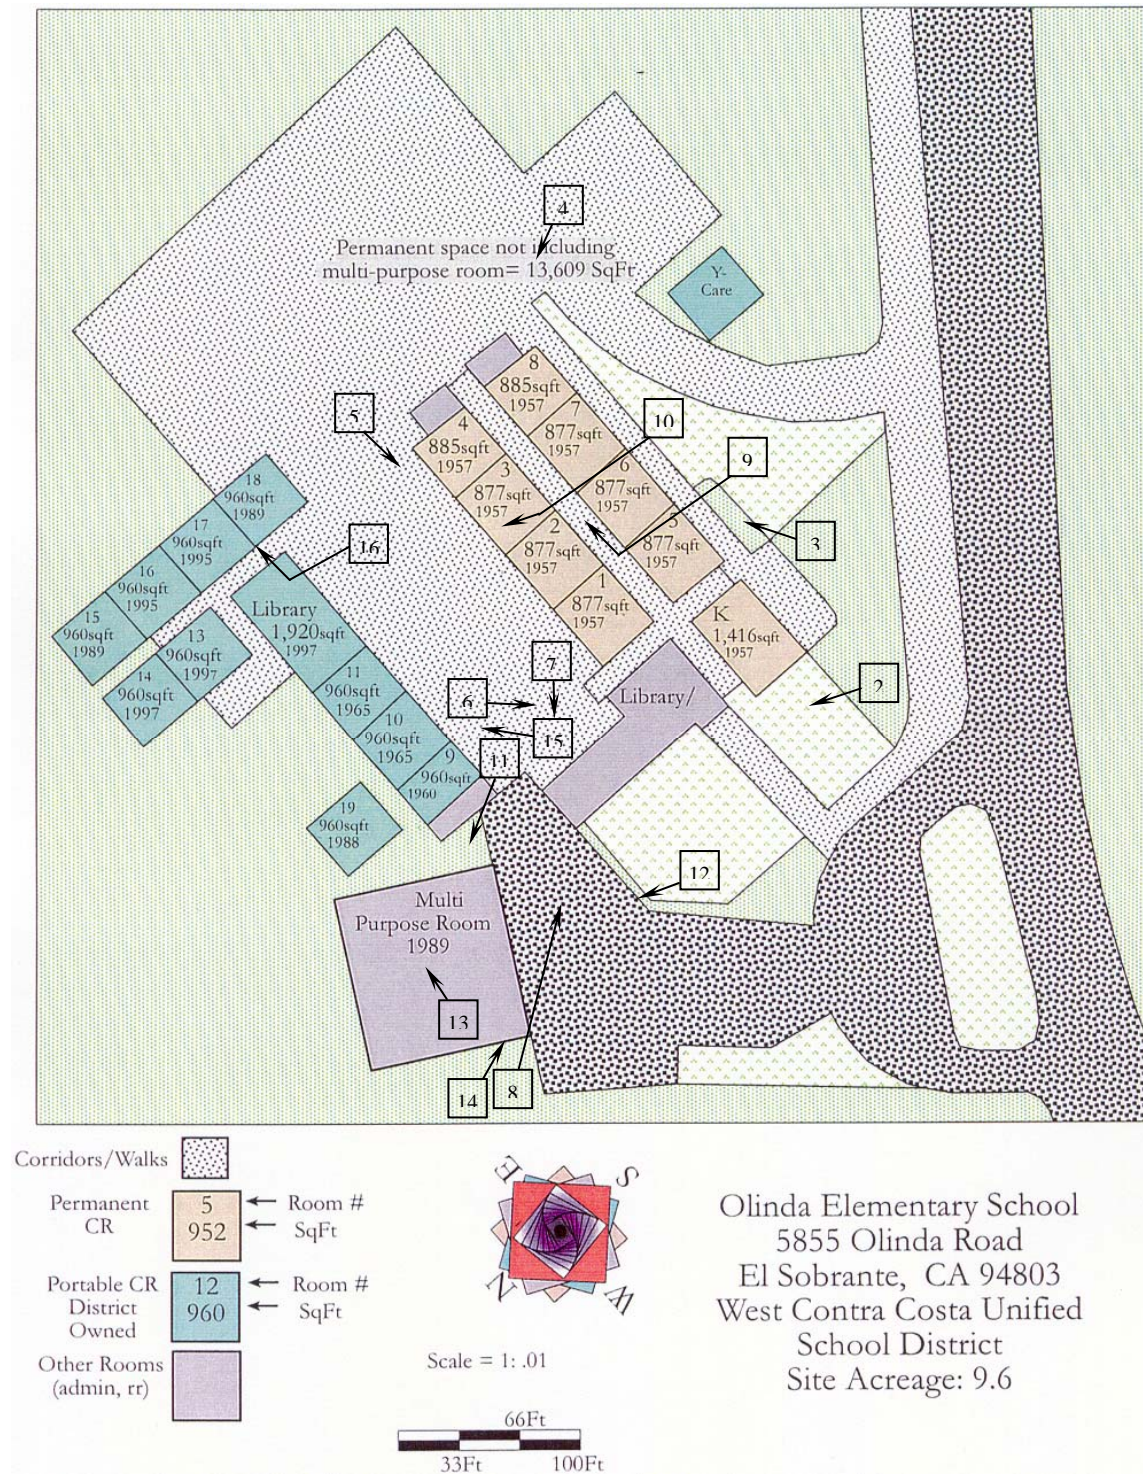
Figure 1: School Layout Plan

The school was built in 1957. The original building is a one-story wood- and steel- framed structure (main building). The multi-purpose building is a wood structure that was constructed in 1989 (see figure 1). There is one 1960 portable, two 1965 portables, one 1988 portable, two 1989 portables, two 1995 portables, four 1997 portables, and one portable whose construction date is not known. The total square footage of the permanent structures is about 18,409 square feet.

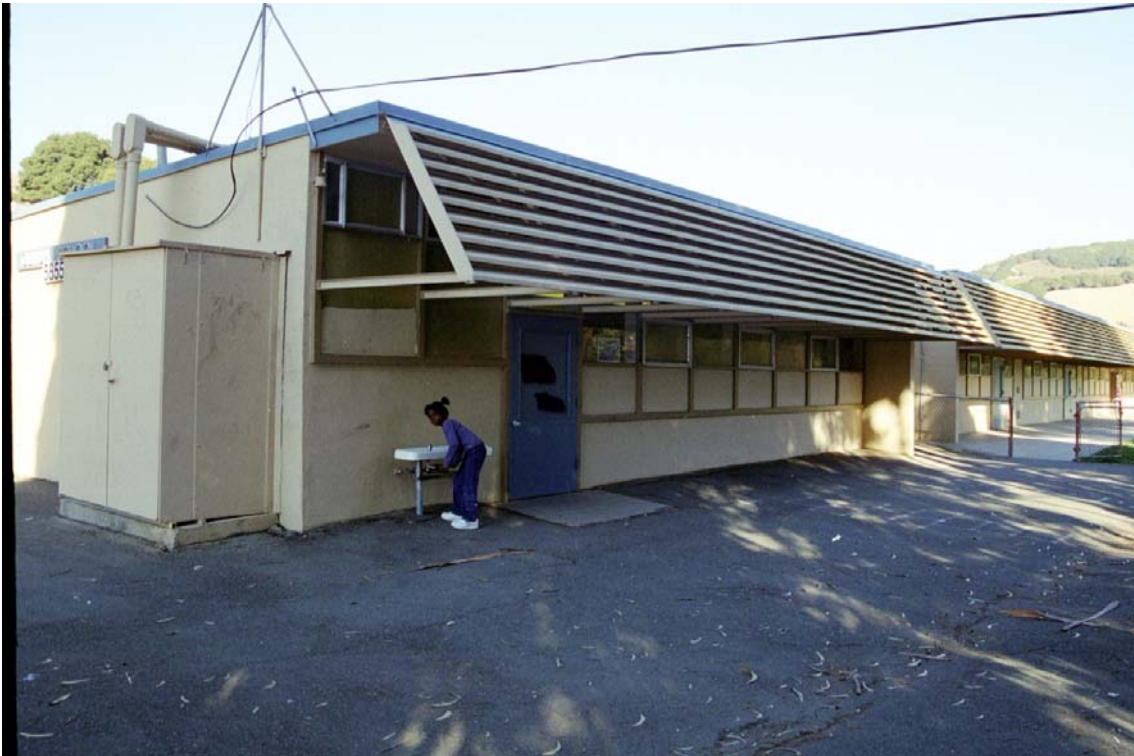
Figure 3: South Face of Main Building

The main building is an L-shaped building with classrooms on both sides of a central longitudinal corridor (see figure 1). The exterior finish is stucco. The main portion of the building, which houses the classrooms, has windows along the exterior longitudinal walls (see figures 3 and 5). The transverse walls between classrooms do not have any openings. There are long sections of shear wall along the central corridor (see figure 9). At the administration and computer room wing, there are windows with a vertically slotted sunshade along most of the west wall (see figures 2 and 8). The east wall of the computer room has clerestory windows above an exterior covered walkway (see figures 6 and 8). The roof is supported by open-web steel joists spaced at about 5 ft o.c. that rest on 4x8 posts (see figure 10). The ceiling has acoustical tiles attached directly to the underside of the roof. There are skylights in the corridor spaced every 10 feet (see figure 9) and there are long sections of skylight that penetrate the roof diaphragm on both sides of the corridor at the classrooms. The presence of these skylights significantly decreases the ability of the diaphragm to transfer forces to the corridor walls. This is of particular concern because the corridor walls are the main lateral force resisting elements in the east-west direction. At the east end of the corridor, there are restrooms that have a low roof

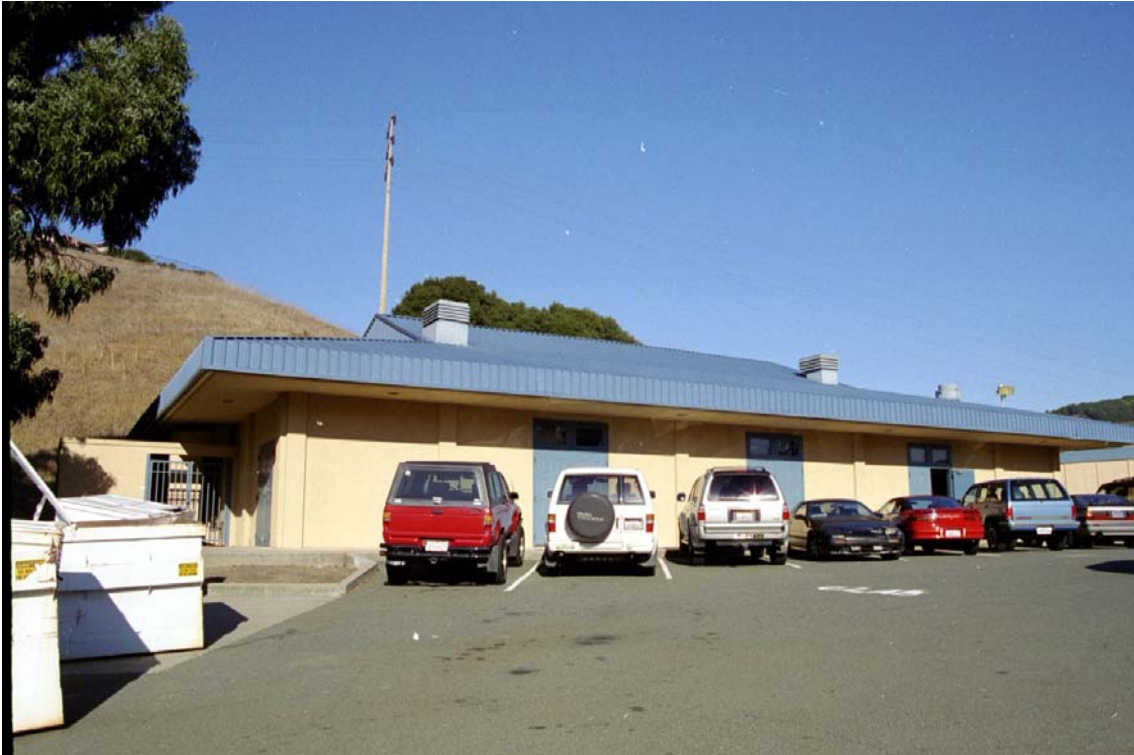
Figure 12: South Face of Multi-Purpose Building

The multi-purpose building is a roughly square wood-framed building with stucco finish. The roof has sheet metal roofing. In the central part of the building, the roof slopes in the east-west direction to a central ridge. At the north and south sides, the roof slopes up in the perpendicular direction from the exterior to a short pony wall (see figures 11 and 12). The exterior walls have windows only above the door openings, leaving reasonable lengths of shear wall at all four sides of the building. The interior of the building has a suspended T-bar ceiling. There is some minor cracking of the exterior slab adjacent to the building.
