STRUCTURAL EVALUATION OF

PERES ELEMENTARY SCHOOL

WEST CONTRA COSTA UNIFIED SCHOOL DISTRICT  
(WCCUSD)

April 30, 2002

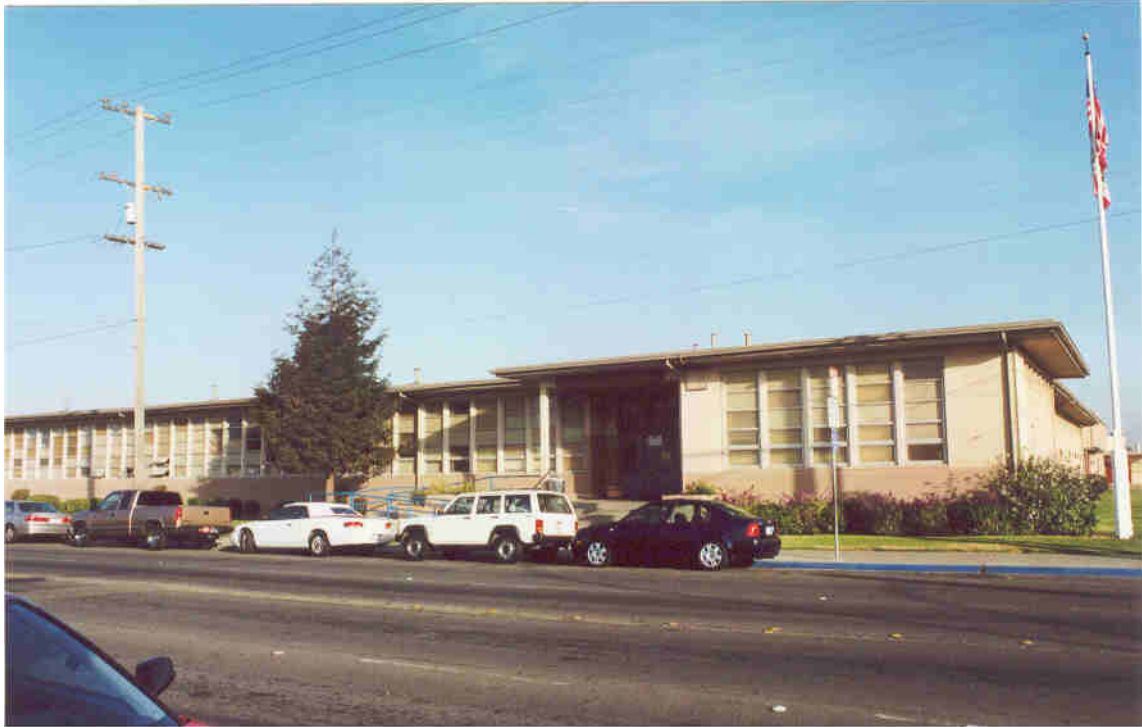
Figure 2: South Entrance Elevation

The 1954 and 1955 classroom buildings (Figures 2 & 3) are located at the south side of the site and form what is now the main entrance to the campus. These buildings are one story and have raised suspended wood framed floors. The 1954 classroom building has an intermittent perimeter foundation utilizing pier/post/and beam construction. The 1955 building was found to have a skip sheathing roof framing system in the bathroom area.
