STRUCTURAL EVALUATION OF
SHELDON ELEMENTARY SCHOOL
WEST CONTRA COSTA UNIFIED SCHOOL DISTRICT
(WCCUSD)

WLC Architects
Kaiser Building
1300 Potrero Avenue
Richmond, CA 94804

DASSE Design, Inc.
33 New Montgomery Street #850
San Francisco, CA 94105
(415) 243-8400

April 30, 2002

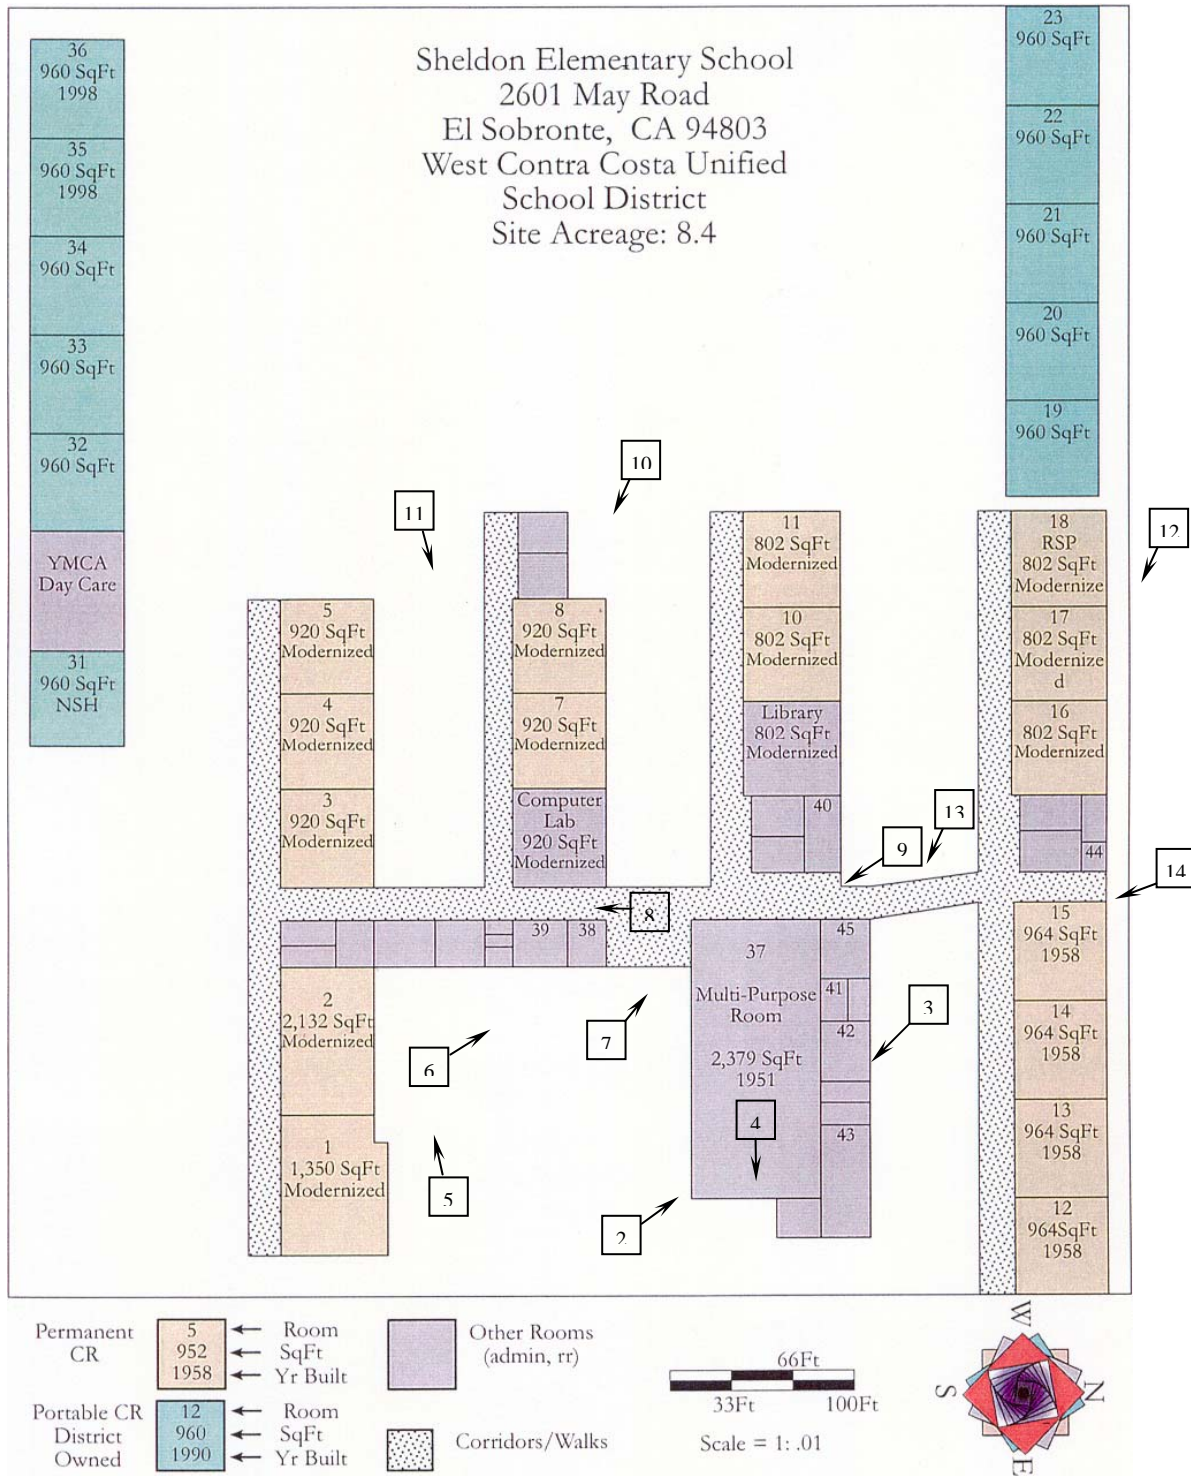
Figure 1: School Layout Plan

The school was built in 1951, 1955, and 1958. The buildings are one-story wood structures. There are eight main buildings (permanent structures) and twelve portable buildings of unknown age (see figure 1). The total square footage of the permanent structures is about 23,000 square feet.

Although many of the classrooms are connected to each other, there are eight separate buildings on the campus (see figure 1). The division of buildings is as follows:
