STRUCTURAL EVALUATION OF
VALLEY VIEW ELEMENTARY SCHOOL
WEST CONTRA COSTA UNIFIED SCHOOL DISTRICT
(WCCUSD)

DASSE Design, Inc.
33 New Montgomery Street #850
San Francisco, CA 94105
(415) 243-8400

April 30, 2002

DASSE Design Project No. 01B300

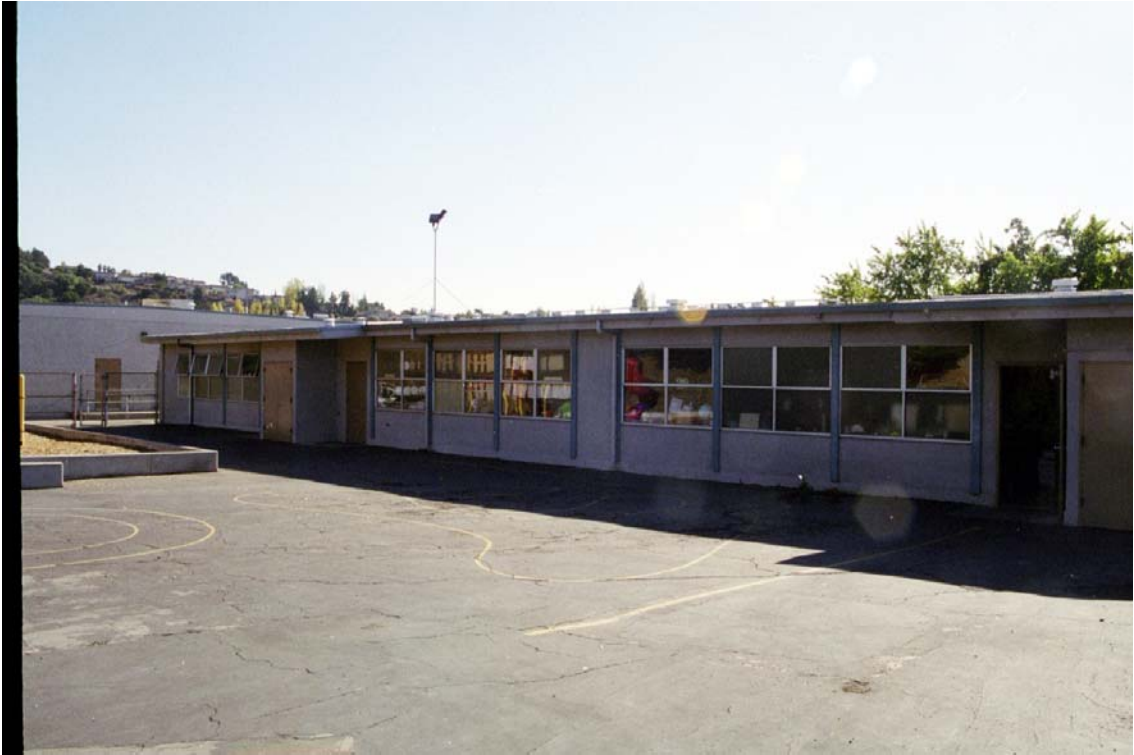
Figure 3: Wing A Classrooms (front)

At the rear end of classroom wing A, there appears to be a deviation between the original construction documents and the existing conditions observed during the site visit. The original drawings show the roof overhang spanning 8 ft. between the rear wall of the building and a steel channel over a row of pipe columns. The existing condition however is a much shorter overhang that is cantilevered over the rear wall of the building (see figure 3).
