STRUCTURAL EVALUATION OF
WOODROW WILSON ELEMENTARY SCHOOL
WEST CONTRA COSTA UNIFIED SCHOOL DISTRICT
(WCCUSD)

DASSE Design, Inc.
33 New Montgomery Street #850
San Francisco, CA 94105
(415) 243-8400

April 30, 2002

DASSE Design Project No. 01B300

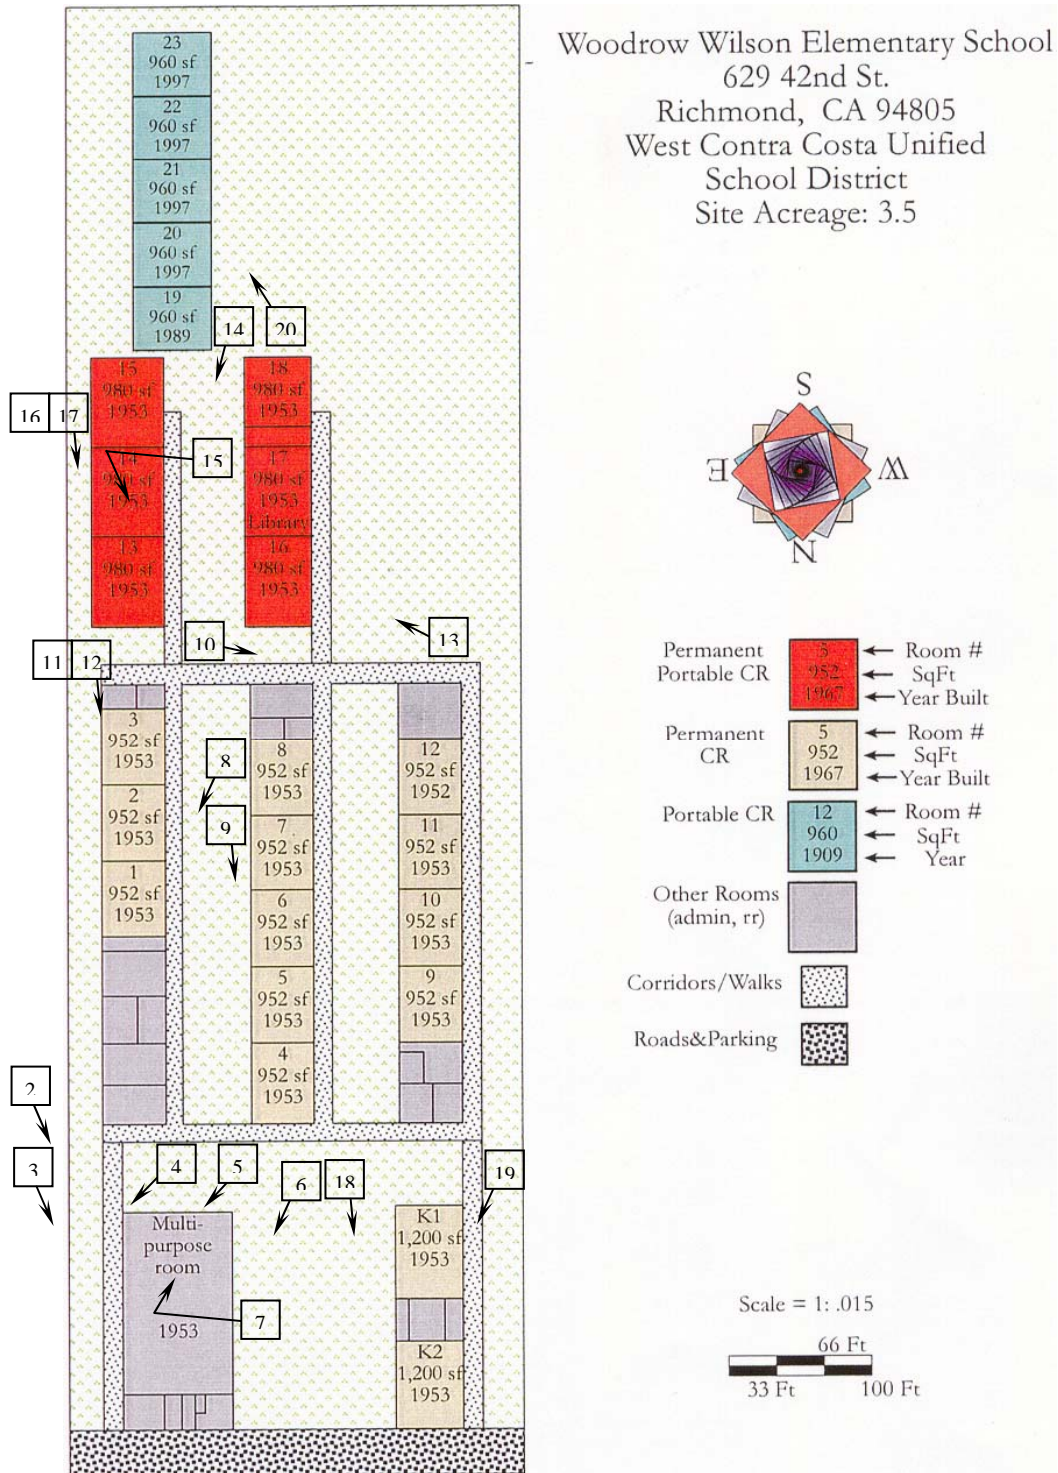
Figure 1: School Layout Plan

The school was built in 1952. The original buildings are four one-story wood structures: three classroom buildings, a multi-purpose building, and a kindergarten building. There are two permanent portable buildings that were built in 1953 and five portable buildings (see figure 1). There is one 1989 portable and four 1997 portables. The total square footage of the permanent structures is about 36,286 square feet. There are two portable buildings on the campus that are used by the YMCA that are not within the scope of this report.

There is a network of covered walkways connecting all of the buildings on the campus (see figures 1, 10, and 13). All of these walkways have plaster soffits. The majority of these walkways are along the longitudinal walls of the buildings and are described above. In between, there are walkway roofs supported on pipe columns. Where the covered walkways meet the buildings, the roof framing appears to be attached to the building wall, without any seismic joints. One exception to this is where the covered walkways attach to the permanent portable classrooms. At this location, there is a distinct seismic joint.

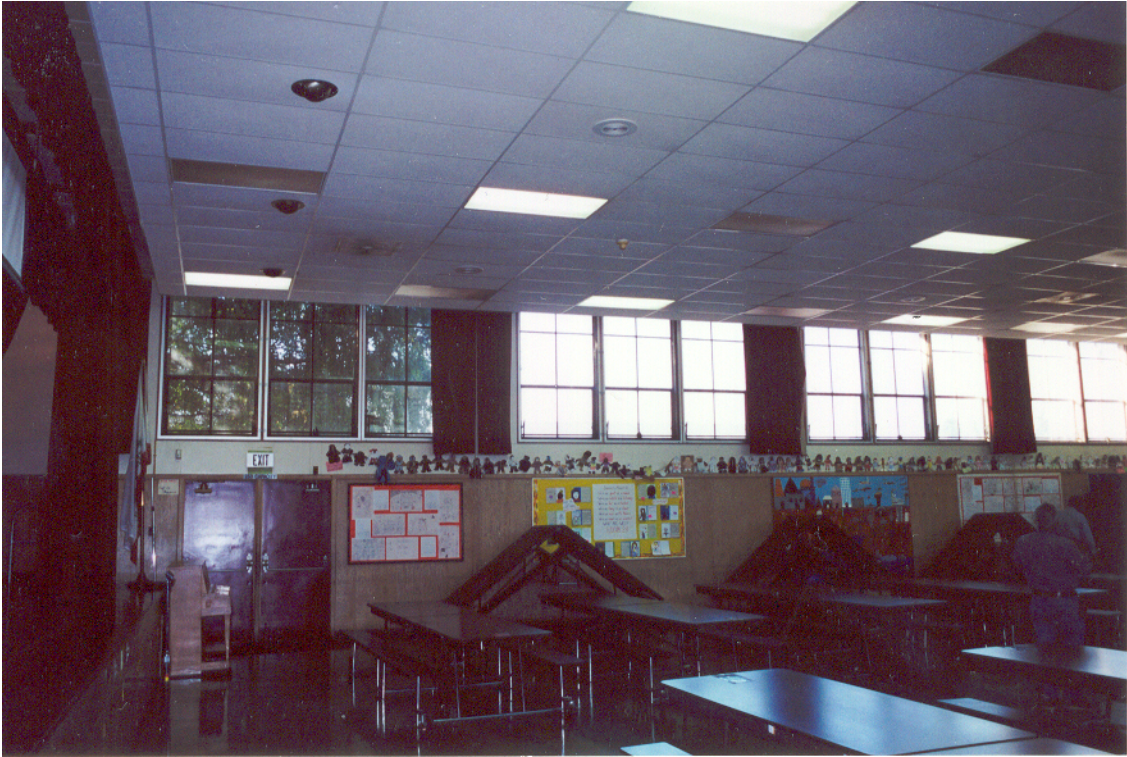
Figure 7: Interior of Multi-Purpose Building

The multi-purpose building is a one-story wood structure with plaster finish. The interior of the building is divided into one large open area and a smaller service area at the north end of the building. The wall between these two areas has multiple door openings and therefore does not carry seismic loads. The transverse end walls have relatively few openings (see figure 5). The exterior longitudinal walls have continuous bands of high windows with some shear wall at the ends (see figures 2, 3, and 6). There is a covered walkway on the east face of the building. The main area has a suspended T-bar ceiling (see figure 7).

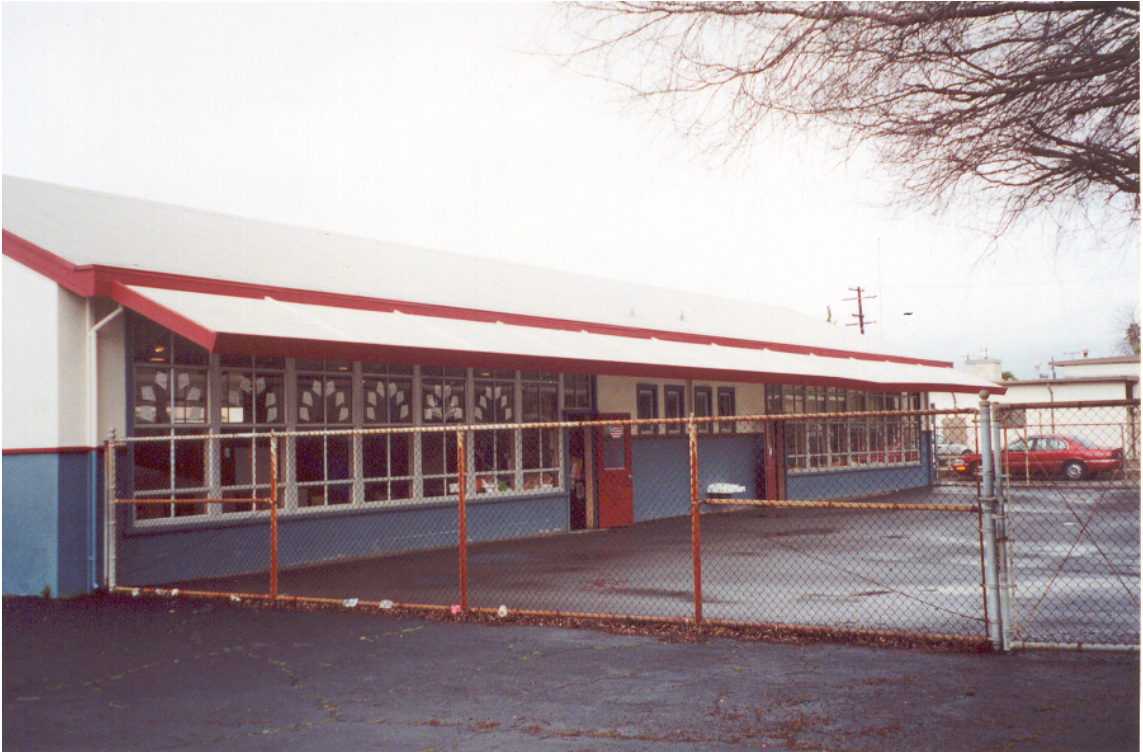
Figure 18: East Face of Kindergarten Building

The kindergarten building is a one-story wood structure with plaster finish. It has two classrooms with service areas in between them. The end walls and the one interior transverse shear wall have only minor openings. The exterior longitudinal walls have large window openings at the classroom area (see figures 18 and 19) and shear panels at the service areas. There is a covered walkway along the west side of the building that is similar to the classroom buildings. There are suspended T-bar ceilings in the classrooms.
