STRUCTURAL EVALUATION OF
DE ANZA HIGH SCHOOL
WEST CONTRA COSTA UNIFIED SCHOOL DISTRICT
(WCCUSD)

WLC Architects
Kaiser Building
1300 Potrero Avenue
Richmond, CA 94804

DASSE Design, Inc.
33 New Montgomery Street #850
San Francisco, CA 94105
(415) 243-8400

October 17, 2002

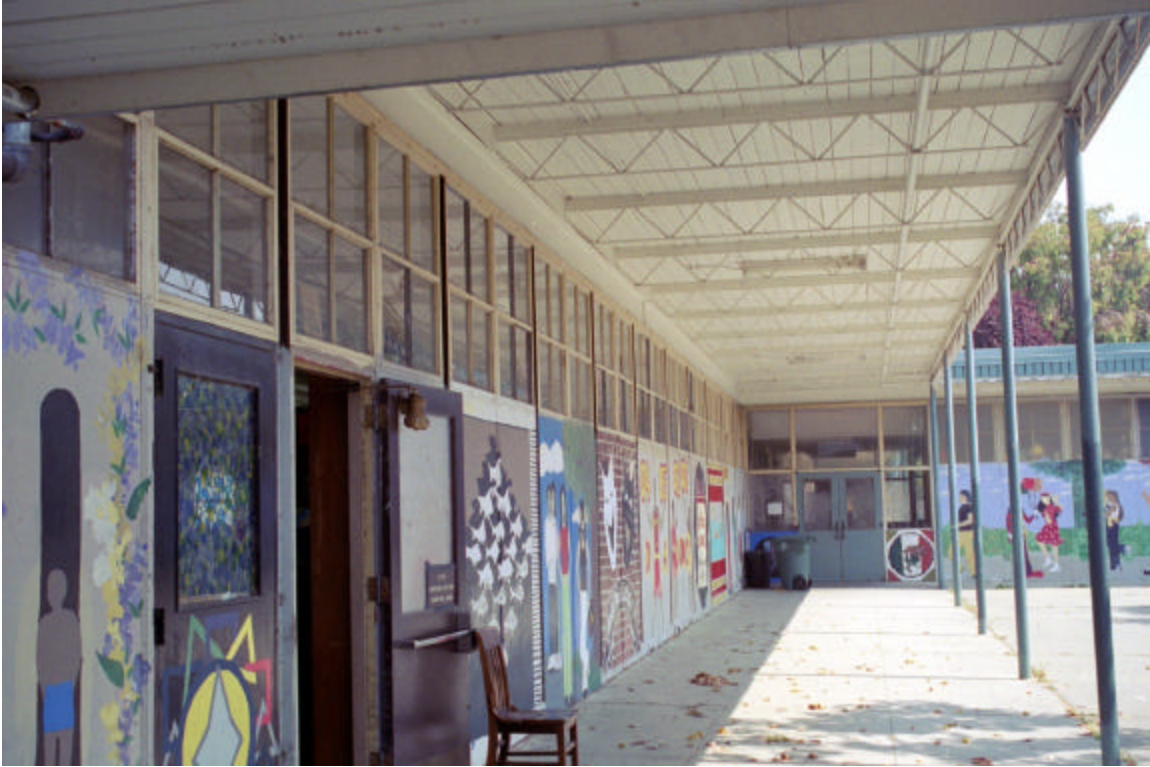
Figure 6: View of Classroom Building from courtyard

The classroom building wings are connected to each other by covered walkways at each end and corridor segments near the middle of the building that are framed contiguously with the main roof. These connecting walkways and corridors form courtyard areas that open to the sky (see figure 6). There is also a connecting corridor to the administration and library building (see figure 3). The classroom buildings could be viewed as being either three buildings that are linked together (i.e. no seismic joints) or as one large building that has significant diaphragm openings. The framing members at the exterior of the courtyard opening are open-web joists that will not perform well as collector elements (see figure 4). This is a life safety hazard because those joists may buckle and collapse during an earthquake. At the central corridor that connects the wings of the classroom building, there are some additional concrete shear walls that align with the exterior longitudinal walls of the classroom building wings. The roof framing does not appear to provide adequate collector capacity to allow these shear walls to carry the seismic load of the roof diaphragm tributary to these lines and may result in failure the collector along these lines. In the transverse direction, there are no continuous collector lines to connect the building wings to each other, which may result in tearing of the roof diaphragm and partial collapse of structure.

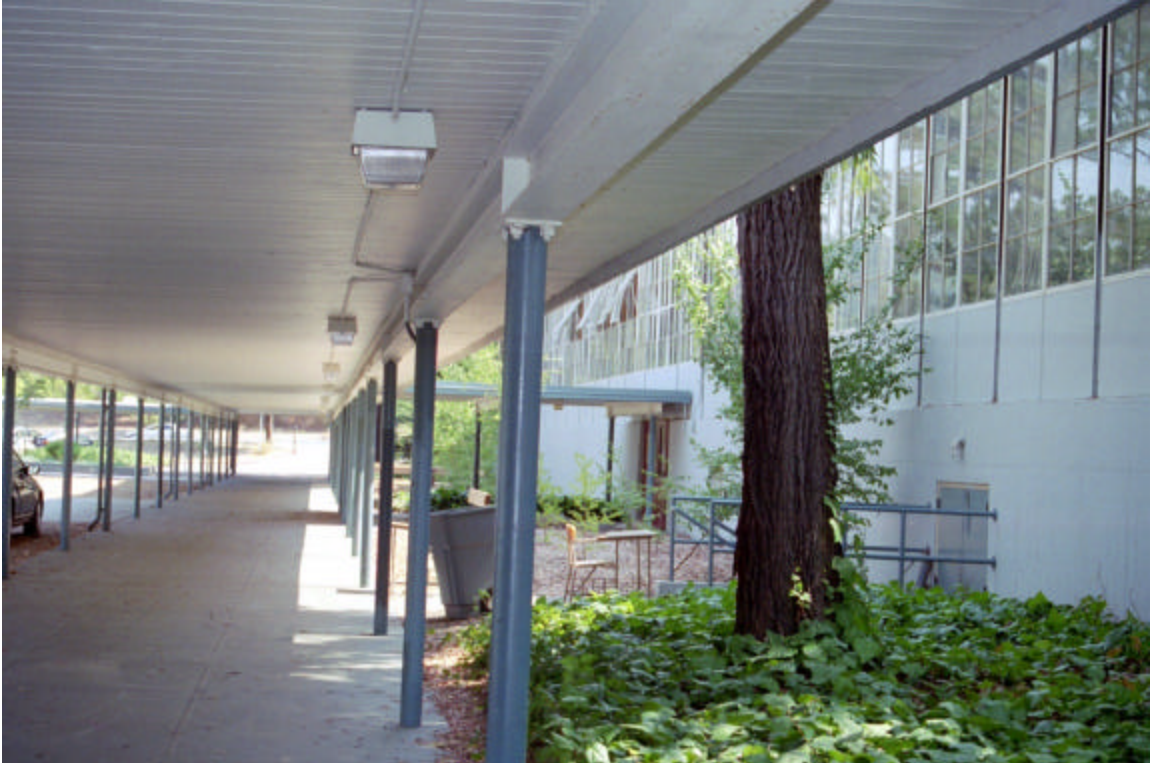
Figure 7: Front of Administration and Library Building

In the transverse direction, lateral support is provided by the 8" thick concrete tilt-up shear walls at the ends of the building. These walls have no direct shear connection to the foundation, having only a shear key into a thin layer of grout that was laid down at the time of erection, and have no restraint to keep them from sliding off of the footing in their out-of-plane direction. There is additional roof framing at the end bays to provide out-of-plane support for the concrete walls, but these ties do not continue across the length of the building to provide continuity. The exterior columns typically rest on a 14" wide strip footing and the interior columns are supported on drilled piers similar to the classroom building. At the north side, the ground slopes down away from the building. There is a suspended concrete slab at the first floor in this area and a small basement under the northwest corner of the building with concrete shear walls on all sides (see figure 7).

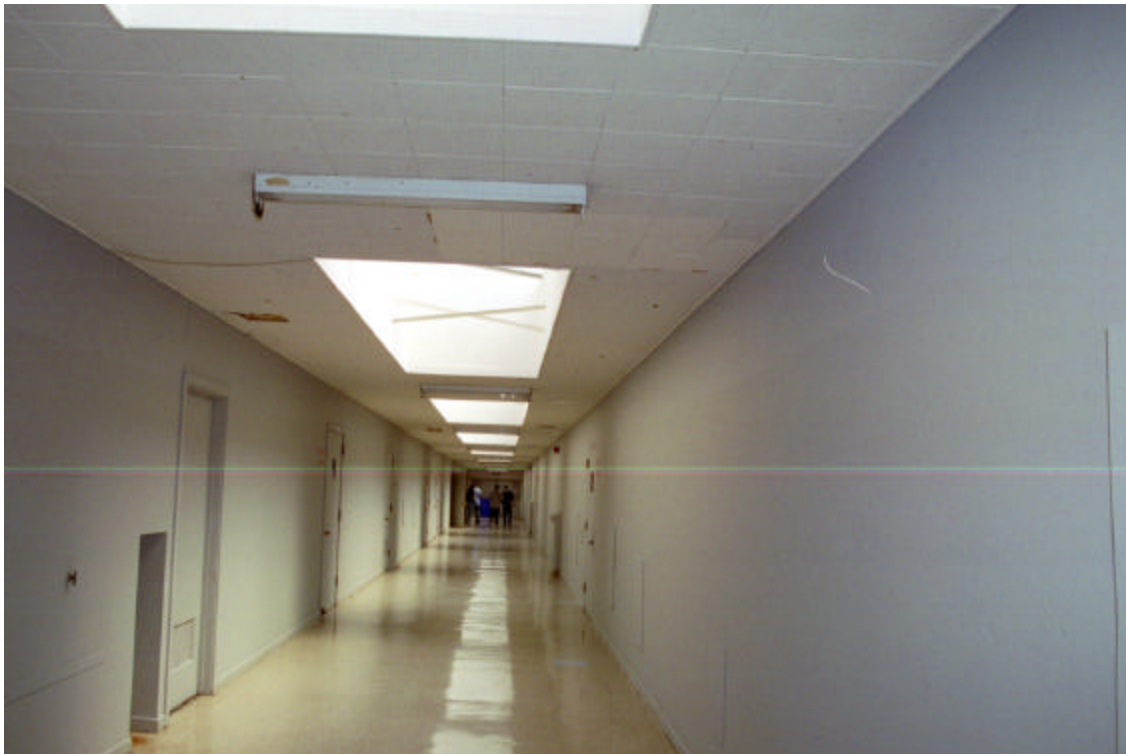
Figure 11: Diagonal bracing at corridor skylights in the Shop Building

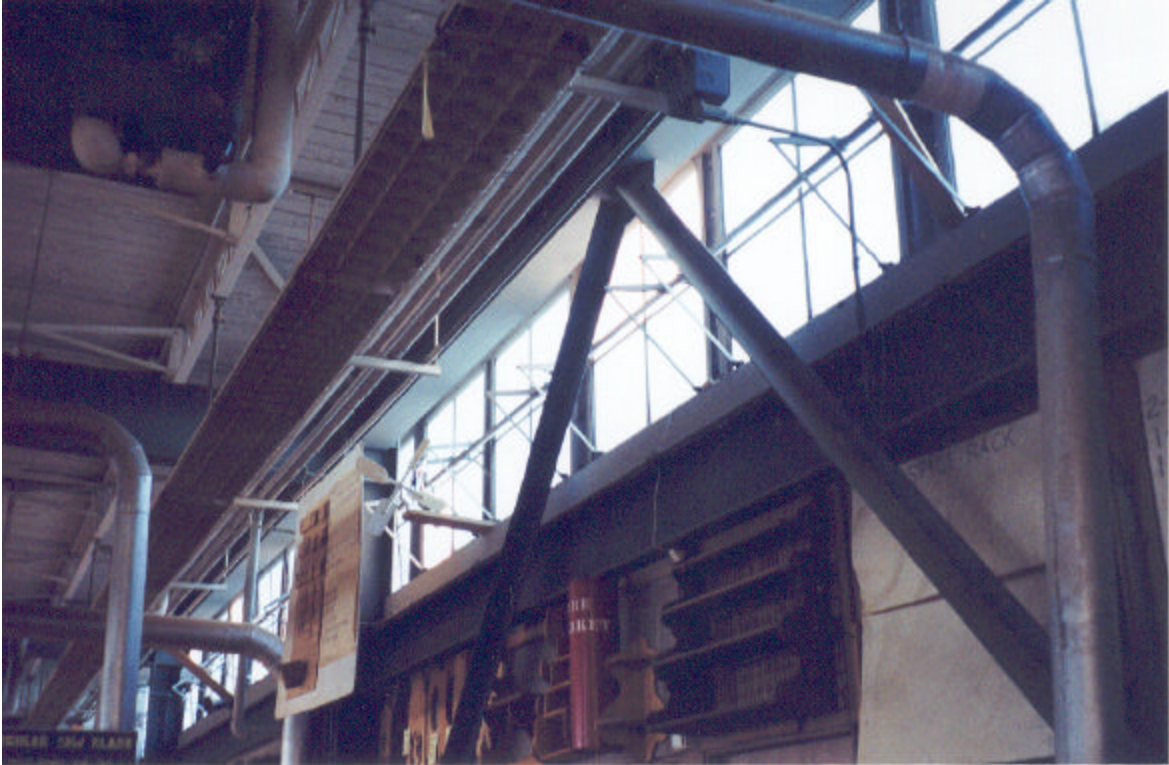
Figure 12: Braced frame at the Shop Building interior

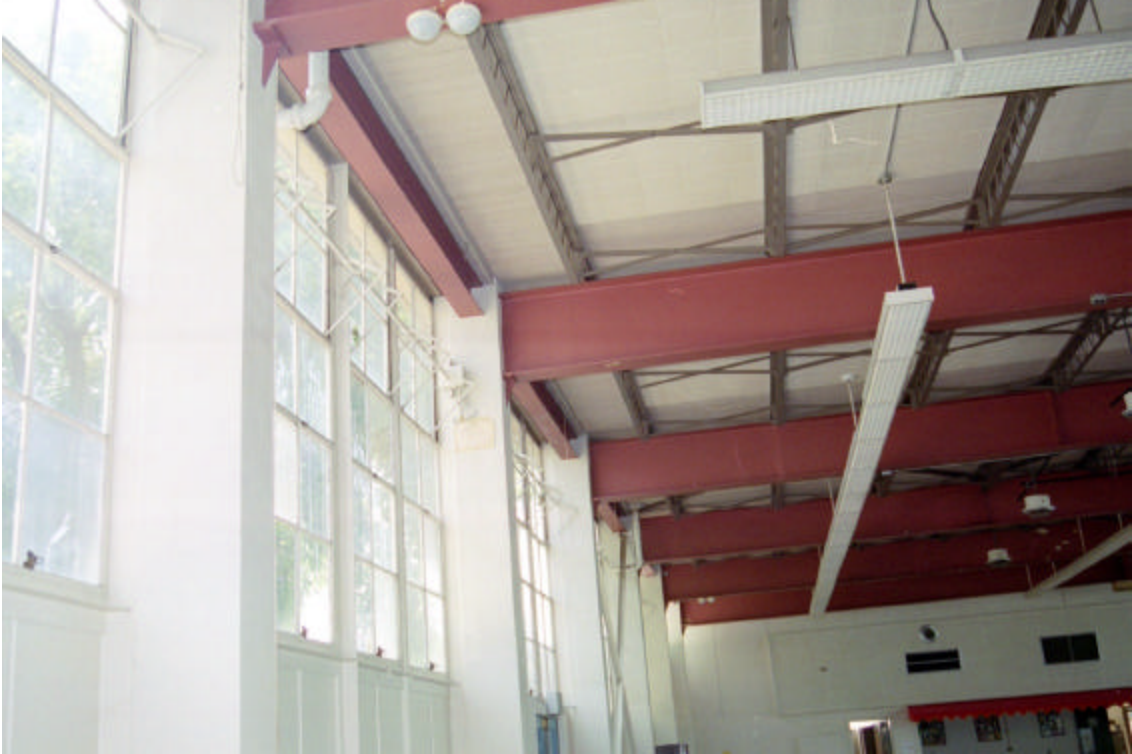
mezzanines above. The structural steel frames and roof diaphragm bracing are exposed to view in the cafeteria area and appear to be in good condition (see figures 13 through 15).

Figure 14: Cafeteria braced frames and roof framing

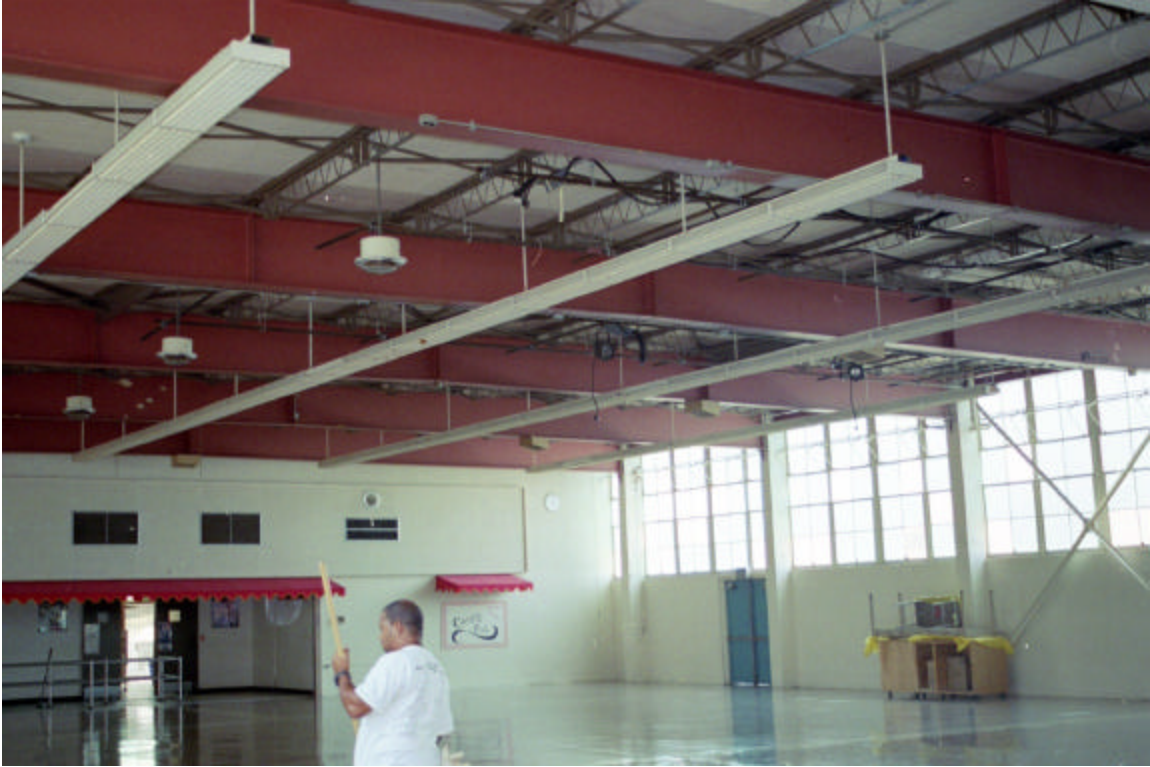
Figure 15: Cafeteria braced frames and roof framing

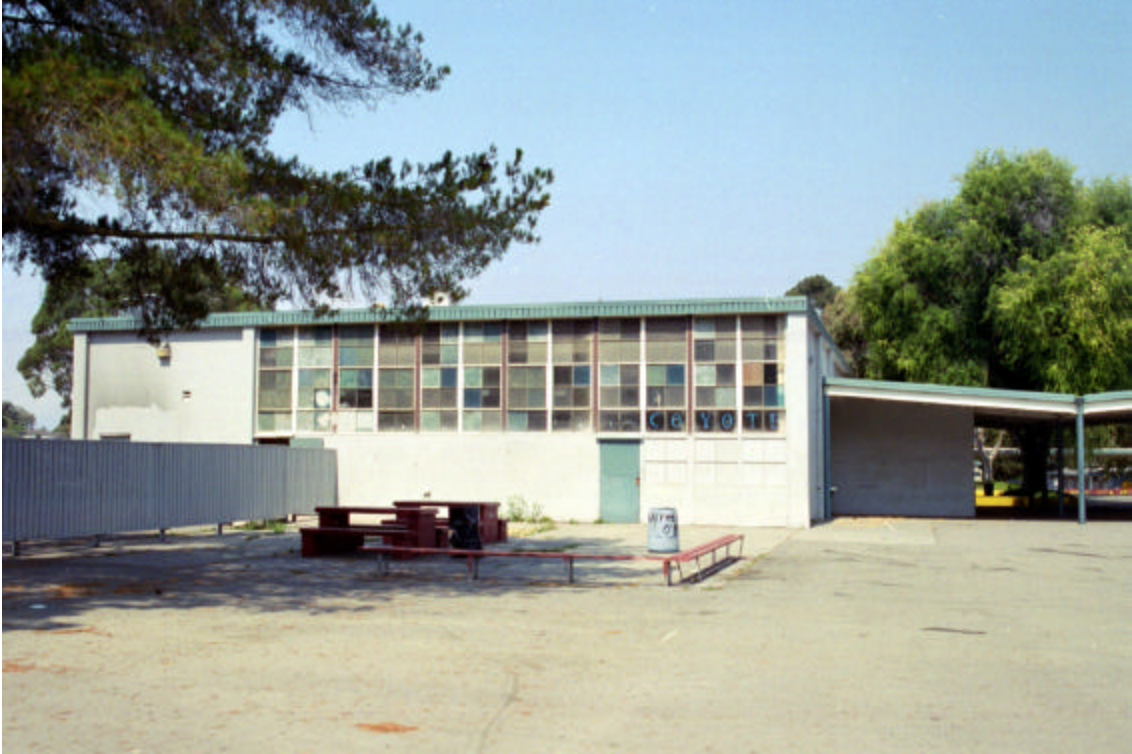
Figure 16: South wall of Cafeteria

were cast in place and the ones at the south end of the building are 8" thick tilt-up walls. The cast walls have dowels into the foundation, whereas the tilt-up walls have no direct shear connection to the foundation and are detailed in a similarly dangerous manner as those in the administration and library building end walls (see figure 16).

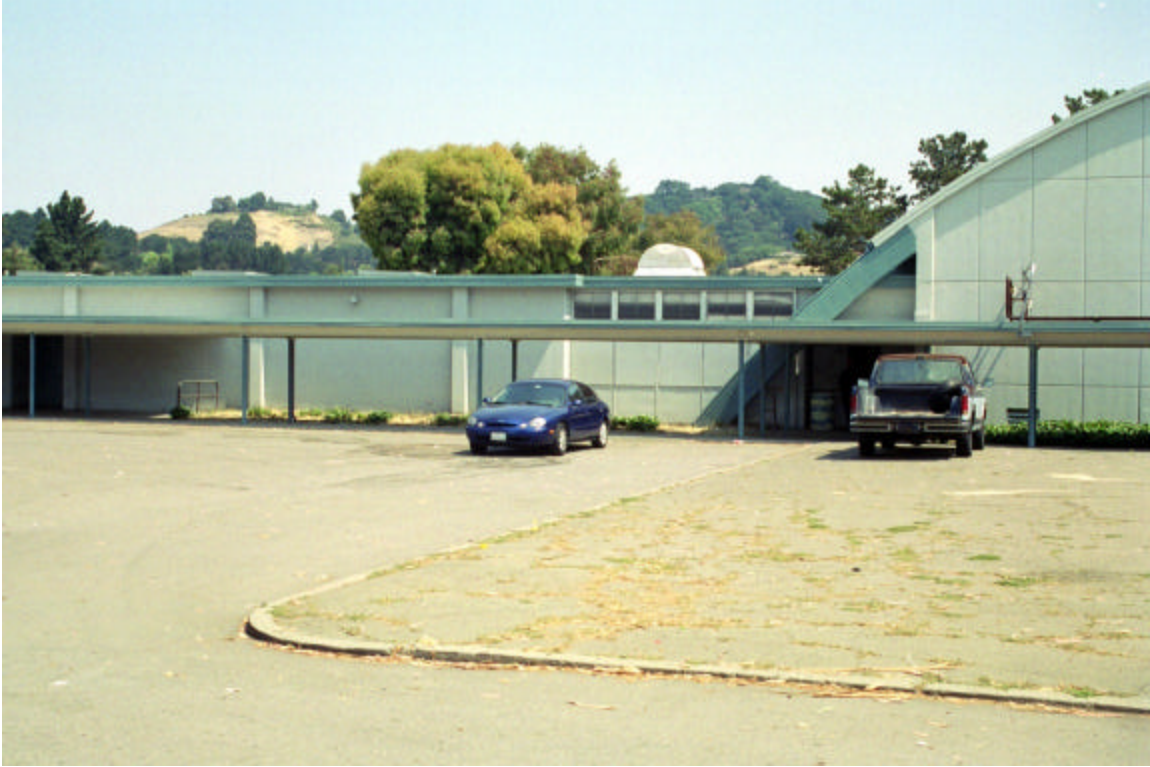
Figure 20: West side of Gymnasium and locker rooms

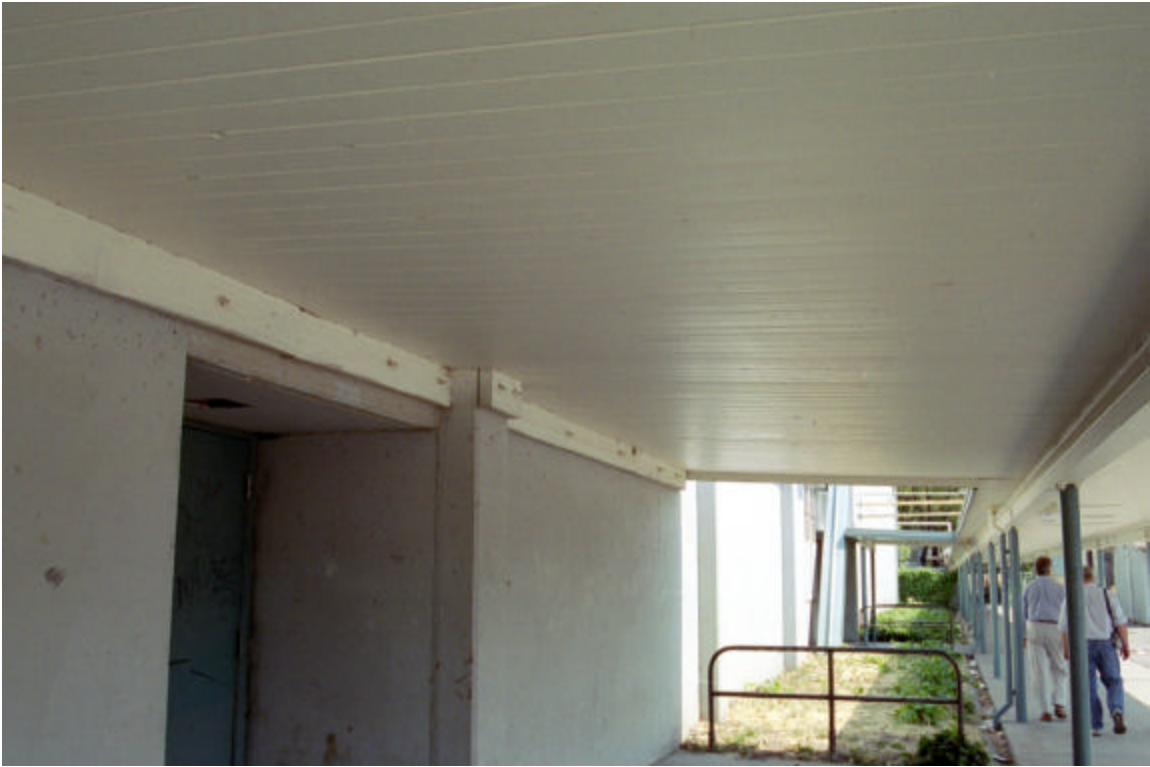
Figure 24: Ledger connection of covered walkway to locker room

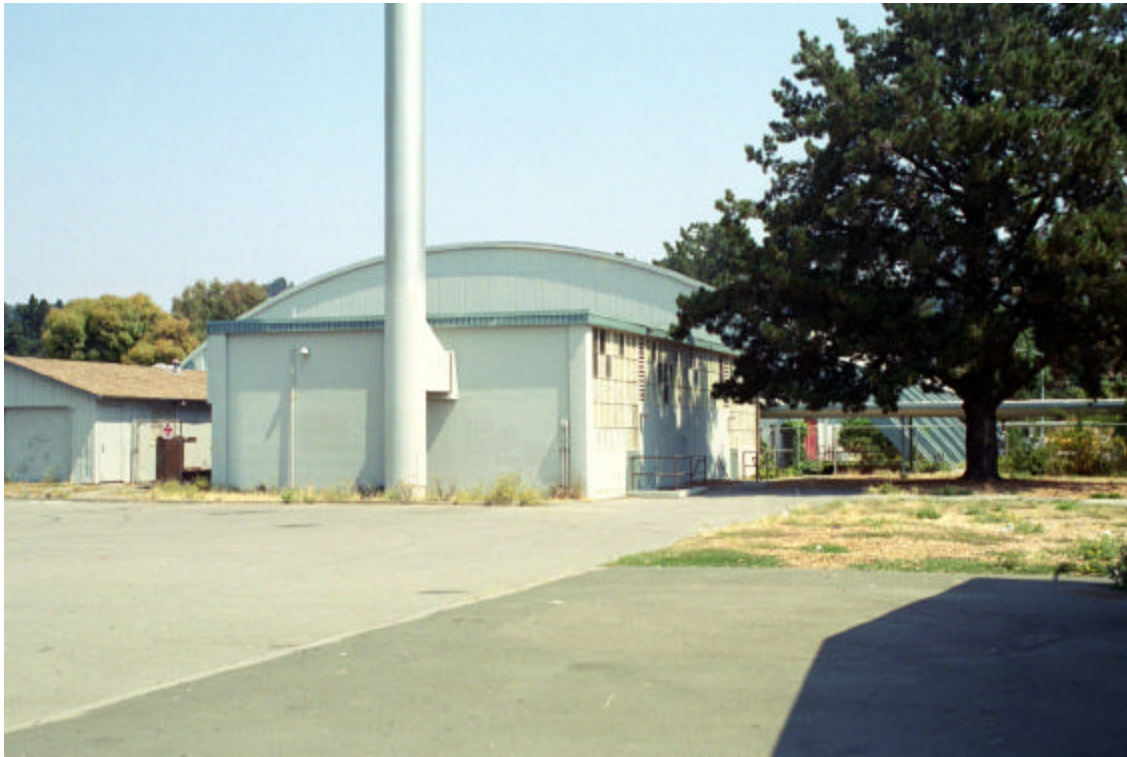
Figure 25: Boiler House

The boiler house is a small free-standing structure with a diagonally sheathed roof supported by open web joists. Those joists span 16 ft. between 16WF36 beams that span 33 ft. between concrete walls. The floor slab is below the level of the adjacent grade. The south wall of the boiler house has windows along the entire length above a half-height concrete wall. The other three sides of the structure have 8" thick concrete tilt-up wall panels. This three-side box configuration will induce some torsion into the structure's motion. At the east and west walls, the out-of-plane wall connection to the diaphragm introduces axial force into the open-web joists. Just outside the boiler house, there is an exhaust stack that is supported on a 7'-6" square footing (see figure 25).

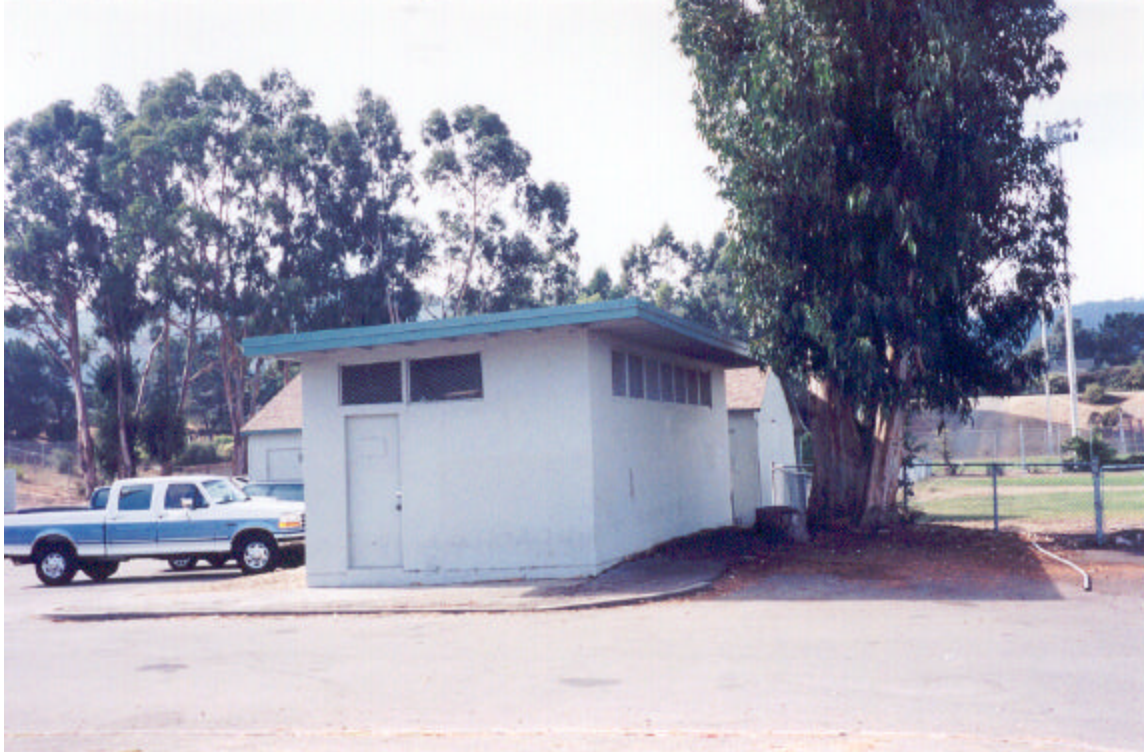
Figure 26: Electrical Service Enclosure

The electrical service enclosure is a small wood-framed building (see figure 26). The roof has 1x diagonal sheathing supported by 2x8 joists at 24" o.c. The 2x8 joists span 13 ft. between exterior longitudinal walls. There are conventional diagonally sheathed shear walls along all
