STRUCTURAL EVALUATION OF
HELMS MIDDLE SCHOOL
WEST CONTRA COSTA UNIFIED SCHOOL DISTRICT
(WCCUSD)

DRAFT
October 17, 2002

DASSE Design Project No. 01B300x2

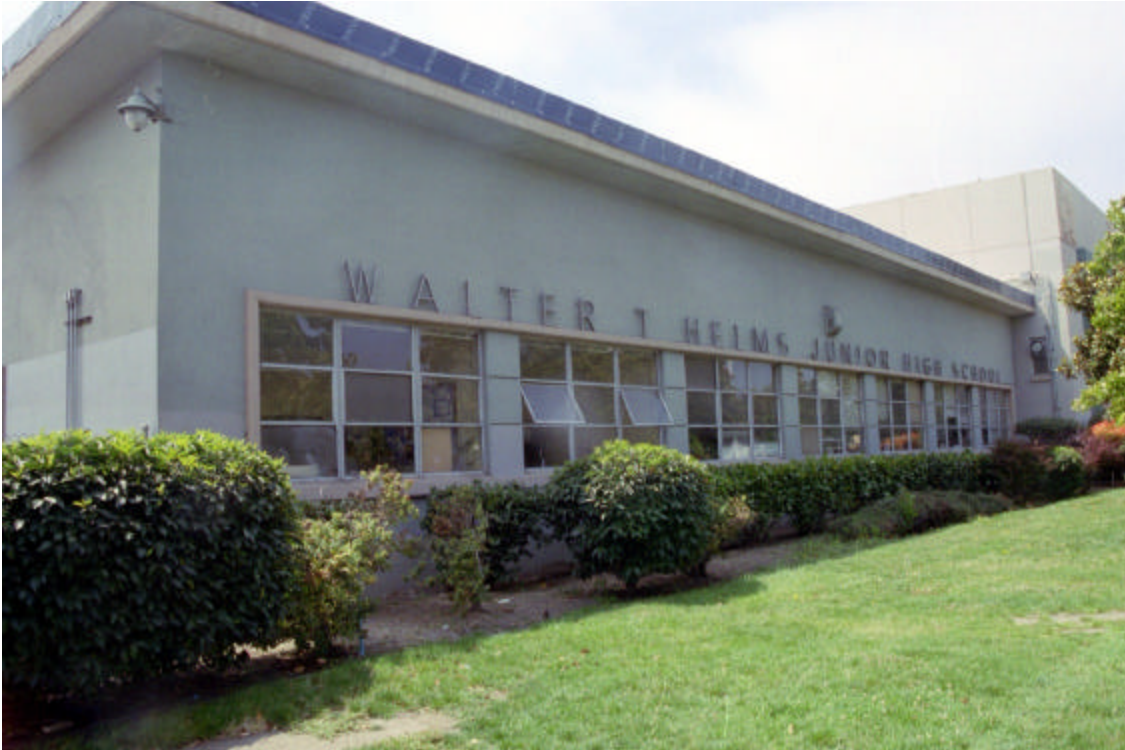
Figure 2: Main Building, administration wing, exterior north wall

The remaining portion of the main building is comprised of the library wing, the administration wing, and various other rooms. The library wing is a larger structure, approximately 20' tall. The library has a plaster ceiling, and the adjacent hallway has a large skylight. Adjacent to the library, large wall height louvers occur in the exterior wall of the mechanical room. Overhead in the same area, a tall chimney extends above the roof level. Extensive window openings were observed at most of the exterior walls throughout the library wing, administration wing, and adjacent areas. While interior shear walls may exist in some of these areas, the excessive window openings indicate a deficiency in the strength of the structure to resist the expected lateral forces, and is consequently perceived to be a life safety hazard. The library wing, administration wing, and adjacent areas of the main building are shown in figures 2, 8, and 9.

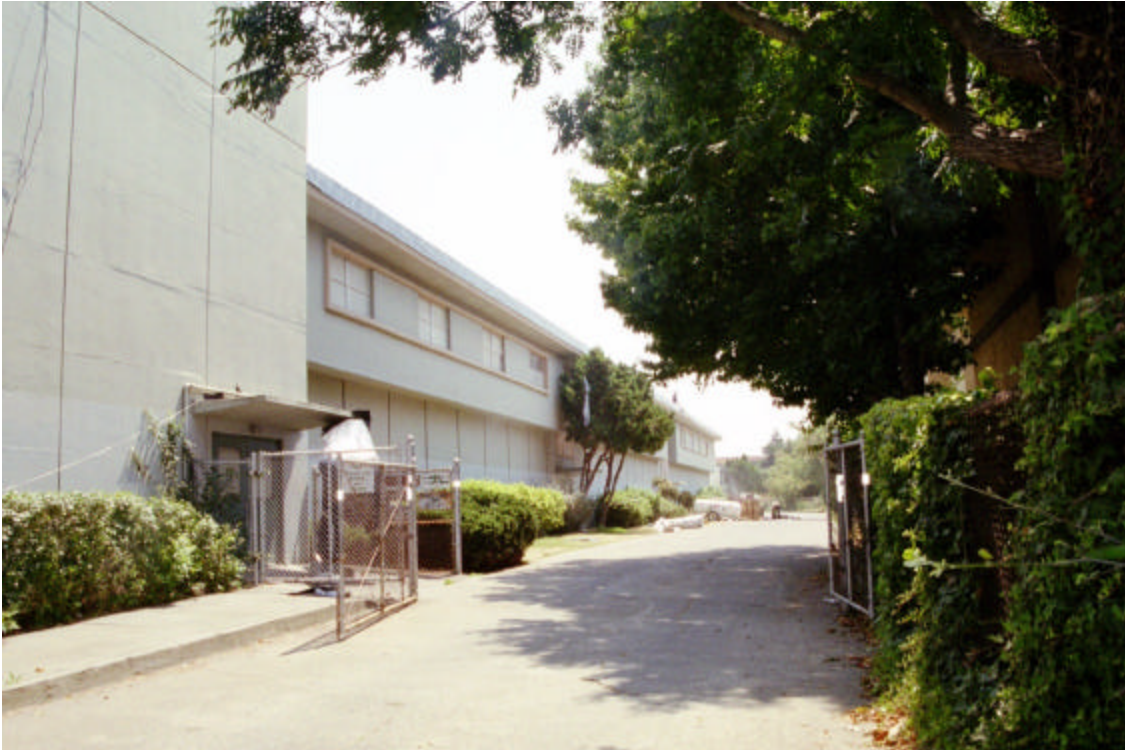
Figure 4: Main Building, exterior west wall

direction at both the exterior and corridor walls. The typical classroom configuration has tall windows at the exterior wall and high windows over lockers at the corridor wall. At the second level, these high windows open to the outside over the lower corridor, while at the lower level the high windows open into the corridor. The classroom corridors have glass block windows at the lower level, and smaller window openings at the second level. At the corridors connecting the various rooms, large windows are found facing into the courtyards, while the outside walls tend to have more solid wall. The interiors typically have a suspended T-bar ceiling in the classrooms, and an acoustical tile ceiling in the corridors. No seismic joints were observed in the corridors, and hard conduits run the length of these corridors without compensation for the potential differential movement of the various building wings. This condition is considered a life safety hazard. The excessive lengths of windows found at the longitudinal walls of the classroom wings of the main building, indicate a severe deficiency in the strength of the structure to resist the expected lateral forces, and are also perceived to be life safety hazards. The classroom wings of the main building are shown in figures 3, 4, 5, 10, and 11.

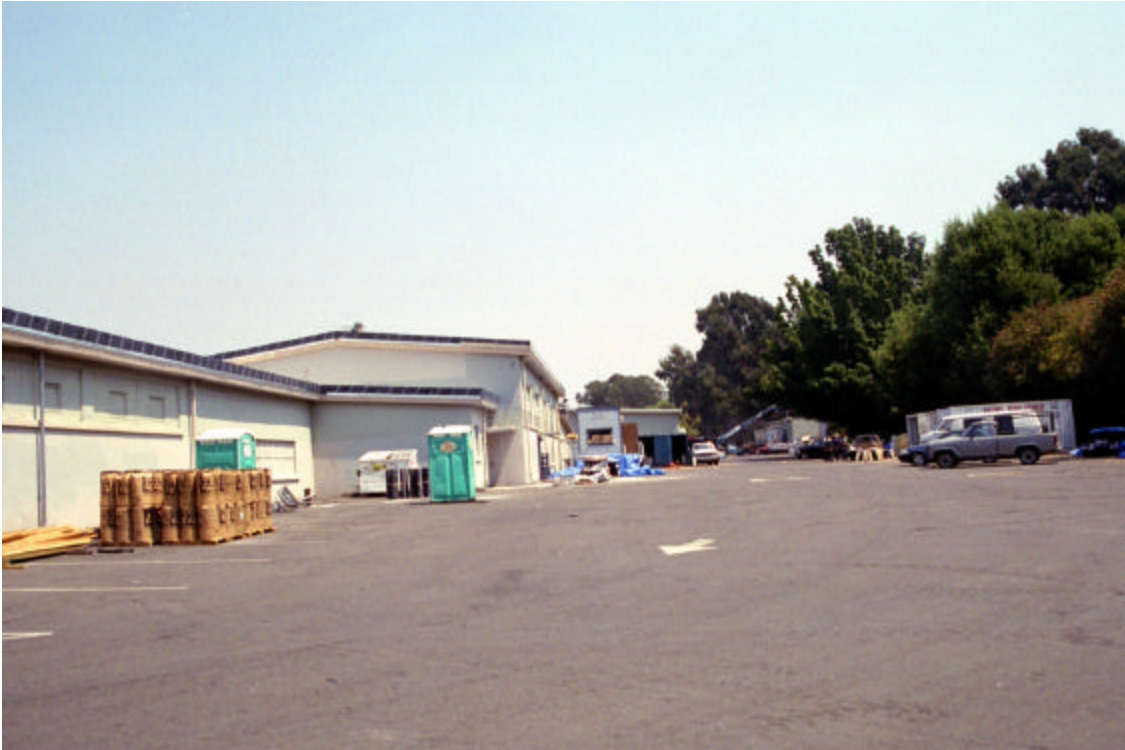
Figure 6: Main Building, wing 5, exterior south wall

Also part of the main building, the cafeteria wing is a single story with a covered walkway supported by steel pipe columns on the north side. The large cafeteria room has a plaster ceiling, and the walls have an interior plaster finish. An additional dining area to the east of the large room is also supported by steel pipe columns that have been infilled with windows, masonry, and concrete. At the time of the initial site observation, the re-roofing of the main building's roof was in progress. In the time between the two site visits, this roofing work was completed, new windows were installed at some locations in the cafeteria wing, and a large canopy structure was constructed to provide an additional outdoor eating area. The cafeteria wing of the main building is shown in figures 6, 7, 12, 13, and 25.

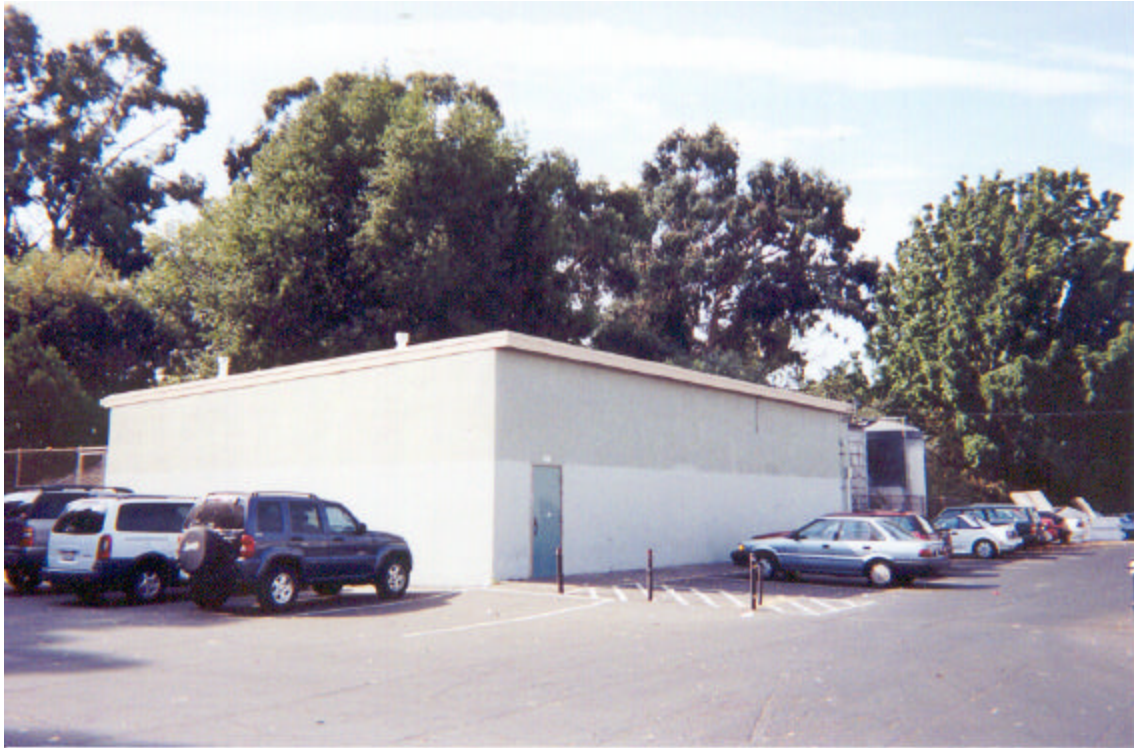
Figure 22: Music Building, exterior northeast corner

At the very rear of the campus the music building is a single story, single room building. This structure has a wood framed system, as interior wood posts and beams were observed running the longitudinal length of the building. This framing appears to have been modified at some point after the original construction by sandwiching the wood beam with two steel channels in order to remove the center post and create a longer beam span. The exterior of this rectangular building has a plaster finish with an appearance that matches the adjacent shop building. The exterior walls are nearly completely solid with only the most minimal window openings. At the west end of the structure some partial height practice rooms are framed out of wood and covered on the interior walls and ceiling with acoustical tile. The greater interior of the building has a hard ceiling and wood wall paneling up to a 7' height and acoustical tile above. The music building is shown in figures 22, and 23.
