STRUCTURAL EVALUATION OF
NORTH CAMPUS/TLC/VISTA CONTINUATION HIGH SCHOOL
WEST CONTRA COSTA UNIFIED SCHOOL DISTRICT
(WCCUSD)

WLC Architects
Kaiser Building
1300 Potrero Avenue
Richmond, CA 94804

DASSE Design, Inc.
33 New Montgomery Street #850
San Francisco, CA 94105
(415) 243-8400

October 17, 2002

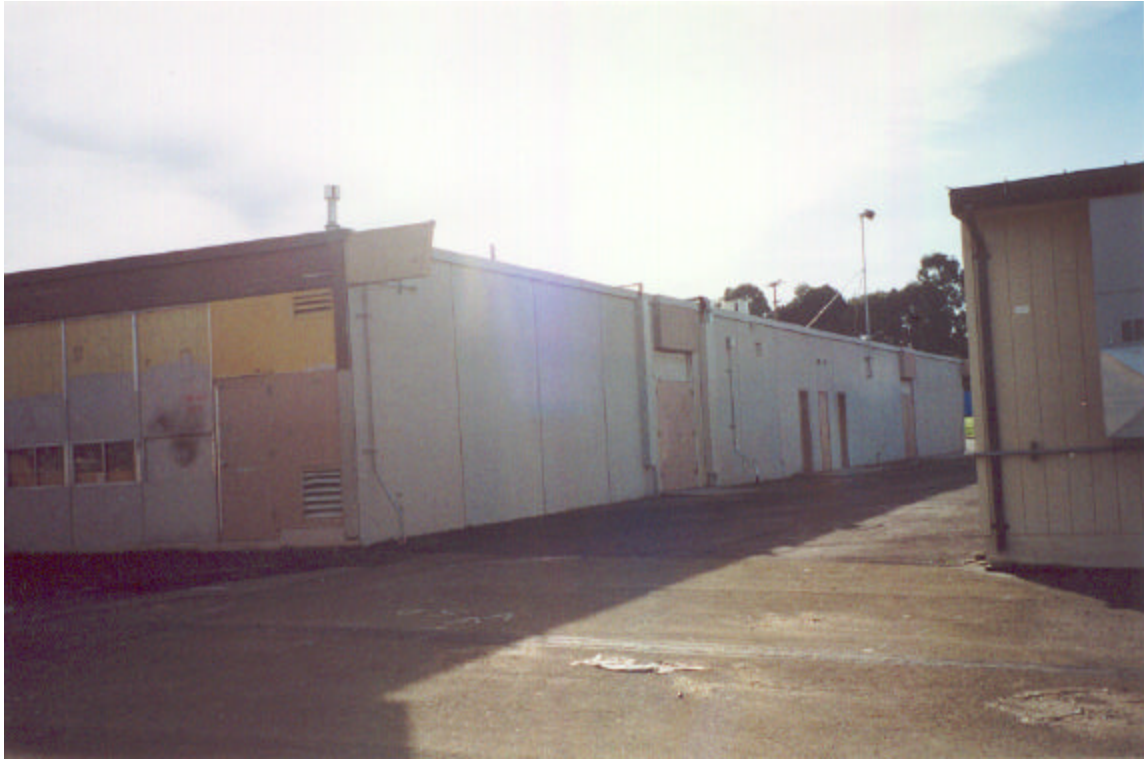
Figure 8: West Face of Main Building

The main building is a one-story wood-framed structure with a plaster exterior finish and a large number of windows, particularly in the longitudinal walls (see figures 2 and 6 through 9). The building is shaped like an "8", having two interior courtyards (see figure 1). Interior corridors are located along the courtyards in the longitudinal direction. The corridors and adjacent classrooms have windows that look into the courtyards, but there appear to be long segments of shear walls on the interior sides of the corridors (see figure 10). The corridors have acoustical tile ceilings and skylights are placed in the areas that are not adjacent to the central courtyards. Classrooms and administration areas have suspended T-bar ceilings. The transverse walls at the classrooms have no openings in them. The main entrance has a canopy above it that is attached to the building along the rear edge and is lower than the main roof diaphragm (see figures 2 and 15).

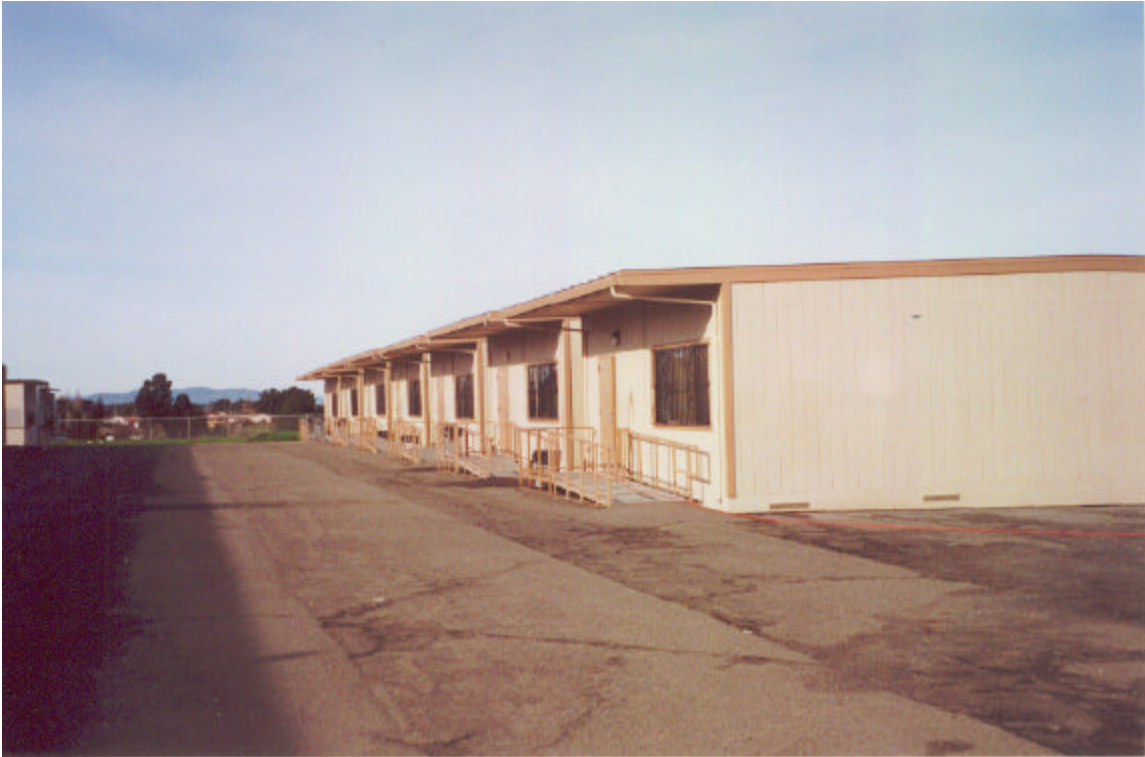
Figure 13: Portable Classrooms

DASSE's review of portable buildings has been limited to identifying clearly visible seismic deficiencies observed during our site visit and these have been documented in the report. Portable buildings pose several issues with regard to assessing their life safety hazards. First, drawings are often not available and when they are, it is not easy to associate specific drawings with specific portable buildings. Second, portable buildings are small one story wood or metal frame buildings and have demonstrated fairly safe performance in past earthquakes. Third, there is a likelihood that portable buildings (especially those constructed prior to 1982) are not in compliance with state regulations, either because they were not permitted or because the permit was for temporary occupancy and has expired.

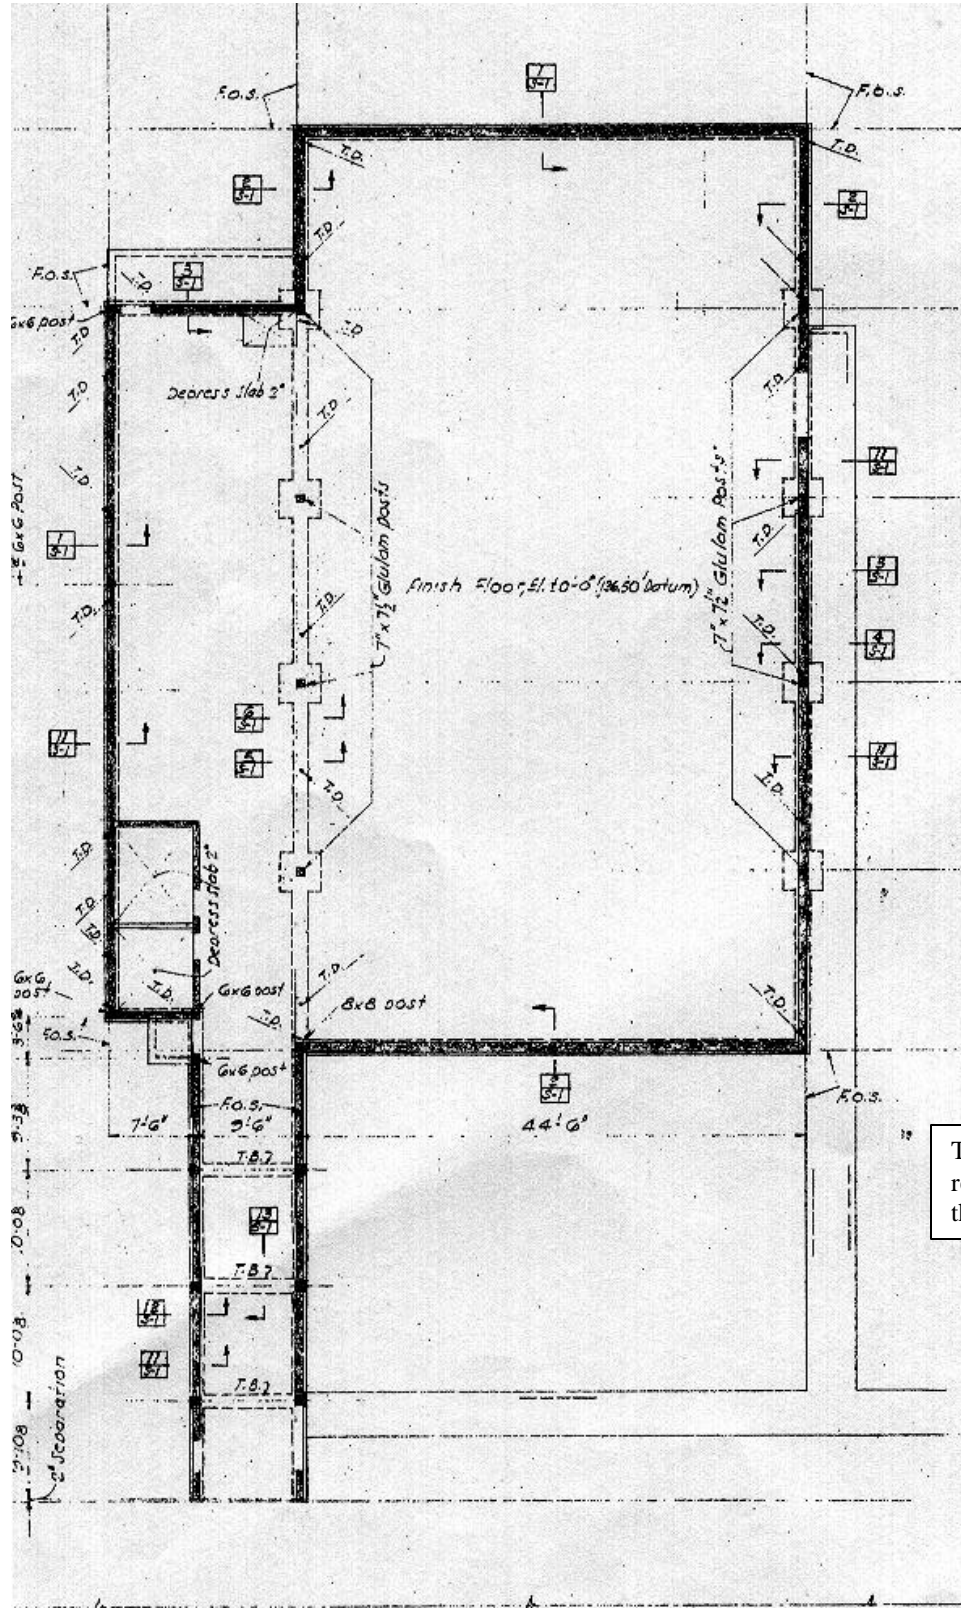
Drawing 3: Multi-purpose building floor plan

There is no seismic retrofit work recommended for this building at the foundation level.
