STRUCTURAL EVALUATION OF  
FAIRMONT ELEMENTARY SCHOOL  
WEST CONTRA COSTA UNIFIED SCHOOL DISTRICT  
(WCCUSD)

WLC Architects  
Kaiser Building  
1300 Potrero Avenue  
Richmond, CA 94804

DASSE Design, Inc.  
33 New Montgomery Street #850  
San Francisco, CA 94105  
(415) 243-8400

April 30, 2002

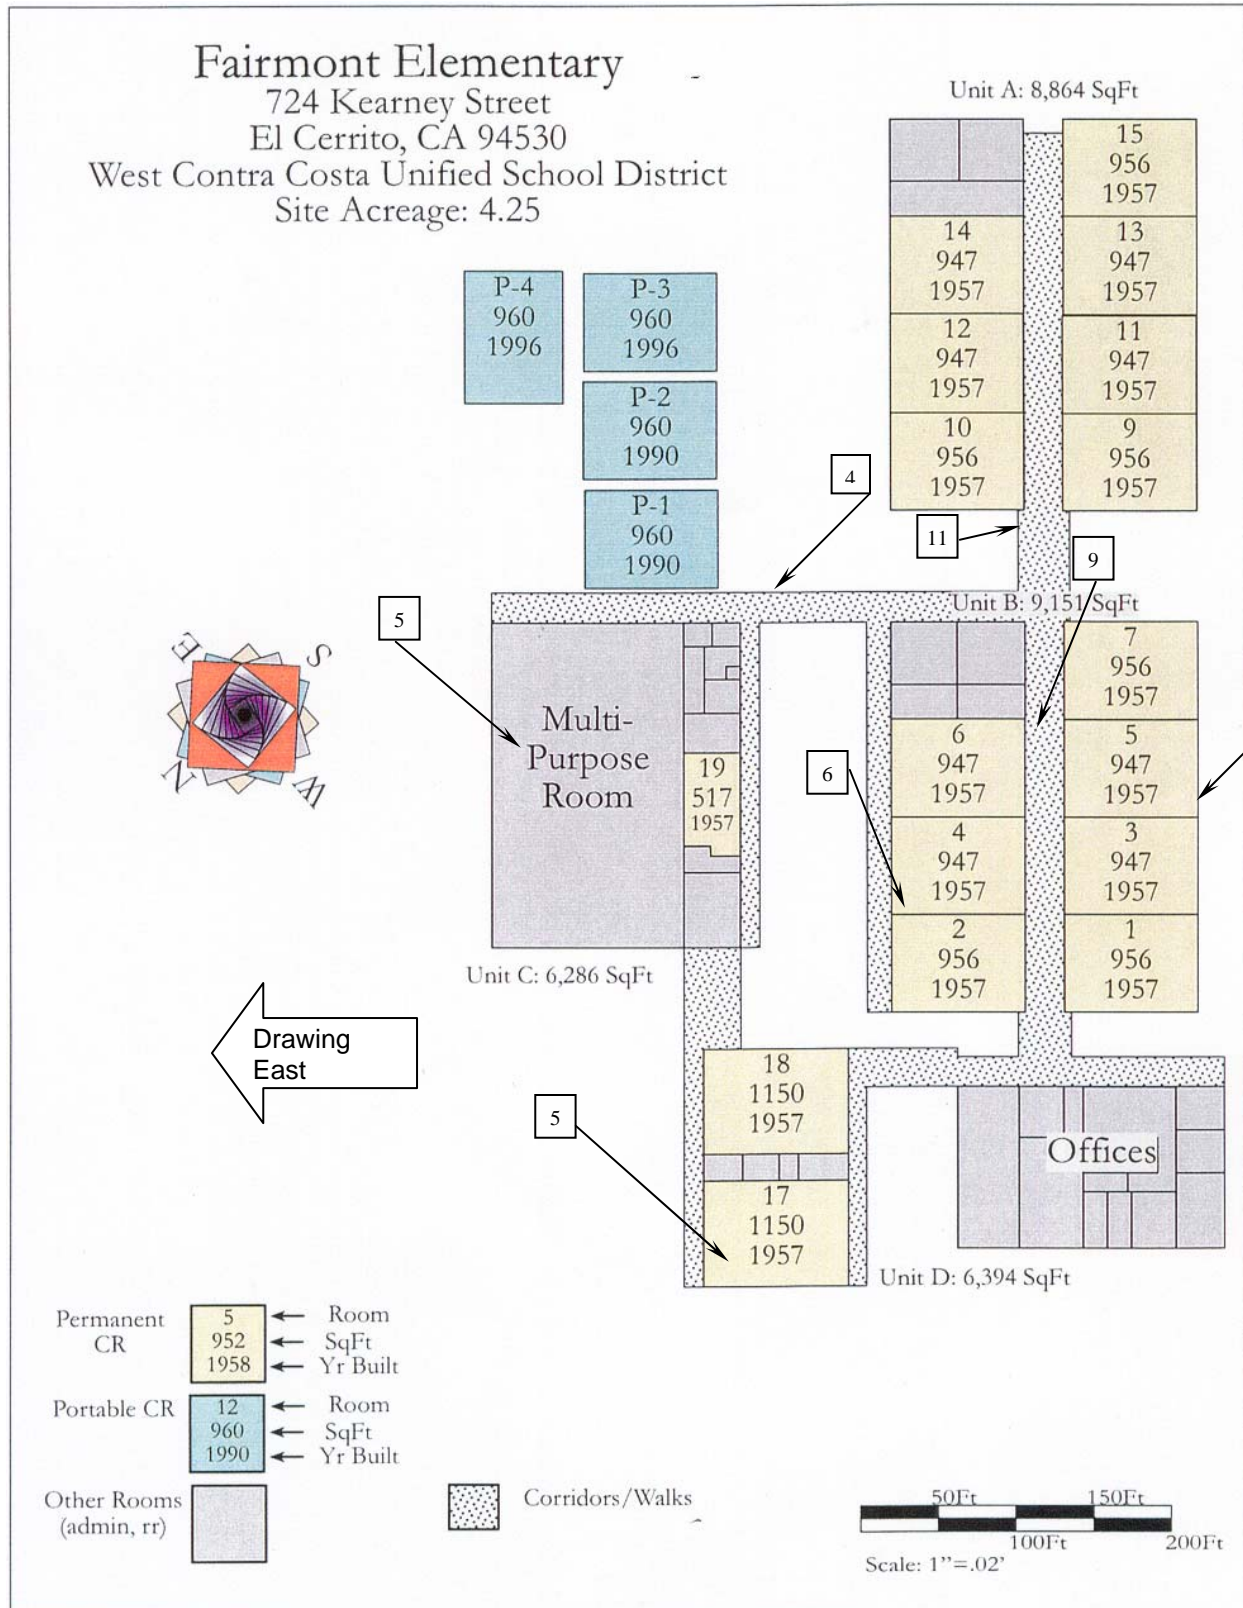
Figure 1: School Layout Plan

The school was built in 1957. There are five permanent buildings: Main classrooms buildings (two), Multi-purpose Building, Kindergarten Building and Administration building. There are four portable buildings (see figure 1). All the permanent buildings are one story wood-framed buildings. There are covered walkways connecting the different units. There are two 1990 portables and two 1996 portables. The total square footage of the permanent structures is about 30,695 square feet.

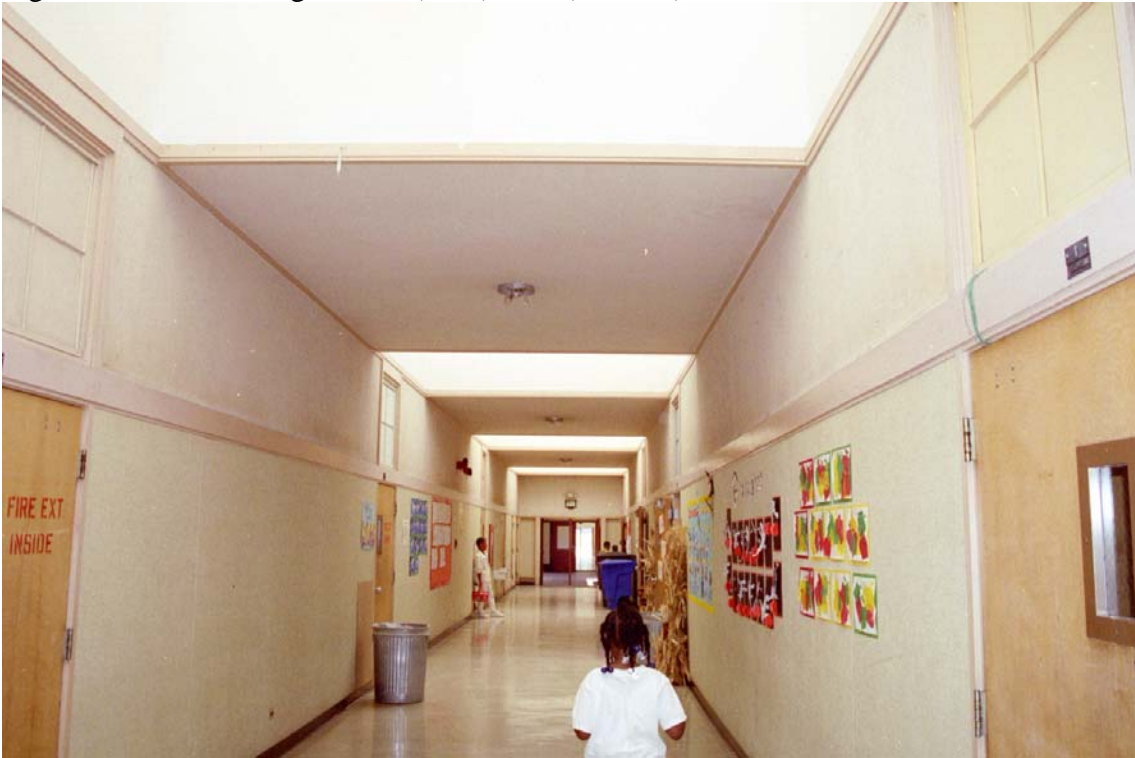
Figure 9: Interior Corridor showing Skylights

The classroom buildings labeled unit 'A' and 'B' (see figure 1), have continuous windows on the west exterior longitudinal walls (see figures 2, 7 & 8). The east exterior longitudinal walls of units 'A' and 'B' also have numerous window openings (see figure 6). There are skylights in the corridor of classroom units 'A' and 'B' (see figure 9). These skylights extend partially into the classrooms and can be seen from inside the classrooms. Some water leakage was noticed in the

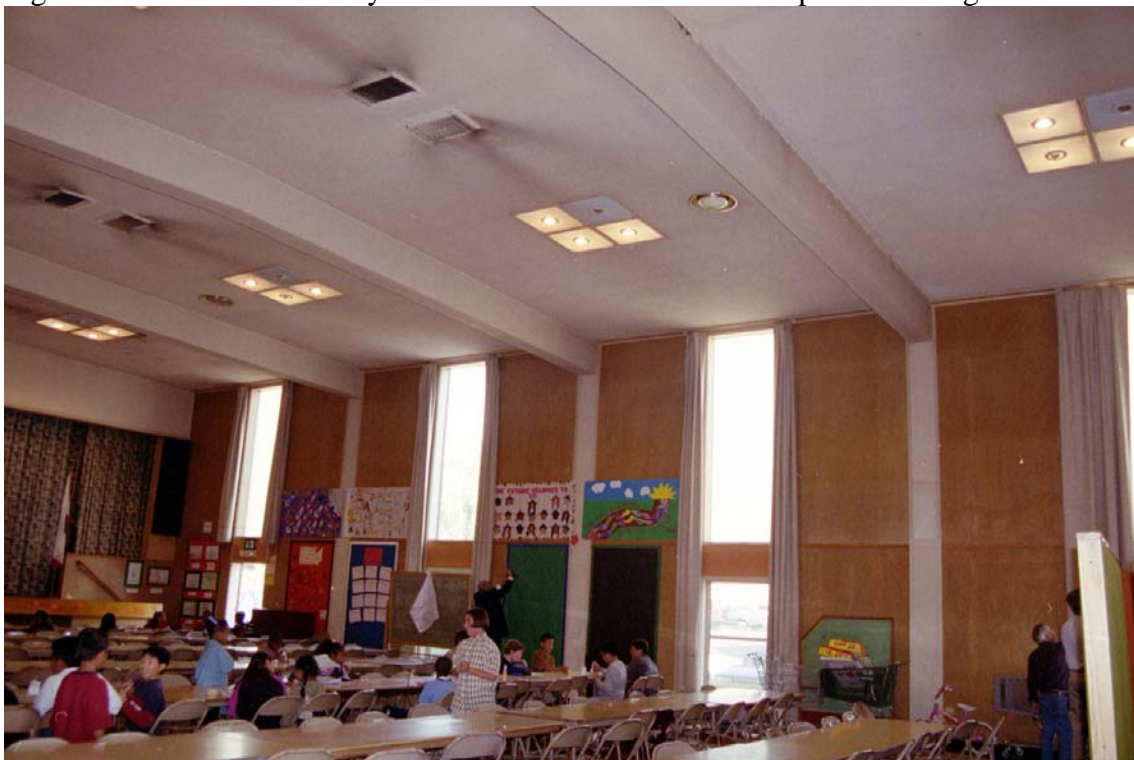
Figure 13: Interior of Multi Purpose Building

The Multi-purpose Building has half inch plywood roof supported by 2x4 intermediate joists and 3x12 main joists spanning in north south direction (approximately 17.5' span) into 21" deep steel bent beams (approximate span 48'). The steel beam frames into 8x8 wood posts at either end of the steel beam (see figure 13). The steel bent beam has full penetration welds at web and flanges with additional reinforcing ¼" fillet weld and with a 5/8" steel stiffener plate at the web joint. There is a low roof area in front of the multi purpose room on the south side approximately 88' long by 19' wide. This low roof has half inch plywood roof with 3x12 joists at 4' on center that frames into 2x stud walls which has 3/8" plywood sheathing. There is a 6' overhang of the low roof towards the west- side of the building.
