STRUCTURAL EVALUATION OF
GRANT ELEMENTARY SCHOOL
WEST CONTRA COSTA UNIFIED SCHOOL DISTRICT
(WCCUSD)

DASSE Design, Inc.
33 New Montgomery Street #850
San Francisco, CA 94105
(415) 243-8400

April 30, 2002

DASSE Design Project No. 01B300

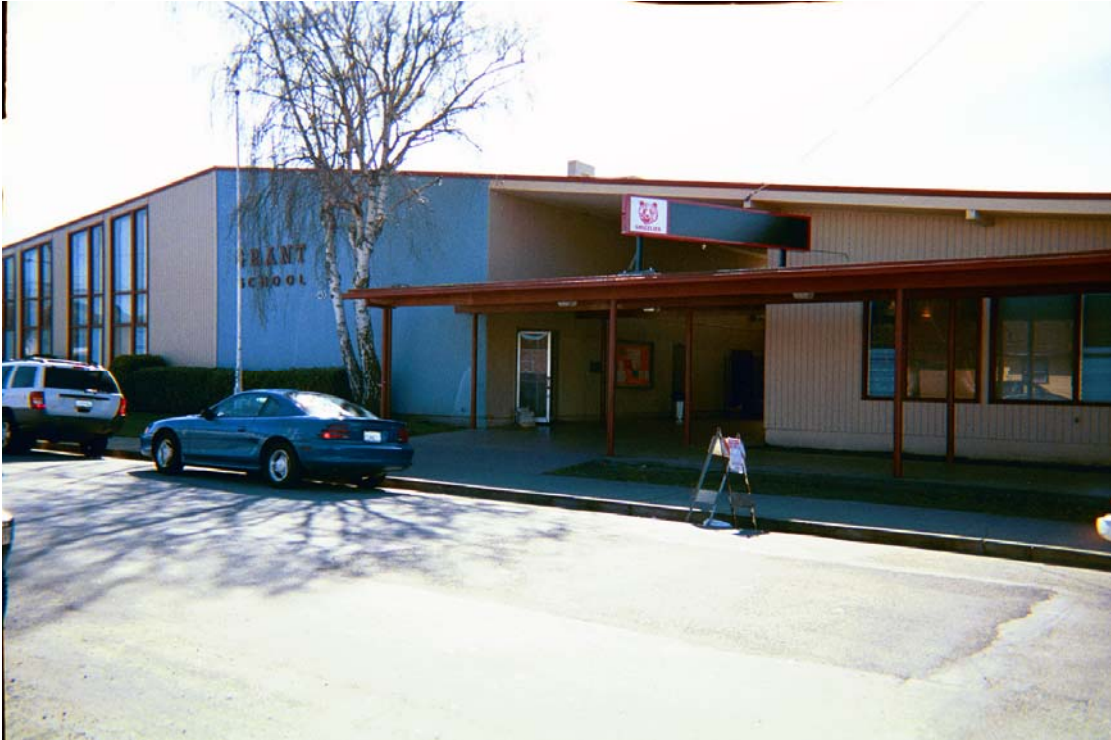
Figure 2: Main Entrance

The school buildings are of one-story wood construction and were built in 1956. The exterior finishes are primarily wood siding with some stucco (Figures 2&3). Typically the interior ceilings are suspended acoustical ceilings (Figure 4).
