STRUCTURAL EVALUATION OF
HERCULES ELEMENTARY SCHOOL
WEST CONTRA COSTA UNIFIED SCHOOL DISTRICT
(WCCUSD)

WLC Architects
Kaiser Building
1300 Potrero Avenue
Richmond, CA 94804

DASSE Design, Inc.
33 New Montgomery Street #850
San Francisco, CA 94105
(415) 243-8400

April 30, 2002

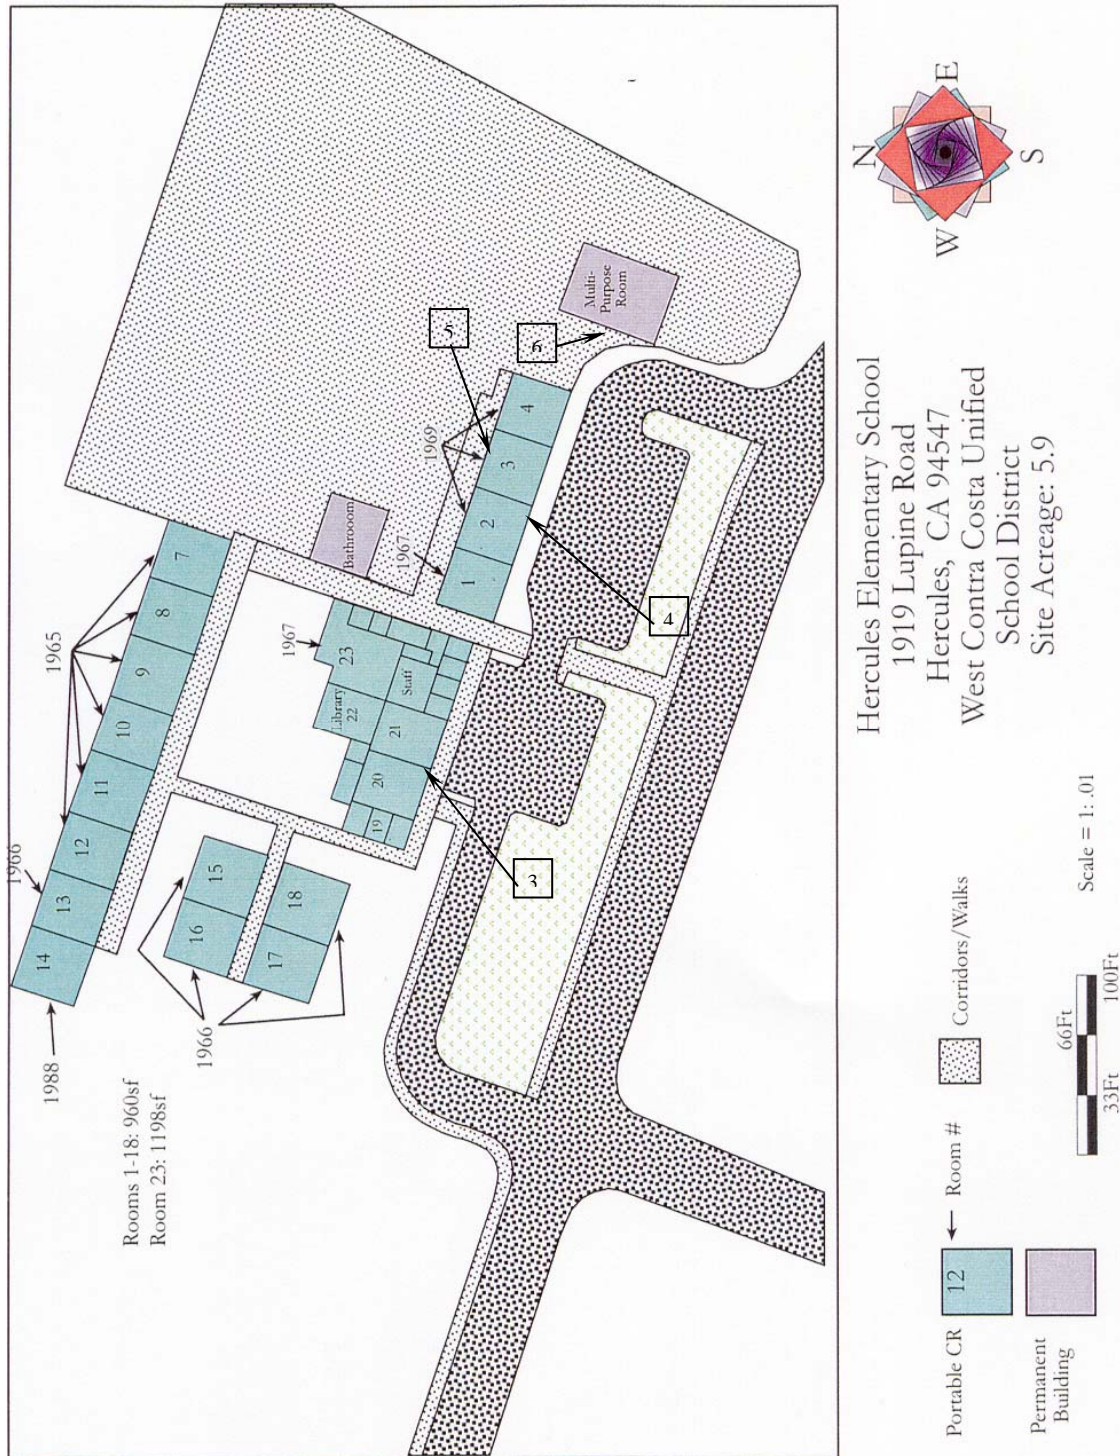
Figure 1: School Layout Plan

This school is located in the city of Hercules and was built in various stages. All the buildings in this campus are portable buildings except for multi purpose building and bathroom building (see figure 1). The classroom buildings towards the east (room numbers 1 to 3), the classroom buildings toward the north (room numbers 7 to 14) and the classroom buildings towards the west (room numbers 15 to 18), were built in the years 1966 to 1967. The year in which the multi purpose building was built is not clear, but it appears it was built in early 1980's. The administration building was built in the year 1977 (room numbers 19 to 23). Classroom number 14 was added in the year 1981. The multi purpose building was built approximately in the year 1988. The total square footage of the permanent structures is about 9000 square feet.
