STRUCTURAL EVALUATION OF
KENSINGTON ELEMENTARY SCHOOL
WEST CONTRA COSTA UNIFIED SCHOOL DISTRICT
(WCCUSD)

DASSE Design, Inc.
33 New Montgomery Street #850
San Francisco, CA 94105
(415) 243-8400

April 30, 2002

DASSE Design Project No. 01B300

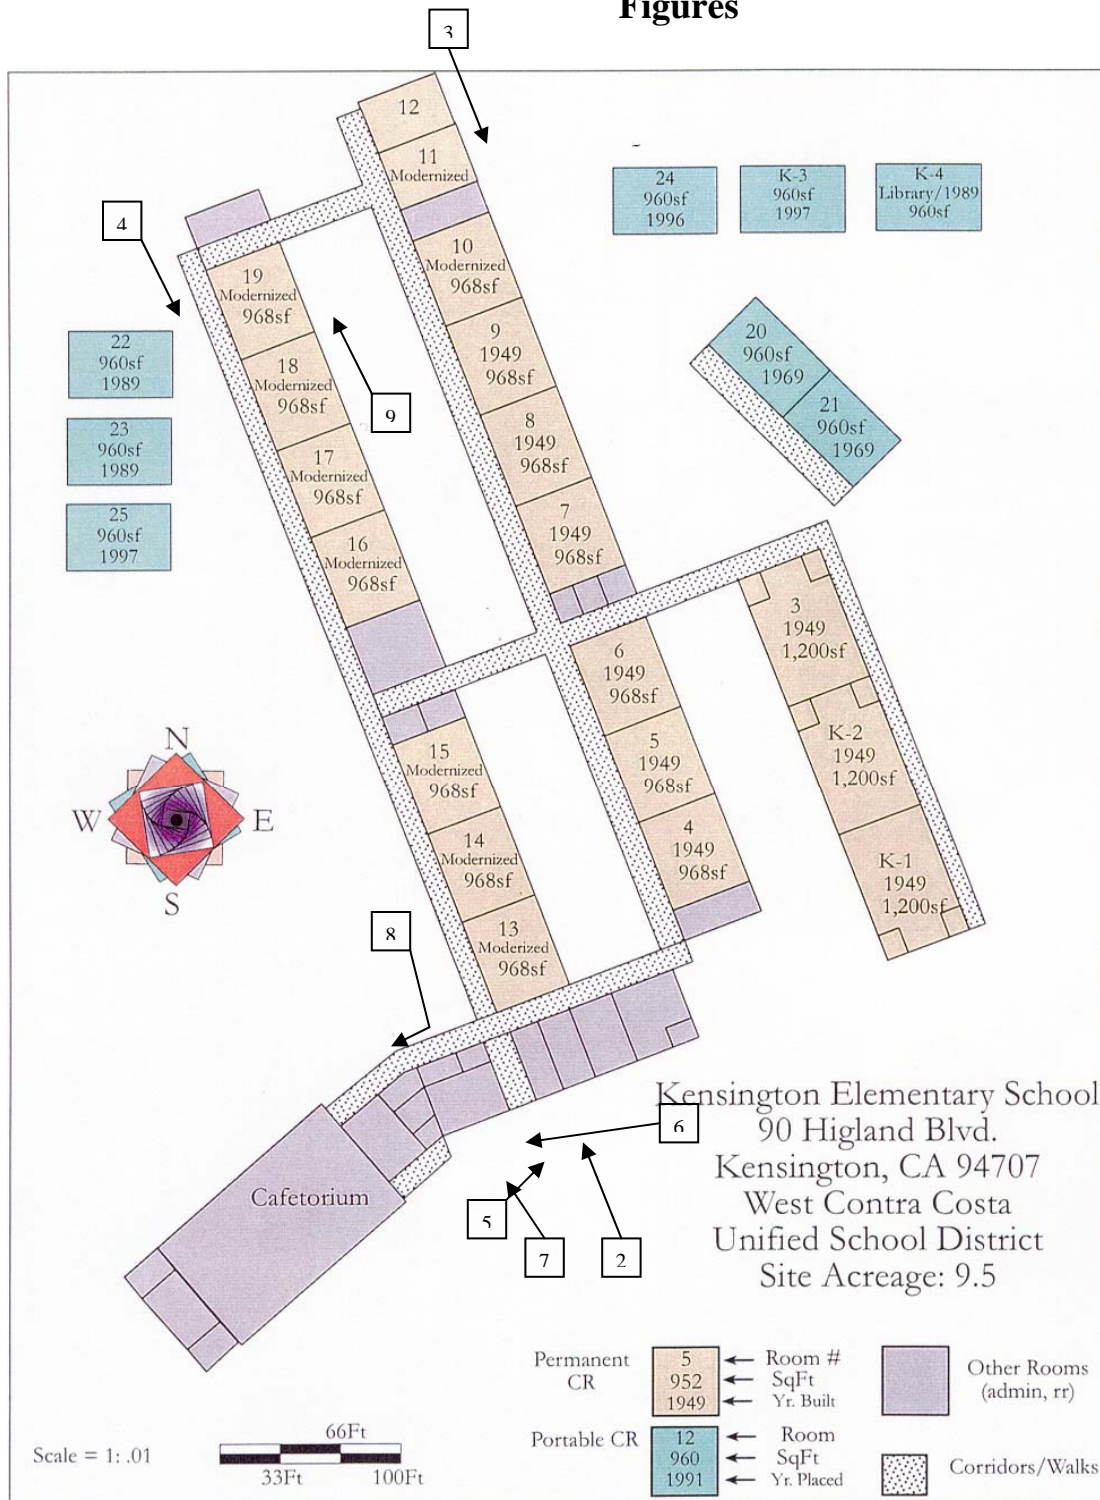
Figure 1: School Layout Plan

The school is located in the city of Kensington and was built in t 1949. The permanent buildings are one story and are primarily constructed of light wood framing. Some of the walls were constructed of masonry. Eight portable buildings were added between 1969 and 1997 (figure 1). The total square footage of the permanent structures is approximately 35,793 square feet.
