STRUCTURAL EVALUATION OF
SEAVIEW ELEMENTARY SCHOOL
WEST CONTRA COSTA UNIFIED SCHOOL DISTRICT
(WCCUSD)

DASSE Design, Inc.
33 New Montgomery Street #850
San Francisco, CA 94105
(415) 243-8400

April 30, 2002

DASSE Design Project No. 01B300

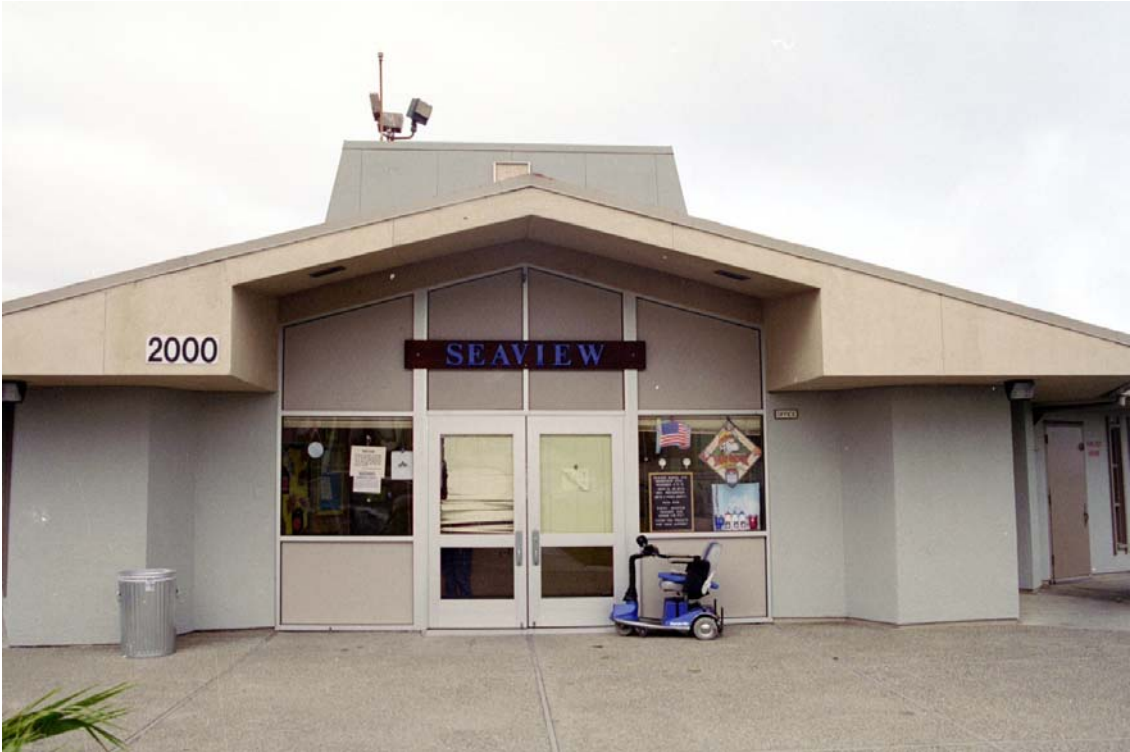
Figure 2: Administration Building, Unit A, main entrance

Construction drawings available for review of the administration building, Unit A, were incomplete at this time. However, because Unit A was designed and constructed along with the classroom buildings, Unit B and C, it is most likely that the conditions identified as life safety concerns at these buildings can be expected to exist at the administration building (see figures 2 and 3). The existing roof of the administration building, Unit A, is about 3 to 5 years old and appears to be in acceptable condition.
