STRUCTURAL EVALUATION OF  
TRANSITION LEARNING CENTER  
WEST CONTRA COSTA UNIFIED SCHOOL DISTRICT  
(WCCUSD)

April 30, 2002

DASSE Design Project No. 01B300

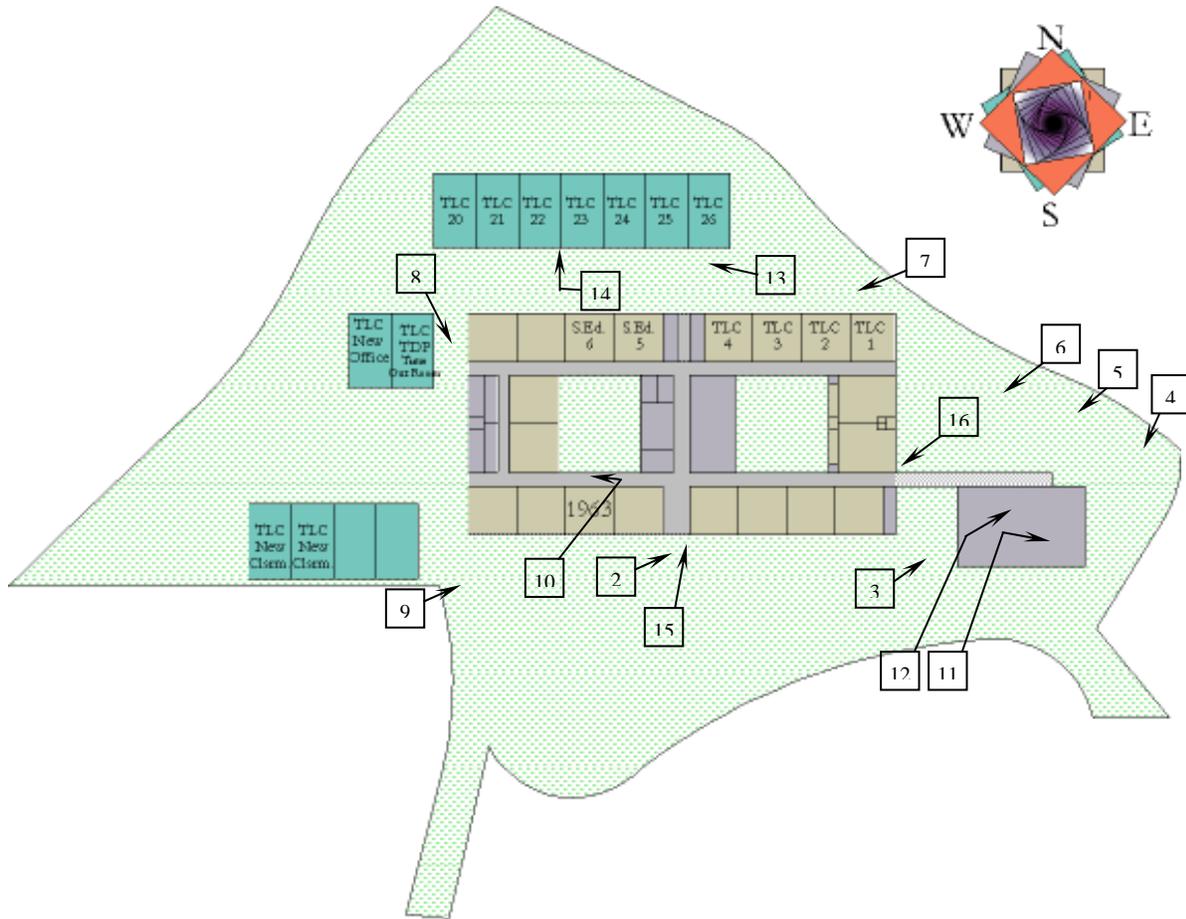
Figure 1: School Layout Plan

The school was built in 1963. The original building is a one-story wood-framed structure (main building). A one-story multi-purpose building and connecting corridor were built at a later unknown date. There are two main buildings (permanent structures) and thirteen portable buildings (see figure 1). The construction dates of the portables are not known, but appear to have at least been built after 1985. The total square footage of the permanent structures is about 44,400 square feet.

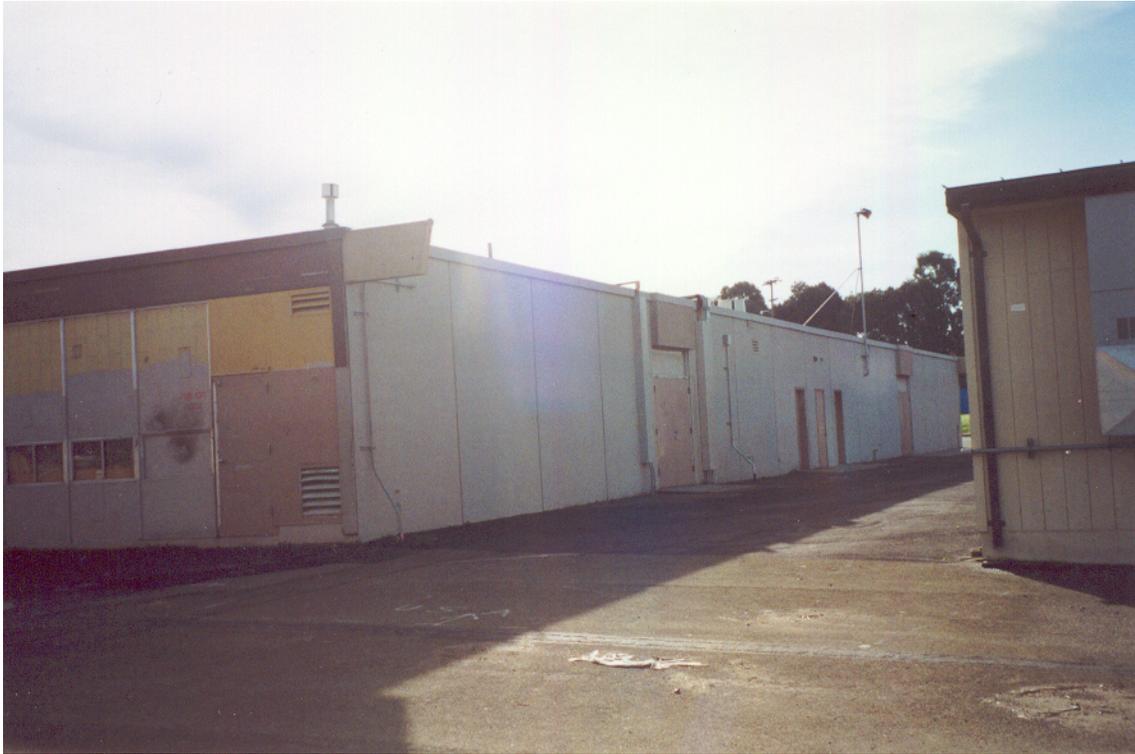
Figure 8: West Face of Main Building

The main building is a one-story wood-framed structure with plaster finish and a large number of windows, particularly on the longitudinal walls (see figures 2 and 6 through 9). The building is shaped like an "8", having two interior courtyards (see figure 1). There are interior corridors along the courtyards in the longitudinal direction. The corridors and adjacent classrooms have windows that look out into the courtyards, but there appear to be long segments of shear wall on the opposite side of the corridors (see figure 10). The corridors have acoustical tile ceilings and there are skylights in the areas that are not adjacent to the central courtyards. The classrooms and administration areas have suspended T-bar ceilings. The transverse walls at the classrooms have no openings in them. The main entrance has a canopy above it (see figures 2 and 15). The canopy is only attached to the building along the rear edge and does not align with the roof diaphragm level. Therefore, it appears that, although there is a mechanism to resist lateral motion of the canopy, there is no mechanism to prevent torsion. The canopy does have its own gravity support system consisting of pipe columns and beams.

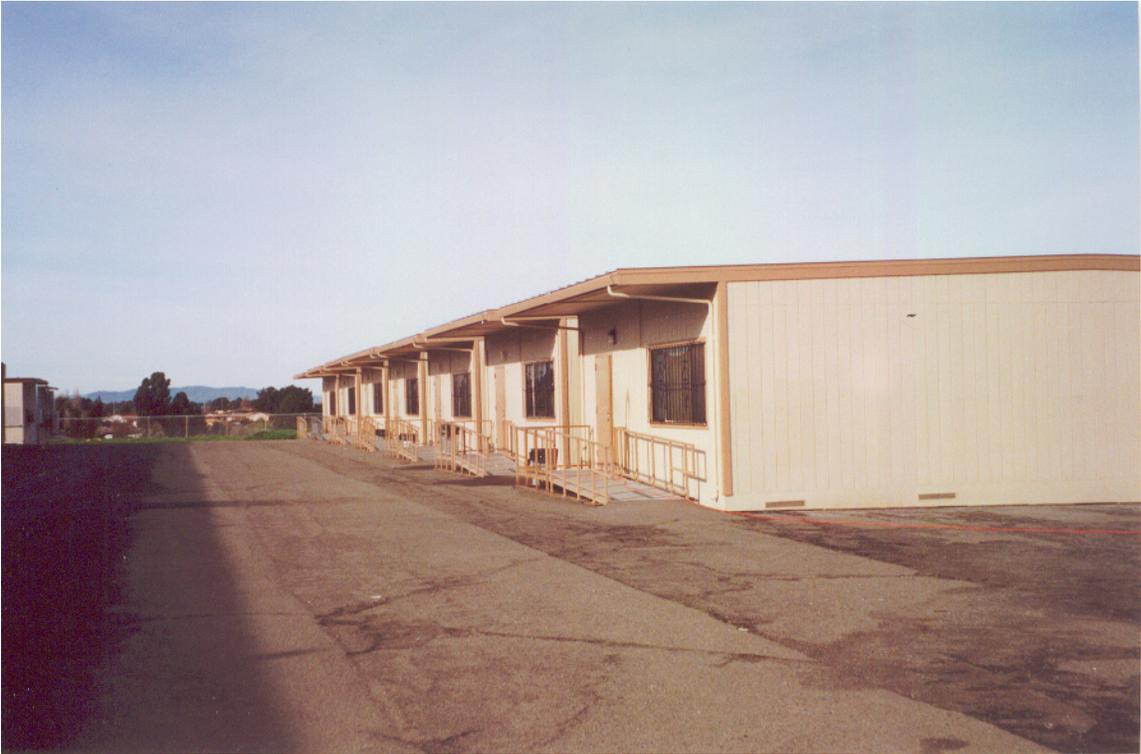
Figure 13: Portable Classrooms

DASSE's review of portable buildings has been limited to identifying clearly visible seismic deficiencies observed during our site visit and these have been documented in the report. Portable buildings pose several issues with regard to assessing their life safety hazards. First, drawings are often not available and when they are, it is not easy to associate specific drawings with specific portable buildings. Second, portable buildings are small one story wood or metal frame buildings and have demonstrated fairly safe performance in past earthquakes. Third, there is a likelihood that portable buildings (especially those constructed prior to 1982) are not in compliance with state regulations, either because they were not permitted or because the permit was for temporary occupancy and has expired.
