STRUCTURAL EVALUATION OF

VERDE ELEMENTARY SCHOOL

WEST CONTRA COSTA UNIFIED SCHOOL DISTRICT
(WCCUSD)

April 30, 2002

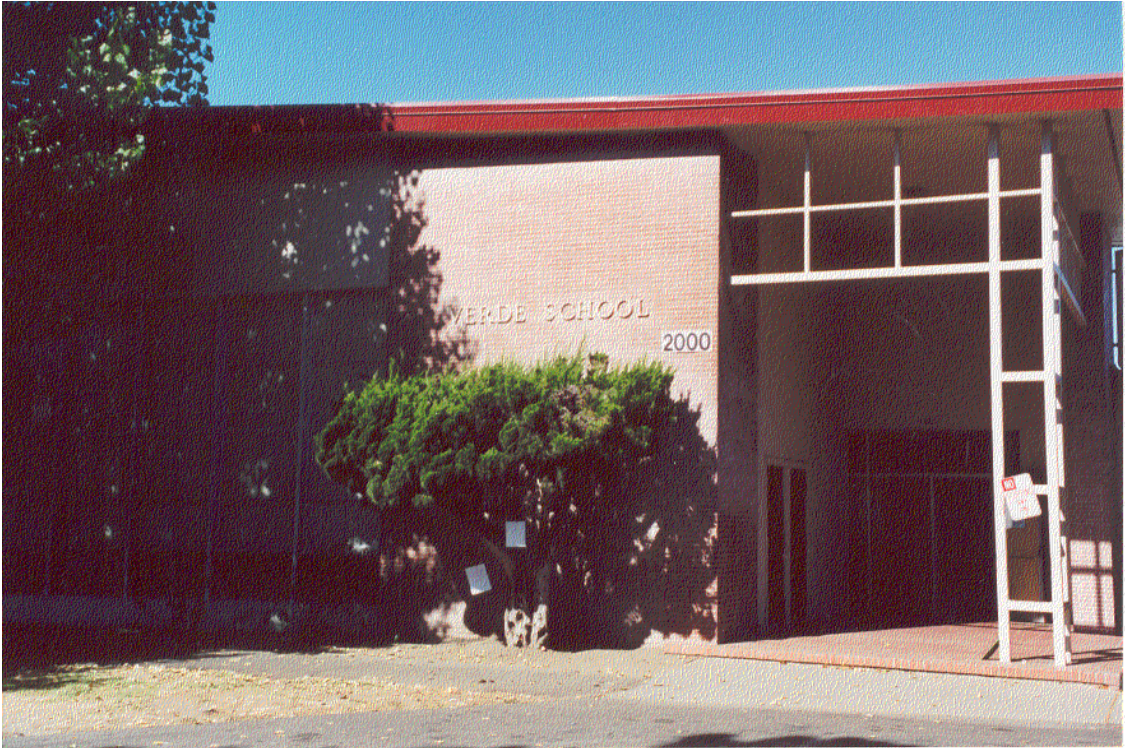
Figure 2: Main Entrance

The Unit A pod classroom building is a wood-framed structure with stucco exterior wall finishes (figure 11). The single story building is built on a slab on grade with spread footings. A built-up asphalt roof is used. The single story Unit B houses the multipurpose room and administrative offices (figures 2 and 10). It is a wood-framed building that includes roof trusses. Most of the building's exterior is stucco, but there are significant portions of brick veneer at the front of the building, including ground to roof veneer in some locations and a 20 foot tall brick pier at the entry canopy. Multiple windows and other wall openings limit the seismic shear strength of the building in the longitudinal direction to the extent that a life safety hazard is observed.

Construction drawings for Unit C are not available for review at this time. However, because the construction of Unit C is very similar to the construction of Unit D, it is most likely that the conditions identified below as life safety concerns at Unit D, can be expected to exist at Unit C as well (see figures 2 and 3). The existing roof of Unit C is about 3 years old and appears to be in acceptable condition.
