STRUCTURAL EVALUATION OF  
WASHINGTON ELEMENTARY SCHOOL  
WEST CONTRA COSTA UNIFIED SCHOOL DISTRICT  
(WCCUSD)

DASSE Design, Inc.  
33 New Montgomery Street #850  
San Francisco, CA 94105  
(415) 243-8400

April 30, 2002

DASSE Design Project No. 01B300

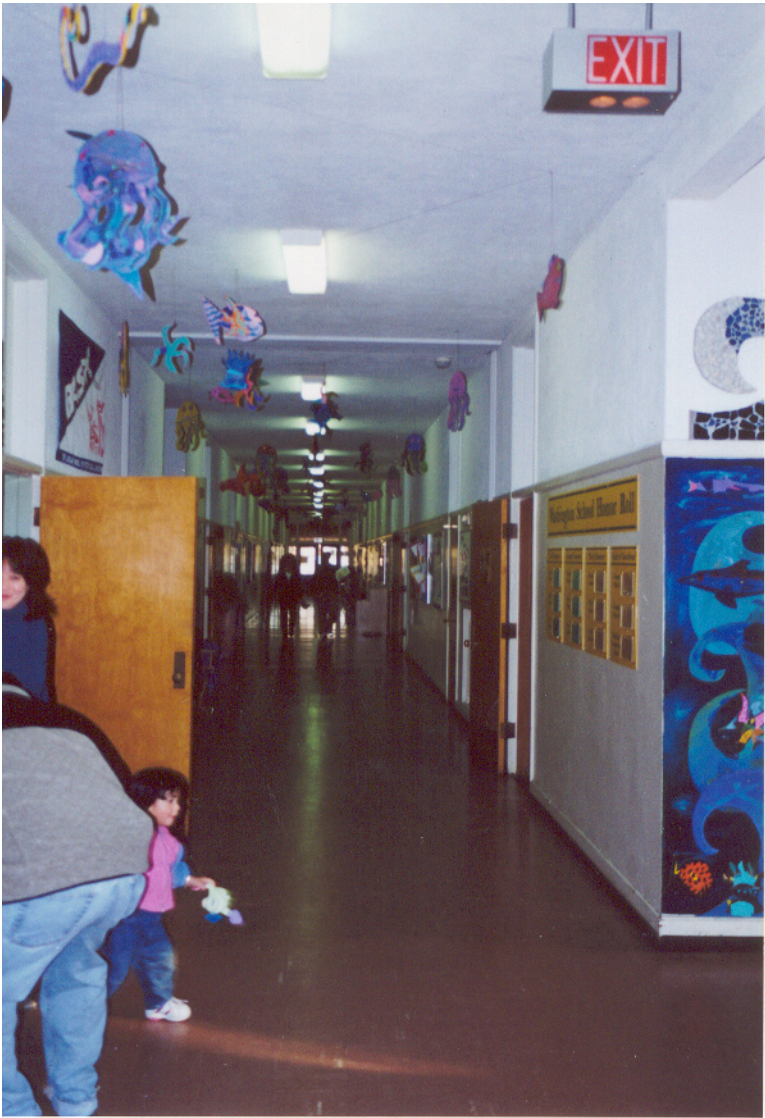
Figure 3: Main building interior corridor

The main building is an L-shaped wood-framed structure with a diagonally sheathed roof and walls. In the classroom wing, the typical roof is 2x14 rafters at 16"o.c. spanning between the exterior and central corridor bearing walls. The west wall of the corridor is diagonally sheathed, but the east wall of the corridor has only some nominal stability bracing above the roof level. The walls rest on a 10" deep x 18" wide strip footing. There are transverse shear walls between all the classrooms that rest on 12" wide strip footings. In the auditorium, 2x6 roof joists at 16"o.c. span between roof trusses. These trusses are spaced at 14' and are supported by 8x8 posts at each end. The bearing walls and posts rest on 12" deep x 24" wide strip footings. The auditorium ceiling consists of 2x6 framing spanning between the lower chords of the roof trusses. There is a system of diagonal tie rods just above the ceiling that act as a horizontal diaphragm. The exterior walls generally have large window openings with shear panels between them. At the auditorium, many of these wall piers have height to width ratios in excess of 3:1 (see figure 5), whereas the classroom wing wall piers usually have height to width ratios of 2:1 or less (see figure 2). None of the shear walls have holdowns. At the west end of the auditorium, there is a boiler room with 8" concrete walls on all sides which is significantly stiffer than the adjacent diagonally sheathed walls and can be expected to attract high loads. There is a large concrete chimney at the boiler room (see figure 5) with fire brick lining on its interior. The existing roofing at the main building is about 4 years old and appears to be in acceptable condition.
